# FACILITY CONDITION ASSESSMENT

## Montgomery County Public Schools

Earle B. Wood Middle School  
14615 Bauer Drive  
Rockville, MD 20853

*May 12, 2026*

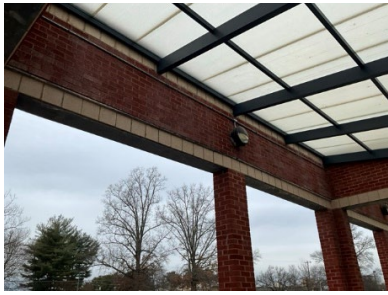
#### Exterior Walls in Poor condition.

any surface, 1-2 Story Building  
Main Building Earle B. Wood Middle School  
Building Exterior

Heavy staining across covered walkways - AssetCALC ID: 10292312

Uniformat Code: B2010  
Recommendation: **Clean in 2026**

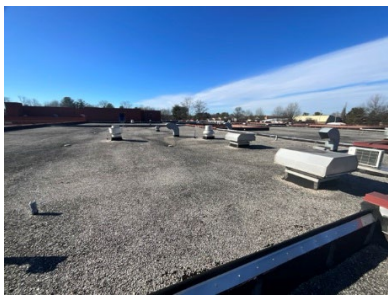
#### Roofing in Poor condition.

Built-Up  
Main Building Earle B. Wood Middle School  
Roof

Facilities department noted multiple leaks, especially in the locker rooms and stated that surface material bubbles up during summer heat. - AssetCALC ID: 10292493

Uniformat Code: B3010  
Recommendation: **Replace in 2027**

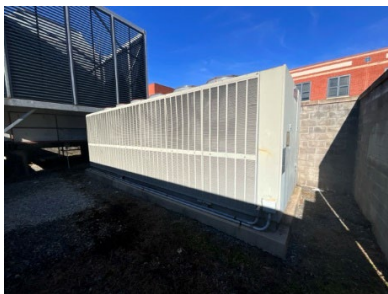
#### Chiller in Poor condition.

Air-Cooled, 101 to 150 TON  
Main Building Earle B. Wood Middle School  
Building Exterior

Unit aging out. Facilities department notes that unit never runs. - AssetCALC ID: 10292527

Uniformat Code: D3030  
Recommendation: **Replace in 2026**

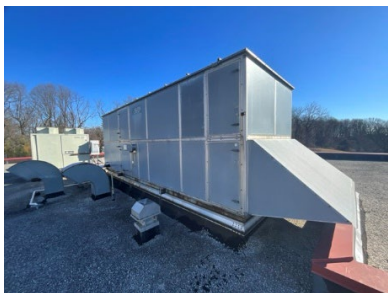
#### Air Handler in Poor condition.

Outside Air Intake Energy Recovery Unit (ERU)  
Main Building Earle B. Wood Middle School  
Roof

Facilities department notes that unit is failing and does not run as it should. - AssetCALC ID: 10292336

Uniformat Code: D3060  
Recommendation: **Replace in 2026**

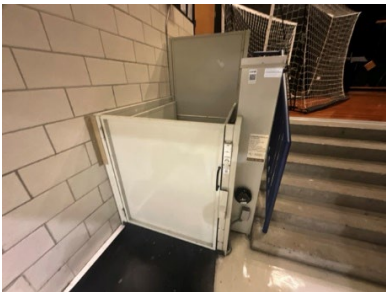
**Vertical Lift in Poor condition.**

Wheelchair, 5' Rise  
Main Building Earle B. Wood Middle School  
Stage

Aged unit. Facilities noted issues with unit due to age. - AssetCALC ID: 10292260

Uniformat Code: D1010  
Recommendation: **Renovate in 2027**

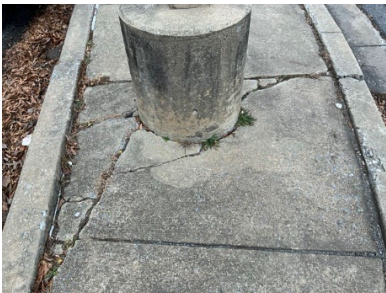
**Sidewalk in Poor condition.**

Concrete, Small Areas/Sections  
Site Earle B. Wood Middle School Site General

Areas of cracked, broken, or missing concrete. Facilities department notes uneven pavement in front of trash room, causing a tripping hazard. - AssetCALC ID: 10292156

Uniformat Code: G2030  
Recommendation: **Replace in 2027**

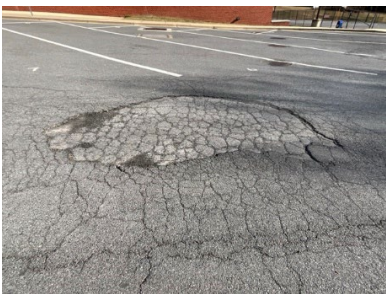
**Parking Lots**

Pavement, Asphalt  
Site Earle B. Wood Middle School Site Parking  
Areas

Patch areas of failed asphalt. Facilities department notes cracks and water accumulation at front entrance. - AssetCALC ID: 10292161

Uniformat Code: G2020  
Recommendation: **Cut & Patch in 2026**

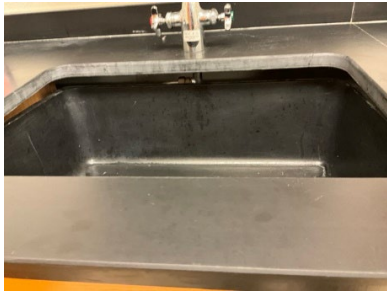
**Plumbing System in Failed condition.**

any type, Repairs per Man-Day  
Main Building Earle B. Wood Middle School  
Science Classroom

Uniformat Code: D2010  
Recommendation: **Repair in 2026**

Resecure loose sink basin - AssetCALC ID: 10292183

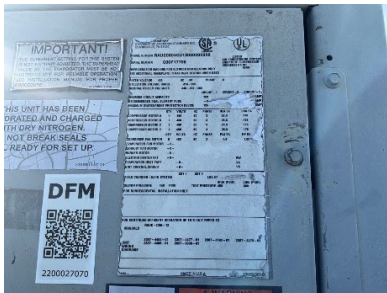
**Packaged Unit in Poor condition.**

RTU, Pad or Roof-Mounted, 51 to 60 TON  
Main Building Earle B. Wood Middle School  
Roof

Uniformat Code: D3050  
Recommendation: **Replace in 2027**
