FACILITY CONDITION ASSESSMENT

Winston Churchill High School
11300 Gainsborough Road
Potomac, MD 20854

172559.25R000-181.354

May 15, 2026

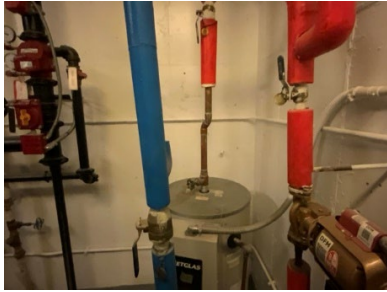
Plumbing System in Poor Condition.

Supply & Sanitary, Low Density (excludes fixtures)
Main Building Winston Churchill High School
Throughout Building

Based on visual observation at the time of assessment, sections of the domestic water supply and sanitary drain piping show signs of corrosion and aging. Localized staining and minor leakage were observed at several fittings. Further evaluation and repair by a licensed plumbing contractor is recommended. - AssetCALC ID: 10204983

Uniformat Code: D2010
Recommendation: **Replace in 2026**

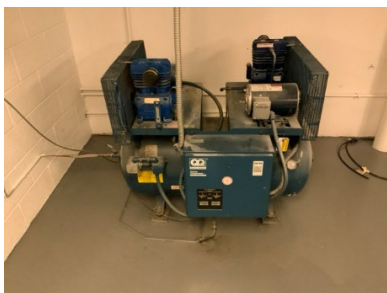
Air Compressor in Failed Condition.

Tank-Style
Main Building Winston Churchill High School
Boiler Room

Uniformat Code: D2060
Recommendation: **Replace in 2026**

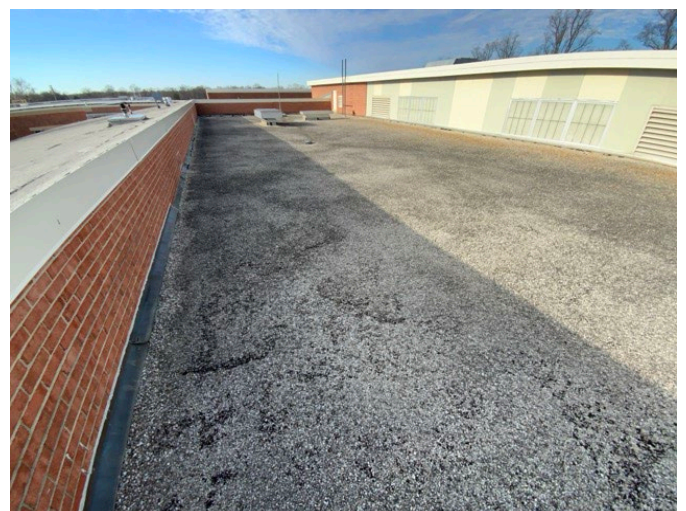
6 - ROOFING

The school's construction is made up of masonry bearing walls with metal roof decks throughout and was observed to be in good condition. The roof is mostly flat construction and features multiple levels of built-up roofing with a stone finish. Metal roofing was also observed above the vestibule connecting the original and renovated areas of the building. No roof leaks were observed or reported during the assessment with replacements budgeted accordingly. Partial roof replacement was completed seven years ago; however, the majority of the roof is aged and has blisters, surface cracking, and gravel loss evident. The exterior façade is mostly of brick veneer with aluminum windows. The interior finishes vary in type and condition throughout but are mostly aged. A large majority of the interior finishes have been replaced, including renovated restrooms, carpet, bathroom fixtures, and interior paint. However, there are a few areas of aging interior finishes. Upgrades for deficient interior finishes have been budgeted accordingly.

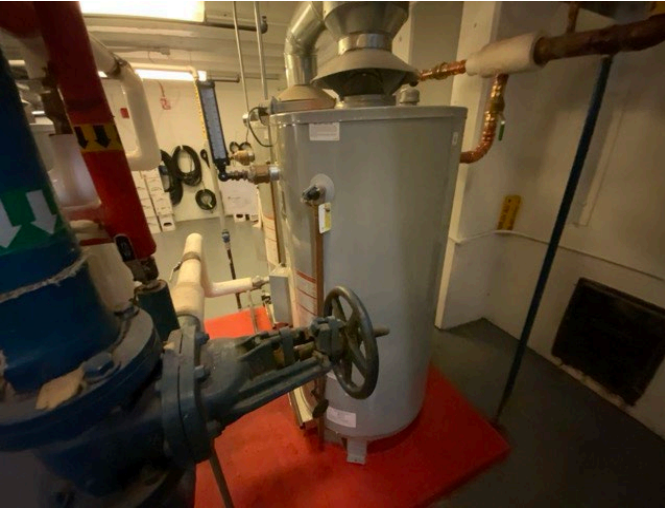
19 - WATER HEATER

Hot water is provided by electric and gas-fired water heaters located in the mechanical rooms and are in fair condition. Some water heaters will need replacement in the short term. Plumbing systems generally consist of copper supply piping and cast-iron waste pipe. The property has undergone renovations over the years, and some piping replacements have been necessary. Based on this history and the age of piping, the plumbing systems require full replacement.

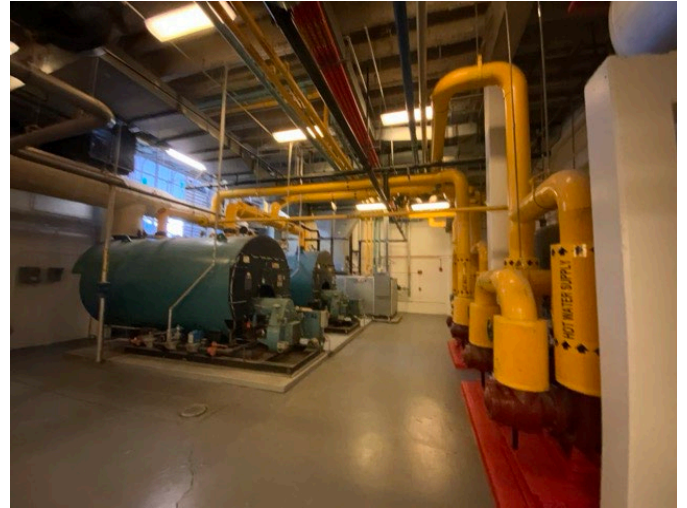
20 - BOILER ROOM

The building utilizes a central cooling and heating system for most of the spaces. The system runs off water-cooled chillers, air cooled chiller, cooling towers, and gas fired boilers. The boilers are aged and will need replacement in the short-term. The air-cooled chiller was recently replaced in 2023; however, the water-cooled chillers are aged and recommended for replacement in the short-term. The chilled and hot water are distributed by pumps to fan coil units, energy recovery units, and air handler units that are in fair condition and located in different mechanical spaces, roofs, and common areas throughout the school. Individual systems include package units and ductless split system, mostly in fair condition. The heating and cooling system overall is in fair condition. Exhaust ventilation is provided by roof mounted exhaust fans that will require lifecycle replacement within the study period.
