FACILITY CONDITION ASSESSMENT

Northwest High School
13501 Richter Farm Road
Germantown, MD 20874

172559.25R000-190.354

May 26, 2026

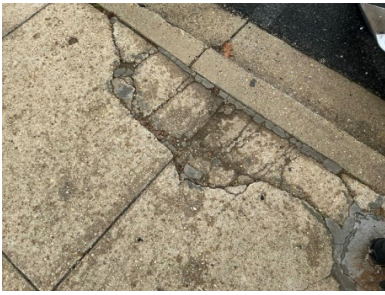
Cracked sidewalk pavement - AssetCALC ID: 10496757

Sidewalk in Poor condition.

any pavement type, Sectional Repairs (per Man-Day)
Site Northwest High School Site

Uniformat Code: G2030
Recommendation: **Repair in 2026**

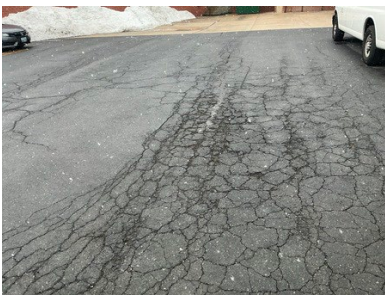
Cracked asphalt pavement and potholes throughout parking lot and driveways - AssetCALC ID: 10496924

Parking Lots in Poor condition.

Uniformat Code: G2020
Recommendation: **Repair in 2026**

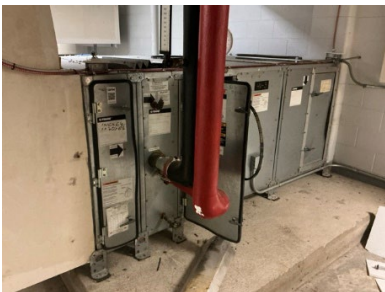
Not functioning - AssetCALC ID: 10497036

Air Handler in Failed condition.

Uniformat Code: D3050
Recommendation: **Replace in 2025**

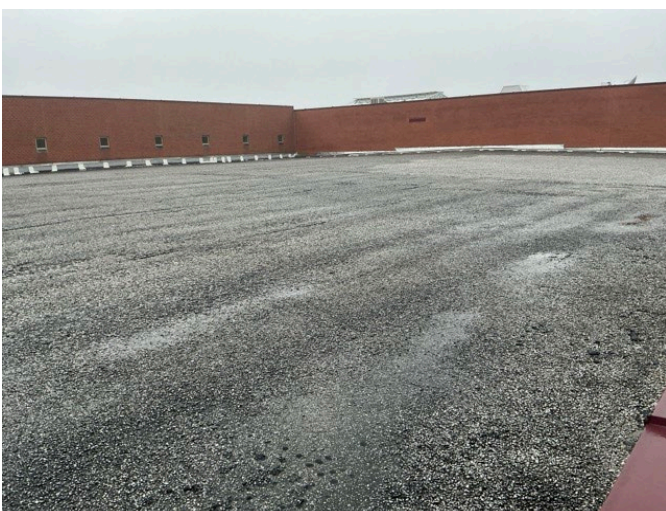
5 - ROOF

In general, the structure appears to be sound, with no significant areas of settlement or structural-related deficiencies observed. Roof leaks have occurred within the past year, and some of these leaks remain active. All active leaks must be repaired. The windows are in fair condition with no window leaks reported. The finishes in the elevator cabs are worn and require replacement. The interior finishes were observed to be in fair condition overall throughout the building. Typical lifecycle replacements of the interior and exterior finishes are budgeted and anticipated.

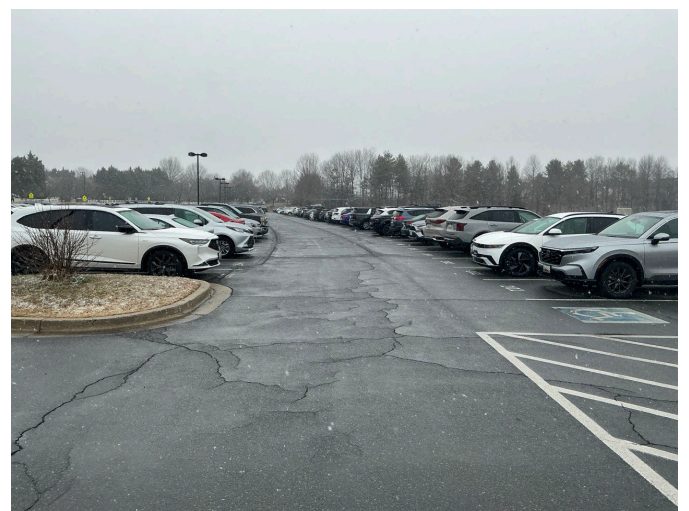
6 - PARKING LOT

Site maintenance appears to be good, and site improvements and landscaping are generally in good condition. The parking lot has developed numerous potholes and heavy surface wear and should be milled and overlaid. The sidewalk has isolated areas of cracking and uneven pavement. To prevent trip hazards, sidewalk repairs are recommended. The majority of the site lighting consists of energy inefficient metal halide and high-pressure sodium fixtures and lamps. The athletic fields and courts were observed to be in fair condition.
