FACILITY CONDITION ASSESSMENT

Quince Orchard High School
15800 Quince Orchard Road
Gaithersburg, MD 20878

172559.25R000-194.354

May 15, 2026

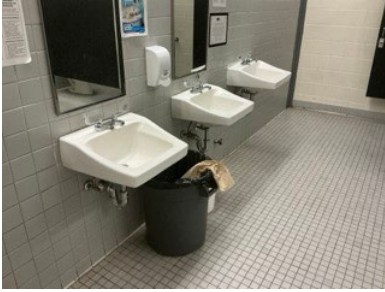
ADA Restrooms in Failed condition.

Lavatory, Pipe Wraps/Insulation
Main Building Quince Orchard High School
Restrooms

Missing ADA pipe wrap in all restrooms - AssetCALC ID: 10040521

Uniformat Code: Y1050
Recommendation: **Install in 2025**

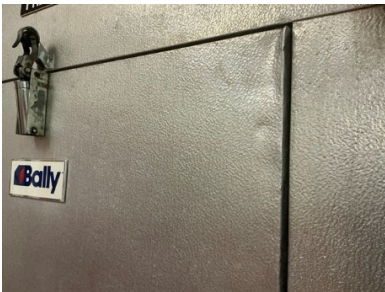
Foodservice Equipment in Failed condition.

Walk-In, Freezer
Main Building Quince Orchard High School
Kitchen

POC reports that door not closing properly so problem with maintaining proper temperature resulting in mold - AssetCALC ID: 9951694

Uniformat Code: E1030
Recommendation: **Replace in 2025**

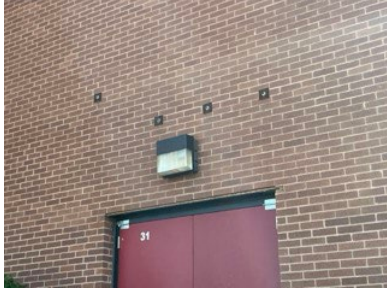
Exterior Light in Poor condition.

Any Type, with LED Replacement
Main Building Quince Orchard High School
Building Exterior

POC indicates that lights dim and antiquated - AssetCALC ID: 9953859

Uniformat Code: D5040
Recommendation: **Replace in 2025**

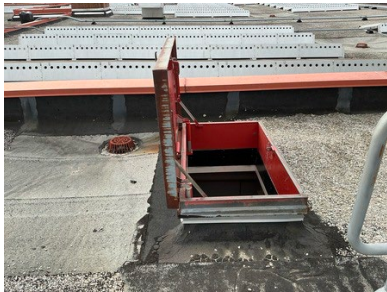
Roof Hatch in Poor condition.

Metal
Main Building Quince Orchard High School
Roof

Rusted hatch. No guard rails around hatch - AssetCALC ID: 9951618

Uniformat Code: B3060
Recommendation: **Replace in 2025**

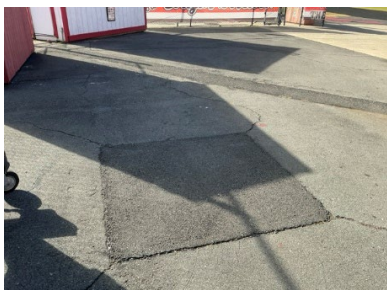
Parking Lots in Poor condition.

Pavement, Asphalt
Site Quince Orchard High School Field House

Large cracks throughout - AssetCALC ID: 10006116

Uniformat Code: G2020
Recommendation: **Mill and Overlay in 2026**

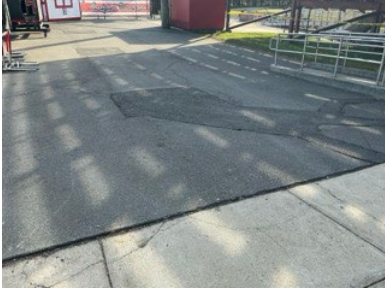
Parking Lots in Poor condition.

Pavement, Asphalt
Site Quince Orchard High School Stadium

Several large cracks throughout the - AssetCALC ID: 9951743

Uniformat Code: G2020
Recommendation: **Mill and Overlay in 2026**

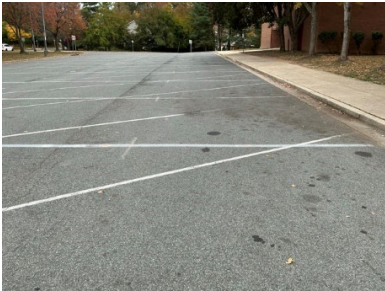
Parking Lots in Poor condition.

Pavement, Asphalt
Site Quince Orchard High School Bus Loop

Large cracks and potholes - AssetCALC ID: 9959416

Uniformat Code: G2020
Recommendation: **Seal and Stripe in 2026**

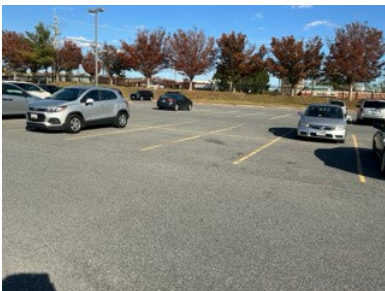
Parking Lots in Poor condition.

Pavement, Asphalt
Site Quince Orchard High School Front Parking

Large cracks throughout - AssetCALC ID: 9959412

Uniformat Code: G2020
Recommendation: **Seal and Stripe in 2026**

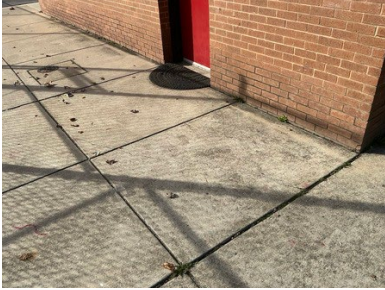
Parking Lots in Poor condition.

Pavement, Concrete
Site Quince Orchard High School Field House

Large cracks throughout - AssetCALC ID: 10006101

Uniformat Code: G2020
Recommendation: **Replace in 2026**

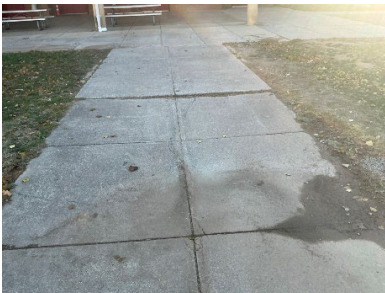
Parking Lots in Poor condition.

Pavement, Concrete
Site Quince Orchard High School Site Rear

Broken, cracked and heaving concrete pavement - AssetCALC ID: 10000596

Uniformat Code: G2020
Recommendation: **Replace in 2026**

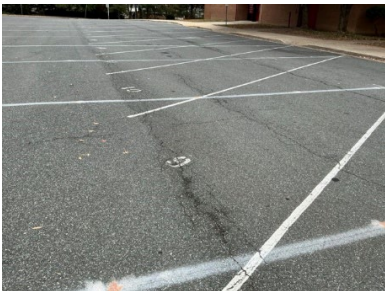
Parking Lots in Poor condition.

Pavement, Asphalt
Site Quince Orchard High School Bus Loop

Large cracks and potholes - AssetCALC ID: 9959415

Uniformat Code: G2020
Recommendation: **Mill and Overlay in 2026**

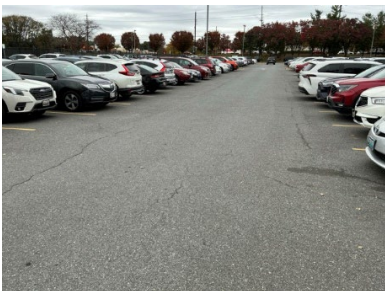
Parking Lots in Poor condition.

Pavement, Asphalt
Site Quince Orchard High School Front Parking

Large cracks throughout - AssetCALC ID: 9959414

Uniformat Code: G2020
Recommendation: **Mill and Overlay in 2026**

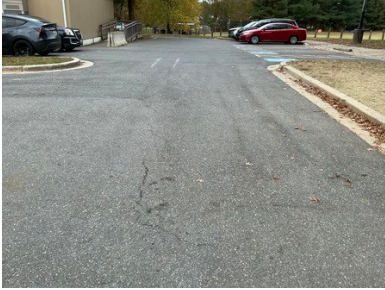
Parking Lots in Poor condition.

Pavement, Asphalt
Site Quince Orchard High School Rear Parking

Large cracks throughout - AssetCALC ID: 9959410

Uniformat Code: G2020
Recommendation: **Mill and Overlay in 2027**

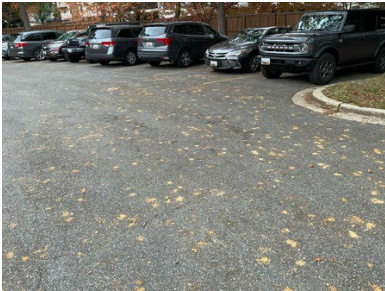
Parking Lots in Poor condition.

Pavement, Asphalt
Site Quince Orchard High School Rear Parking

Large cracks throughout - AssetCALC ID: 9959413

Uniformat Code: G2020
Recommendation: **Seal and Stripe in 2027**

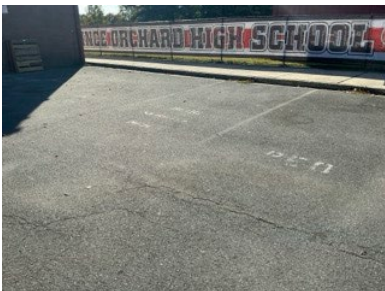
Parking Lots in Poor condition.

Pavement, Asphalt
Site Quince Orchard High School
Receiving/Parking

Large cracks throughout - AssetCALC ID: 9951728

Uniformat Code: G2020
Recommendation: **Seal and Stripe in 2027**

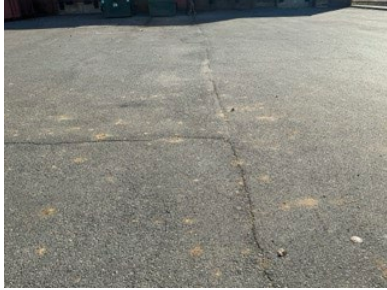
Parking Lots in Poor condition.

Pavement, Asphalt
Site Quince Orchard High School
Receiving/Parking

Several large cracks throughout - AssetCALC ID: 9951729

Unifomat Code: G2020
Recommendation: **Mill and Overlay in 2027**

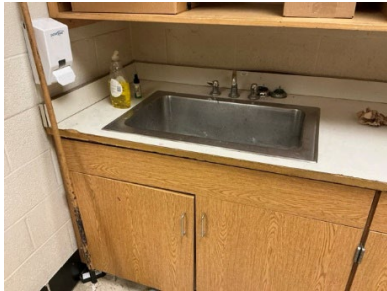
Casework in Failed condition.

Countertop, Plastic Laminate
Main Building Quince Orchard High School
Instrumental Music

Plastic laminate missing from edges and bubbling - AssetCALC ID: 9953887

Unifomat Code: E2010
Recommendation: **Replace in 2026**

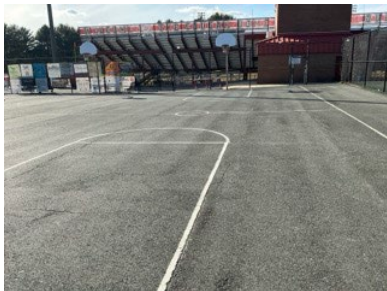
Athletic Surfaces and Courts in Poor condition.

Basketball/General, Asphalt Pavement
Site Quince Orchard High School Basketball
Court

Large cracks throughout - AssetCALC ID: 9951748

Unifomat Code: G2050
Recommendation: **Replace in 2026**

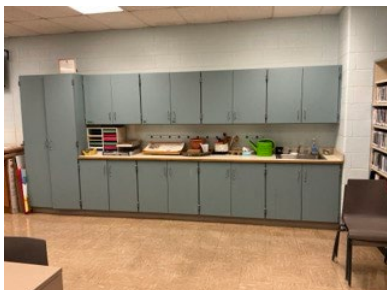
Casework in Poor condition.

Countertop, Plastic Laminate
Main Building Quince Orchard High School
Media

Plastic laminate missing at edge - AssetCALC ID: 9951719

Unifomat Code: E2010
Recommendation: **Replace in 2026**

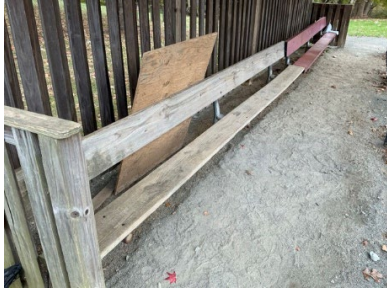
Sports Apparatus in Poor condition.

Player/Dugout Benches, 12' Length
Site Quince Orchard High School Baseball Field

Wood seats warped and cracked - AssetCALC ID: 9953944

Uniformat Code: G2050
Recommendation: **Replace in 2026**

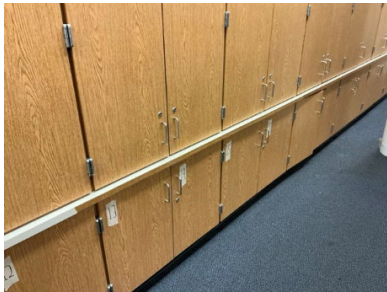
Casework in Poor condition.

Cabinetry, High-End or Laboratory
Main Building Quince Orchard High School Instrumental Music

Plastic laminate missing at edges and bubbling - AssetCALC ID: 9953902

Uniformat Code: E2010
Recommendation: **Replace in 2026**

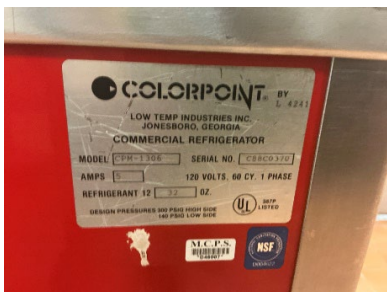
Foodservice Equipment in Failed condition.

Refrigerator, 1-Door Reach-In
Main Building Quince Orchard High School Kitchen

Not working - AssetCALC ID: 9951615

Uniformat Code: E1030
Recommendation: **Replace in 2025**

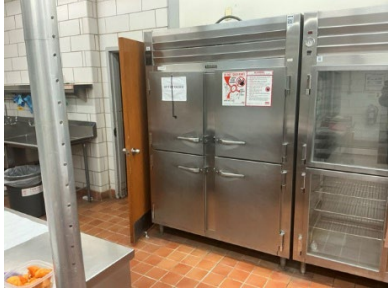
Foodservice Equipment in Failed condition.

Refrigerator, 2-Door Reach-In
Main Building Quince Orchard High School
Kitchen

Not working - AssetCALC ID: 9951570

Uniformat Code: E1030
Recommendation: **Replace in 2025**

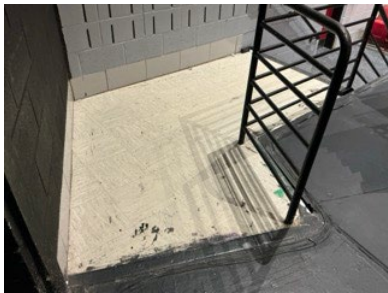
Flooring in Poor condition.

Vinyl Tile (VCT)
Main Building Quince Orchard High School
Auditorium Stage

VCT cracked and broken, missing pieces - AssetCALC ID: 9951634

Uniformat Code: C2030
Recommendation: **Replace in 2026**

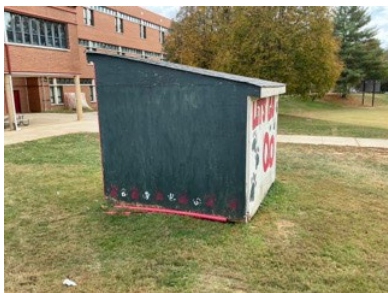
Shed/Gazebo/Shade Structure in Poor condition.

Wood or Metal-Framed, Basic/Minimal
Site Quince Orchard High School Softball Field
Storage

Bottom of panels water damaged and warped. Missing door - AssetCALC ID: 9953927

Uniformat Code: F1020
Recommendation: **Replace in 2026**

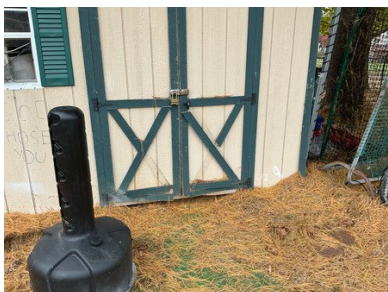
Shed/Gazebo/Shade Structure in Poor condition.

Wood or Metal-Framed, Basic/Minimal
Site Quince Orchard High School Baseball
Storage

Siding warped and rotted - AssetCALC ID: 9953928

Uniformat Code: F1020
Recommendation: **Replace in 2026**

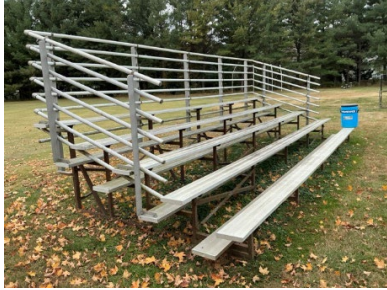
Bleachers in Poor condition.

Fixed Steel Frame, Aluminum Benches (per Seat)
Site Quince Orchard High School
Baseball/Softball Field

Supports rusted. Some benches bent - AssetCALC ID: 9953948

Uniformat Code: E2010
Recommendation: **Replace in 2026**

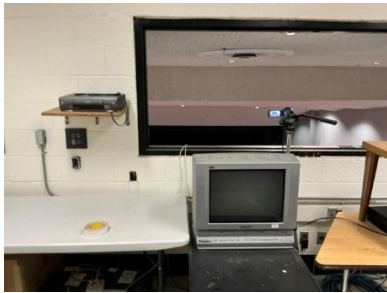
Sound System in Poor condition.

Theater/Auditorium/Church
Main Building Quince Orchard High School
Auditorium

POC reports system continuously not working properly. - AssetCALC ID: 10000510

Uniformat Code: D6030
Recommendation: **Replace in 2026**

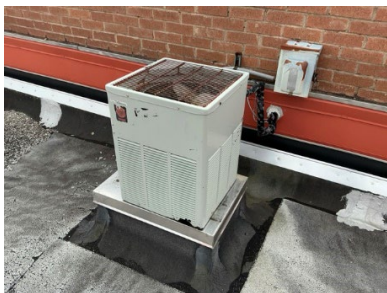
Split System in Poor condition.

Condensing Unit/Heat Pump
Main Building Quince Orchard High School
Roof

Exceedingly aged and corroded unit uses outdated R-22 refrigerant - AssetCALC ID: 9959304

Uniformat Code: D3030
Recommendation: **Replace in 2026**

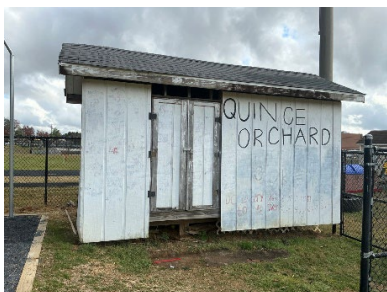
Shed/Gazebo/Shade Structure in Poor condition.

Wood or Metal-Framed, Basic/Minimal
Site Quince Orchard High School Softball Field
Storage

Panels loose. Missing step to shed. - AssetCALC ID: 9953931

Uniformat Code: F1020
Recommendation: **Replace in 2026**

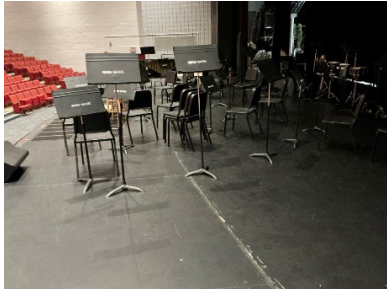
Flooring in Poor condition.

Plywood
Main Building Quince Orchard High School
Auditorium Stage

POC reports that needs new surface - AssetCALC ID: 9951722

Uniformat Code: C2030
Recommendation: **Replace in 2027**

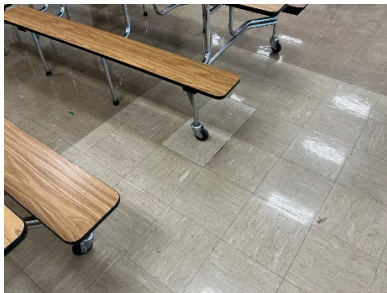
Flooring in Poor condition.

Vinyl Tile (VCT)
Main Building Quince Orchard High School
Cafeteria

Broken, stained tile - AssetCALC ID: 10000509

Uniformat Code: C2030
Recommendation: **Replace in 2027**

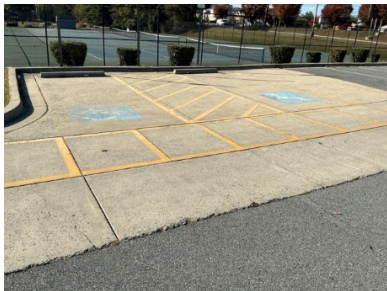
ADA Parking in Failed condition.

Signage, Pole-Mounted
Site Quince Orchard High School Site Parking
Areas

Missing signs at ADA parking - AssetCALC ID: 10049511

Uniformat Code: Y1010
Recommendation: **Install in 2025**
