# FACILITY CONDITION ASSESSMENT

**Montgomery County Public Schools**  
45 West Gude Drive, Suite 4000  
Rockville, MD 20850

Thomas Edison High School of Technology  
12501 Dalewood Drive  
Silver Spring, MD 20906

*May 15, 2026*

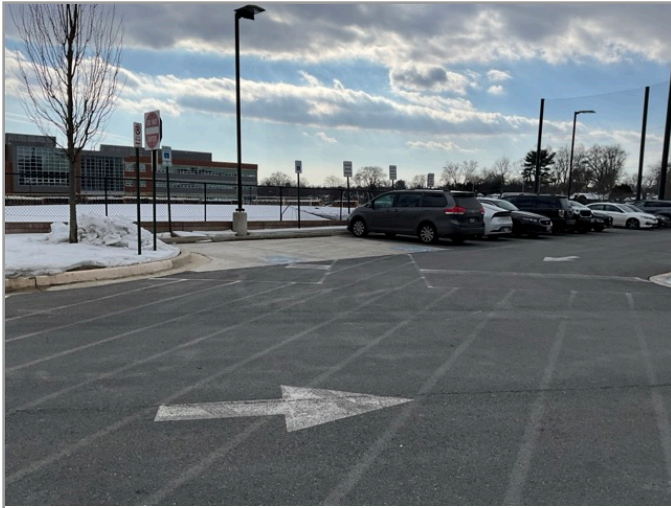
OVERVIEW OF ACCESSIBLE PARKING AREA

Question		Yes	No	NA	Comments
1	Does the required number of standard ADA designated spaces appear to be provided ?	✗			
2	Does the required number of van-accessible designated spaces appear to be provided ?	✗			
3	Are accessible spaces on the shortest accessible route to an accessible building entrance ?	✗			
4	Does parking signage include the International Symbol of Accessibility ?	✗			
5	Does each accessible space have an adjacent access aisle ?	✗			
6	Do parking spaces and access aisles appear to be relatively level and without obstruction ?	✗

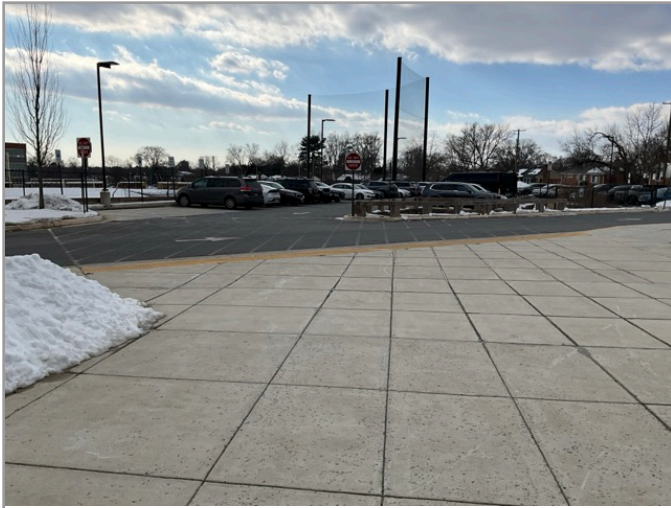
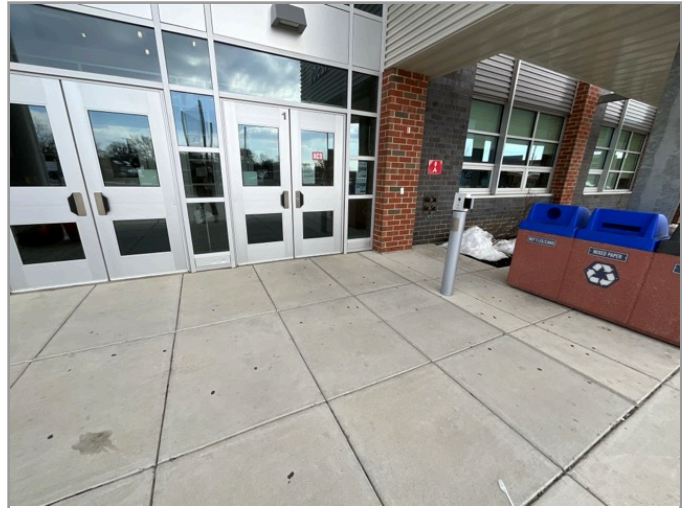
ACCESSIBLE PATH

Question		Yes	No	NA	Comments
1	Is an accessible route present from public transportation stops and municipal sidewalks on or immediately adjacent to the property ?	X			
2	Does a minimum of one accessible route appear to connect all public areas on the exterior, such as parking and other outdoor amenities, to accessible building entrances ?	X			
3	Are curb ramps present at transitions through raised curbs on all accessible routes?	X			
4	Do curb ramps appear to have compliant slopes for all components ?	X			
5	Do ramp runs on an accessible route appear to have compliant slopes ?			X	
6	Do ramp runs on an accessible route appear to have a compliant rise and width ?			X

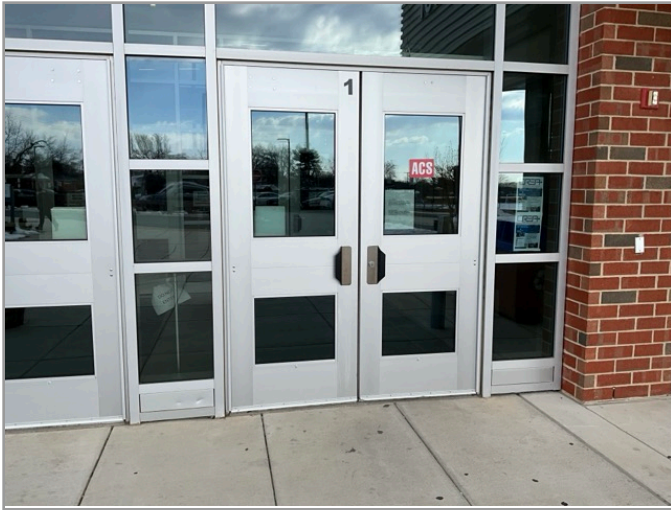
ACCESSIBLE ENTRANCE

Question		Yes	No	NA	Comments
1	Do a sufficient number of accessible entrances appear to be provided ?	✗			
2	If the main entrance is not accessible, is an alternate accessible entrance provided?	✗			
3	Is signage provided indicating the location of alternate accessible entrances ?	✗			
4	Do doors at accessible entrances appear to have compliant maneuvering clearance area on each side ?	✗			
5	Do doors at accessible entrances appear to have compliant hardware ?	✗			
6	Do doors at accessible entrances appear to have a compliant clear opening width ?	✗

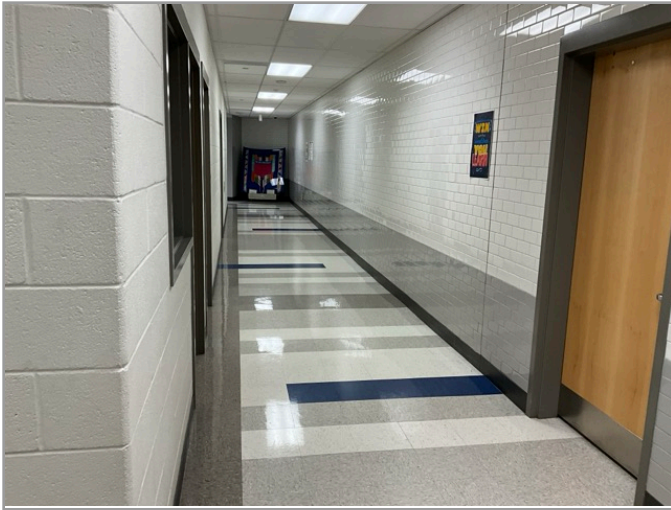
ACCESSIBLE INTERIOR PATH

Question		Yes	No	NA	Comments
1	Does an accessible route appear to connect all public areas inside the building ?	✗			
2	Do accessible routes appear free of obstructions and/or protruding objects ?	✗			
3	Do ramps on accessible routes appear to have compliant slopes ?	✗			
4	Do ramp runs on an accessible route appear to have a compliant rise and width ?	✗			
5	Do ramps on accessible routes appear to have compliant end and intermediate landings ?	✗			
6	Do ramps on accessible routes appear to have compliant handrails ?			✗

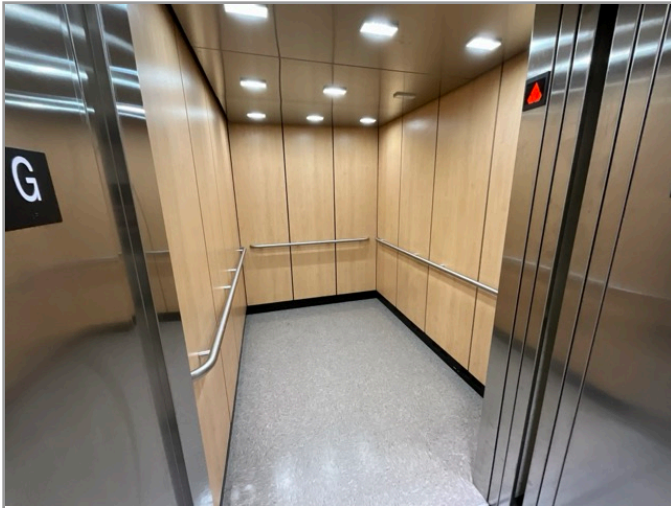
LOBBY LOOKING AT CABS (WITH DOORS OPEN)

Question		Yes	No	NA	Comments
1	Are hallway call buttons configured with the "UP" button above the "DOWN" button?	✗			
2	Is accessible floor identification signage present on the hoistway sidewalls on each level ?	✗			
3	Do the elevators have audible and visual arrival indicators at the lobby and hallway entrances?	✗			
4	Do the elevator hoistway and car interior appear to have a minimum compliant clear floor area ?	✗			
5	Do the elevator car doors have automatic re-opening devices to prevent closure on obstructions?	✗			
6	Do elevator car control buttons appear to be mounted at a compliant height ?	✗

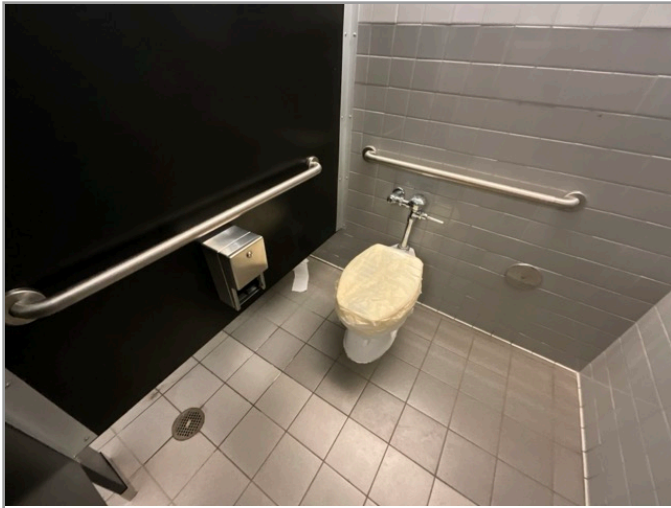
TOILET STALL OVERVIEW

Question		Yes	No	NA	Comments
1	Do publicly accessible toilet rooms appear to have a minimum compliant floor area ?	✗			
2	Does the lavatory appear to be mounted at a compliant height and with compliant knee area ?	✗			
3	Does the lavatory faucet have compliant handles ?	✗			
4	Is the plumbing piping under lavatories configured to protect against contact ?	✗			
5	Are grab bars provided at compliant locations around the toilet ?	✗			
6	Do toilet stall doors appear to provide the minimum compliant clear width ?	✗

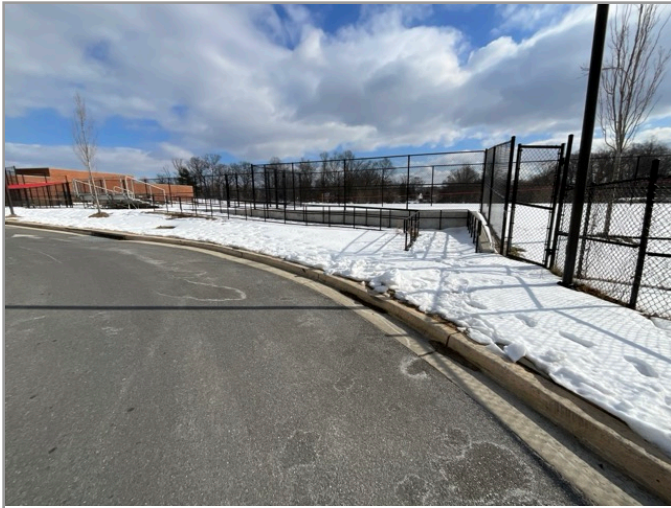
ACCESSIBLE ROUTE TO FIELD

Question		Yes	No	NA	Comments
1	Is there an accessible route to the play area / s?	✘			
2	Has the play area been reviewed for accessibility ?			✘	Unknown
3	Are publicly accessible swimming pools equipped with an entrance lift ?			✘
