# FACILITY CONDITION ASSESSMENT

**Montgomery County Public Schools**  
45 West Gude Drive, Suite 4000  
Rockville, MD 20850

Bradley Hills Elementary School  
8701 Hartsdale Avenue  
Bethesda, MD 20817

*October 13, 2025*

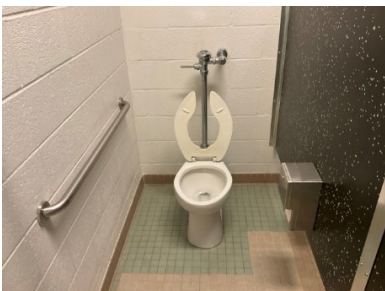
ADA Restroom toilet stall - AssetCALC ID: 9631678

Uniformat Code: Y1050  
Recommendation: **Modify in 2025**
