FACILITY CONDITION ASSESSMENT

Montgomery County Public Schools
45 West Gude Drive, Suite 4000
Rockville, MD 20850

DuFief Elementary School
15001 DuFief Drive
Gaithersburg, MD 20878

August 14, 2025

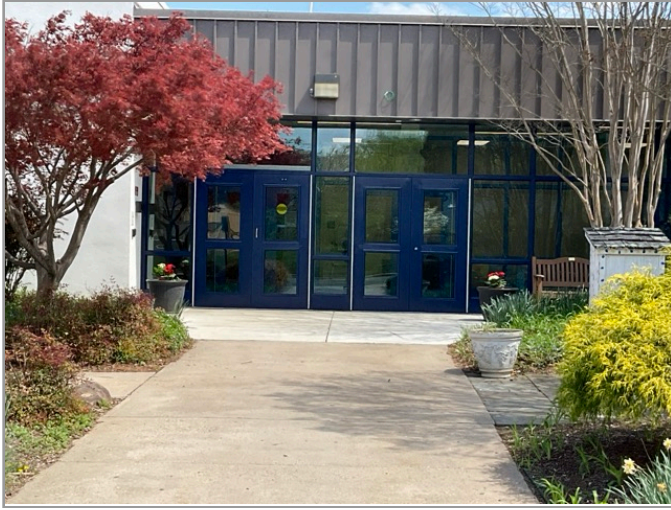
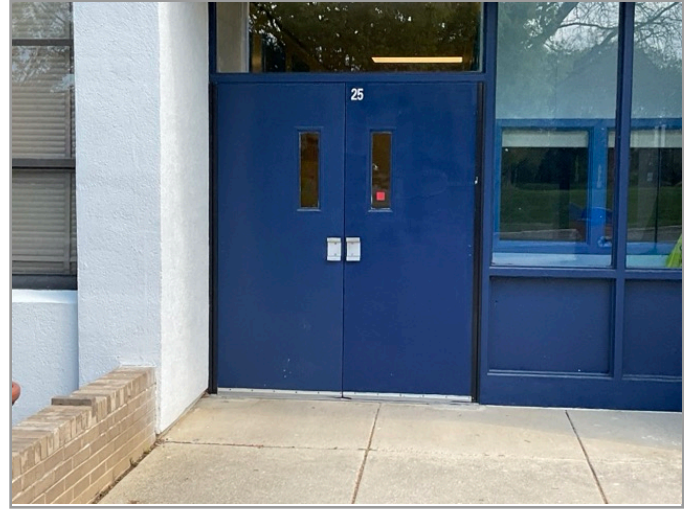
Building Entrances

Question		Yes	No	NA	Comments
1	Do a sufficient number of accessible entrances appear to be provided ?	✗			
2	If the main entrance is not accessible, is an alternate accessible entrance provided?	✗			
3	Is signage provided indicating the location of alternate accessible entrances ?		✗		No secondary signage observed
4	Do doors at accessible entrances appear to have compliant maneuvering clearance area on each side ?	✗			
5	Do doors at accessible entrances appear to have compliant hardware ?		✗		Hardware not accessible
6	Do doors at accessible entrances appear to have a compliant clear opening width ?	✗

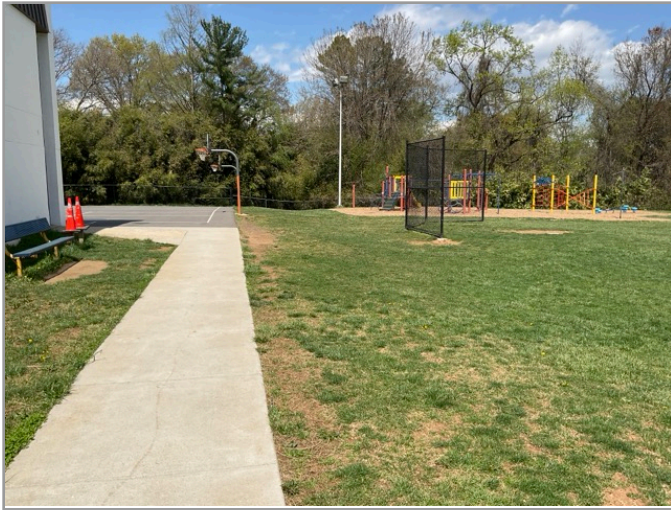
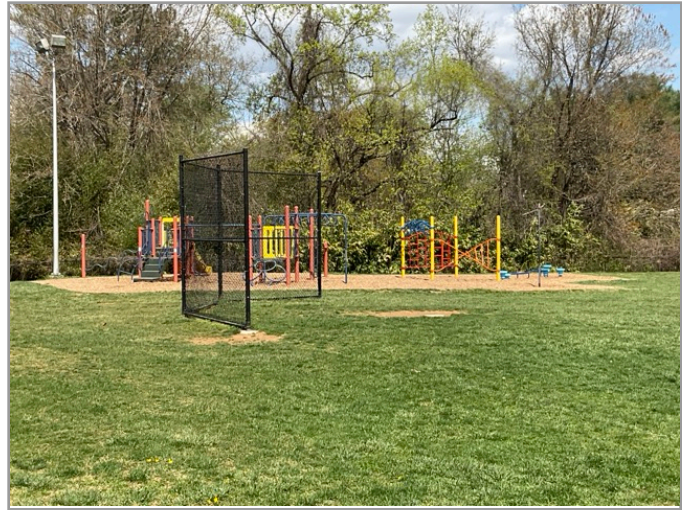
Playgrounds & Swimming Pools

Question		Yes	No	NA	Comments
1	Is there an accessible route to the play area / s?	✗			
2	Has the play area been reviewed for accessibility ?			✗	Unknown
3	Are publicly accessible swimming pools equipped with an entrance lift ?			✗
