# FACILITY CONDITION ASSESSMENT

East Silver Spring Elementary School  
631 Silver Spring Avenue  
Silver Spring, MD 20910

172559.25R000-039.354

*August 20, 2025 (original)*  
*September 24, 2025 (revised)*

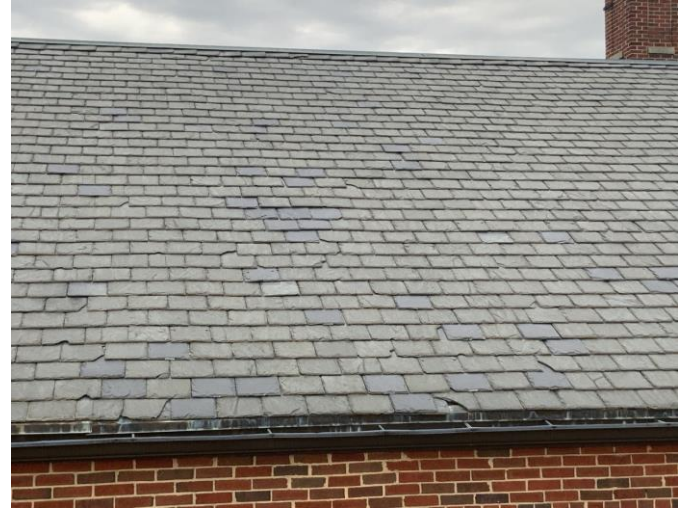
8 - SLATE TILE ROOFING

Many slate tiles are chipped and broken - AssetCALC ID: 9219169

Uniformat Code: B3010  
Recommendation: **Replace in 2027**

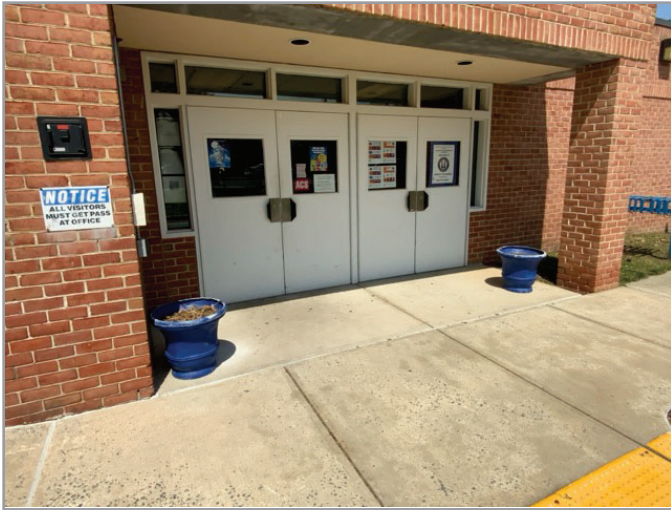
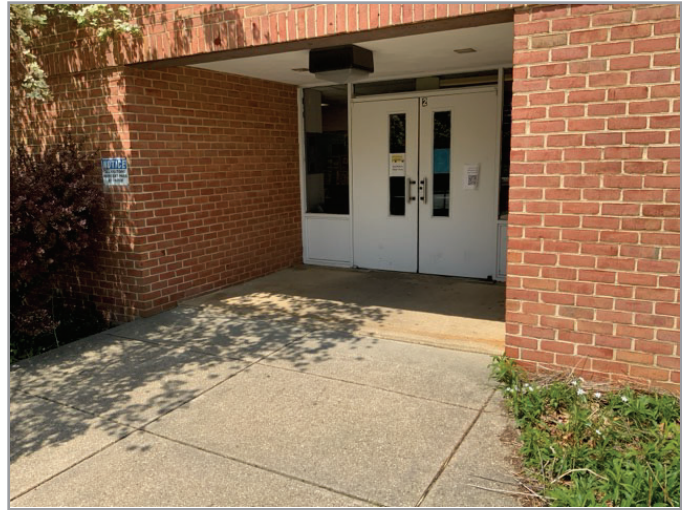
Question		Yes	No	NA	Comments
1	Do a sufficient number of accessible entrances appear to be provided ?	✗			
2	If the main entrance is not accessible, is an alternate accessible entrance provided?	✗			
3	Is signage provided indicating the location of alternate accessible entrances ?		✗		No signage indicating alternate accessible entrance
4	Do doors at accessible entrances appear to have compliant maneuvering clearance area on each side ?	✗			
5	Do doors at accessible entrances appear to have compliant hardware ?	✗			
6	Do doors at accessible entrances appear to have a compliant clear opening width ?	✗
