FACILITY CONDITION ASSESSMENT

Montgomery County Public Schools
45 West Gude Drive, Suite 4000
Rockville, MD 20850

Jones Lane Elementary School
15110 Jones Lane
Gaithersburg, MD 20878

Bureau Veritas
6021 University Boulevard, Suite 200
Ellicott City, MD 21043
800.733.0660
www.bvna.com

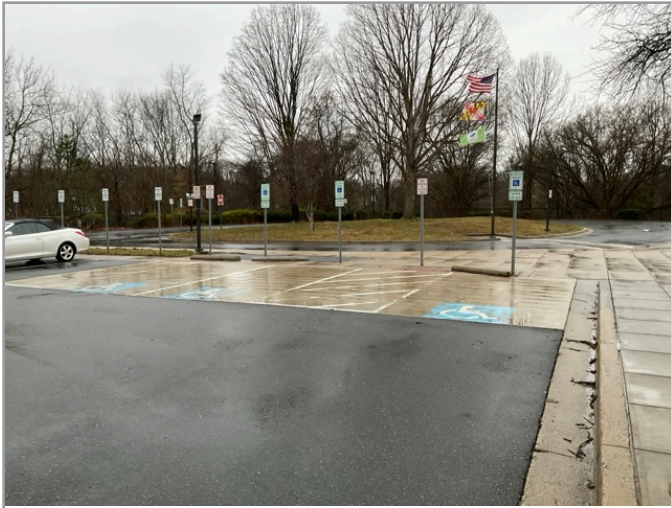
OVERVIEW OF ACCESSIBLE PARKING AREA

Question		Yes	No	NA	Comments
1	Does the required number of standard ADA designated spaces appear to be provided ?	✗			
2	Does the required number of van-accessible designated spaces appear to be provided ?	✗			
3	Are accessible spaces on the shortest accessible route to an accessible building entrance ?	✗			
4	Does parking signage include the International Symbol of Accessibility ?	✗			
5	Does each accessible space have an adjacent access aisle ?	✗			
6	Do parking spaces and access aisles appear to be relatively level and without obstruction ?	✗

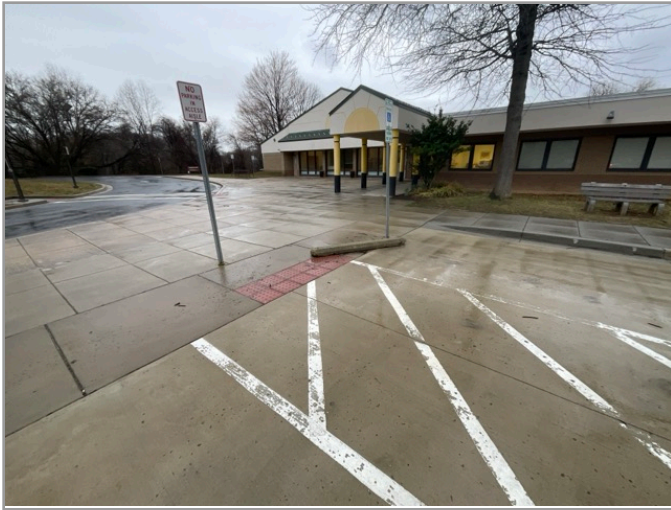
CURB CUT

Question		Yes	No	NA	Comments
1	Is an accessible route present from public transportation stops and municipal sidewalks on or immediately adjacent to the property ?	✘			
2	Does a minimum of one accessible route appear to connect all public areas on the exterior, such as parking and other outdoor amenities, to accessible building entrances ?	✘			
3	Are curb ramps present at transitions through raised curbs on all accessible routes?	✘			
4	Do curb ramps appear to have compliant slopes for all components ?	✘			
5	Do ramp runs on an accessible route appear to have compliant slopes ?	✘			
6	Do ramp runs on an accessible route appear to have a compliant rise and width ?	✘

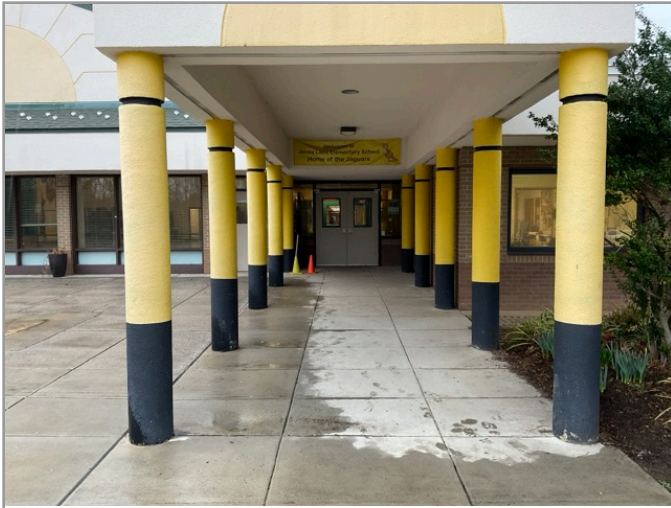
MAIN ENTRANCE

Question		Yes	No	NA	Comments
1	Do a sufficient number of accessible entrances appear to be provided ?	X			
2	If the main entrance is not accessible, is an alternate accessible entrance provided?	X			
3	Is signage provided indicating the location of alternate accessible entrances ?	X			
4	Do doors at accessible entrances appear to have compliant maneuvering clearance area on each side ?	X			
5	Do doors at accessible entrances appear to have compliant hardware ?	X			
6	Do doors at accessible entrances appear to have a compliant clear opening width ?	X

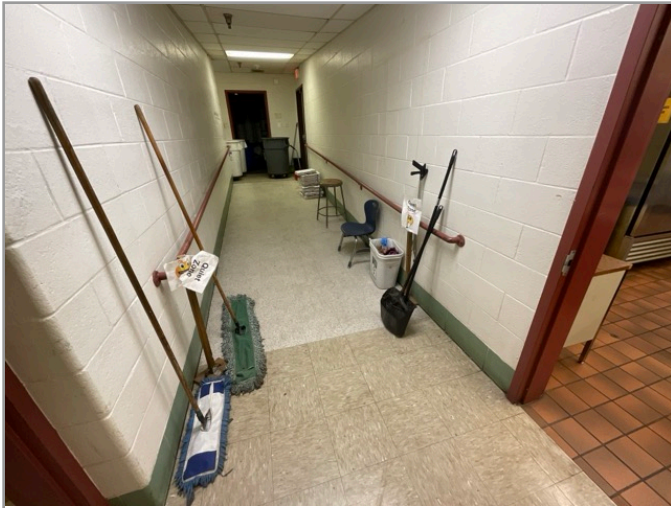
ACCESSIBLE INTERIOR RAMP

Question		Yes	No	NA	Comments
1	Does an accessible route appear to connect all public areas inside the building ?	✗			
2	Do accessible routes appear free of obstructions and/or protruding objects ?	✗			
3	Do ramps on accessible routes appear to have compliant slopes ?	✗			
4	Do ramp runs on an accessible route appear to have a compliant rise and width ?	✗			
5	Do ramps on accessible routes appear to have compliant end and intermediate landings ?	✗			
6	Do ramps on accessible routes appear to have compliant handrails ?	✗

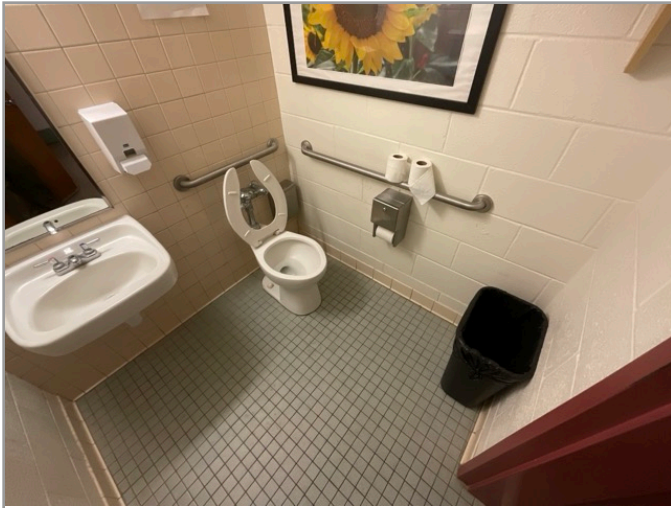
TOILET STALL OVERVIEW

Question		Yes	No	NA	Comments
1	Do publicly accessible toilet rooms appear to have a minimum compliant floor area ?	✗			
2	Does the lavatory appear to be mounted at a compliant height and with compliant knee area ?	✗			
3	Does the lavatory faucet have compliant handles ?	✗			
4	Is the plumbing piping under lavatories configured to protect against contact ?	✗			
5	Are grab bars provided at compliant locations around the toilet ?	✗			
6	Do toilet stall doors appear to provide the minimum compliant clear width ?	✗

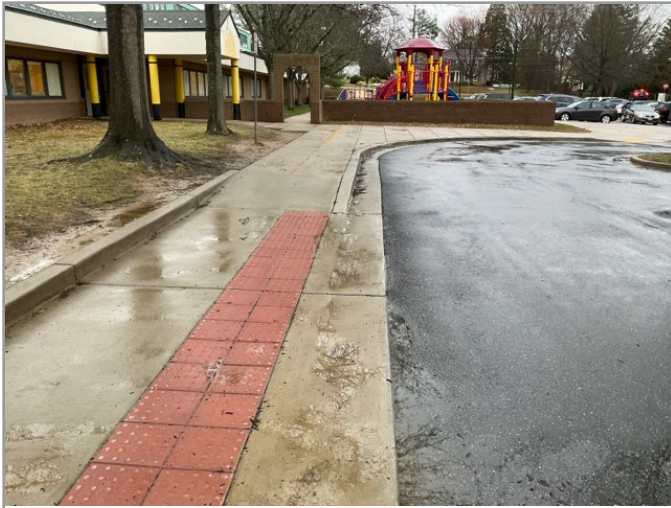
ACCESSIBLE ROUTE TO PLAYGROUND

Question		Yes	No	NA	Comments
1	Is there an accessible route to the play area / s?	X			
2	Has the play area been reviewed for accessibility ?		X		
3	Are publicly accessible swimming pools equipped with an entrance lift ?			X
