FACILITY CONDITION ASSESSMENT

Montgomery County Public Schools
45 West Gude Drive, Suite 4000
Rockville, MD 20850

Lakewood Elementary School
2534 Lindley Terrace
Rockville, MD 20850

April 13, 2026

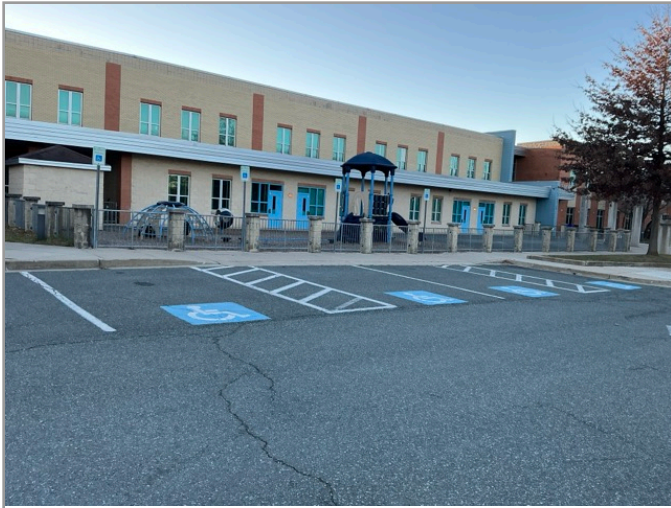
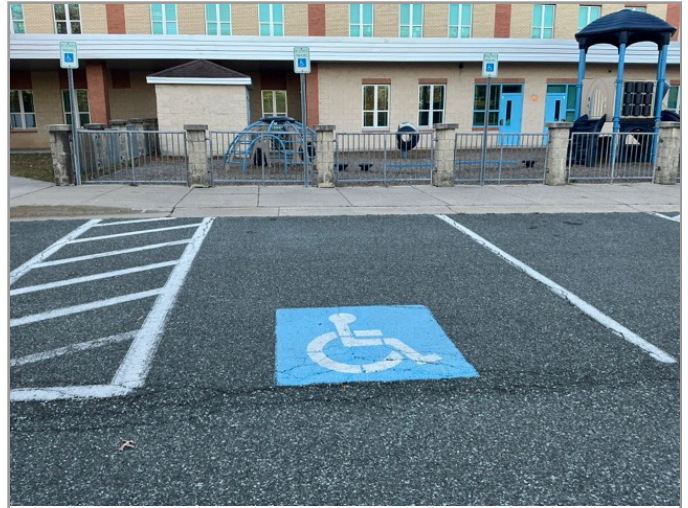
Parking

Question		Yes	No	NA	Comments
1	Does the required number of standard ADA designated spaces appear to be provided ?	✘			
2	Does the required number of van-accessible designated spaces appear to be provided ?	✘			
3	Are accessible spaces on the shortest accessible route to an accessible building entrance ?	✘			
4	Does parking signage include the International Symbol of Accessibility ?	✘			
5	Does each accessible space have an adjacent access aisle ?	✘			
6	Do parking spaces and access aisles appear to be relatively level and without obstruction ?	✘

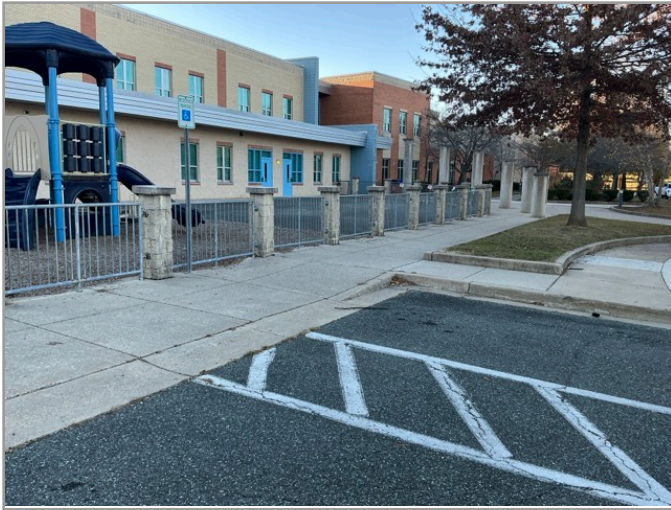
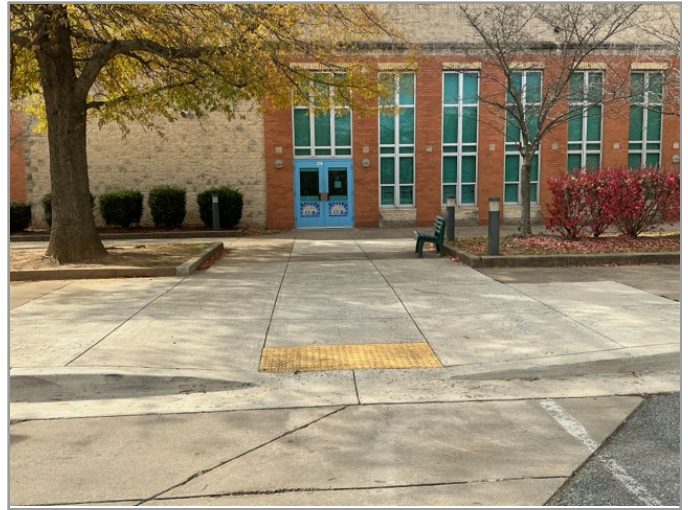
Exterior Accessible Route

Question		Yes	No	NA	Comments
1	Is an accessible route present from public transportation stops and municipal sidewalks on or immediately adjacent to the property ?	✗			
2	Does a minimum of one accessible route appear to connect all public areas on the exterior, such as parking and other outdoor amenities, to accessible building entrances ?	✗			
3	Are curb ramps present at transitions through raised curbs on all accessible routes?	✗			
4	Do curb ramps appear to have compliant slopes for all components ?	✗			
5	Do ramp runs on an accessible route appear to have compliant slopes ?	✗			
6	Do ramp runs on an accessible route appear to have a compliant rise and width ?	✗

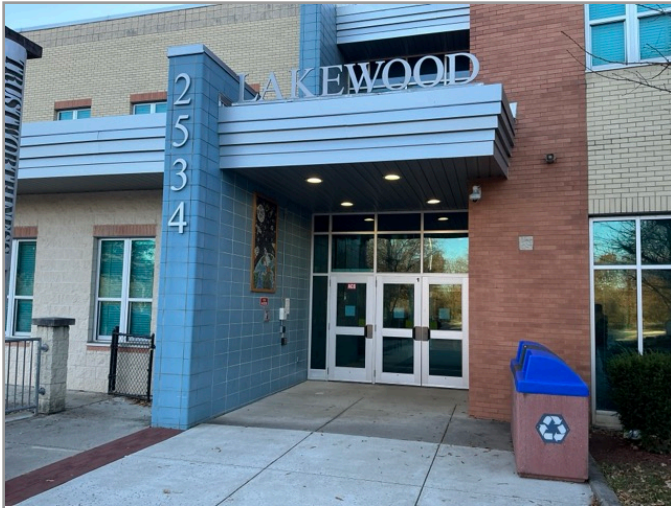
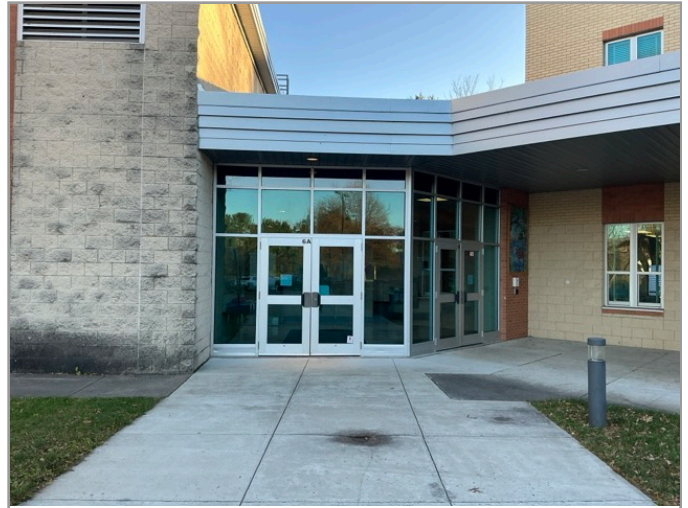
Building Entrances

Question		Yes	No	NA	Comments
1	Do a sufficient number of accessible entrances appear to be provided ?	X			
2	If the main entrance is not accessible, is an alternate accessible entrance provided?	X			
3	Is signage provided indicating the location of alternate accessible entrances ?		X		
4	Do doors at accessible entrances appear to have compliant maneuvering clearance area on each side ?	X			
5	Do doors at accessible entrances appear to have compliant hardware ?	X			
6	Do doors at accessible entrances appear to have a compliant clear opening width ?	X

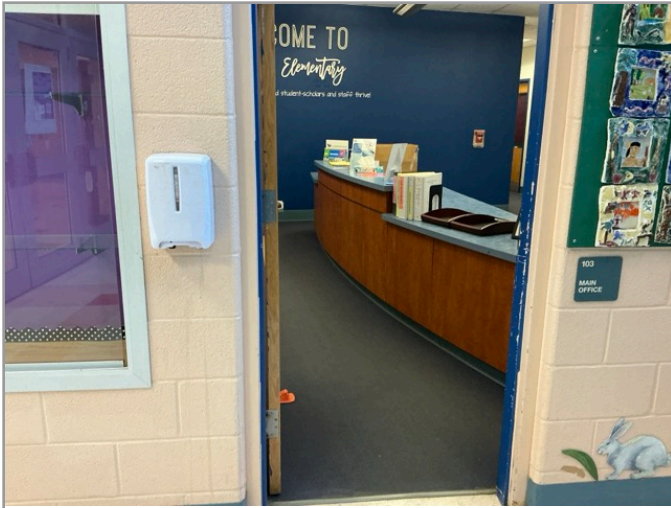
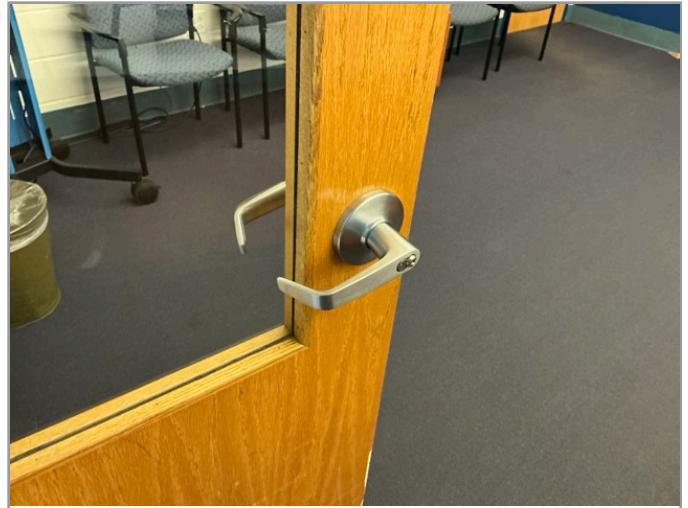
Interior Accessible Route

Question		Yes	No	NA	Comments
1	Does an accessible route appear to connect all public areas inside the building ?	✗			
2	Do accessible routes appear free of obstructions and/or protruding objects ?	✗			
3	Do ramps on accessible routes appear to have compliant slopes ?			✗	
4	Do ramp runs on an accessible route appear to have a compliant rise and width ?			✗	
5	Do ramps on accessible routes appear to have compliant end and intermediate landings ?			✗	
6	Do ramps on accessible routes appear to have compliant handrails ?			✗

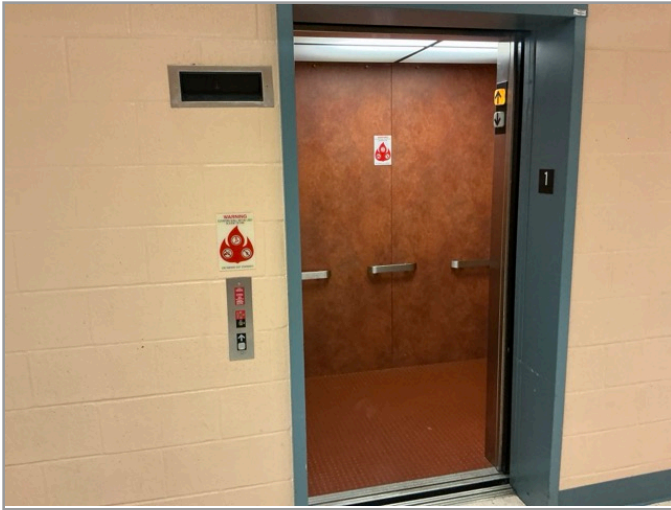
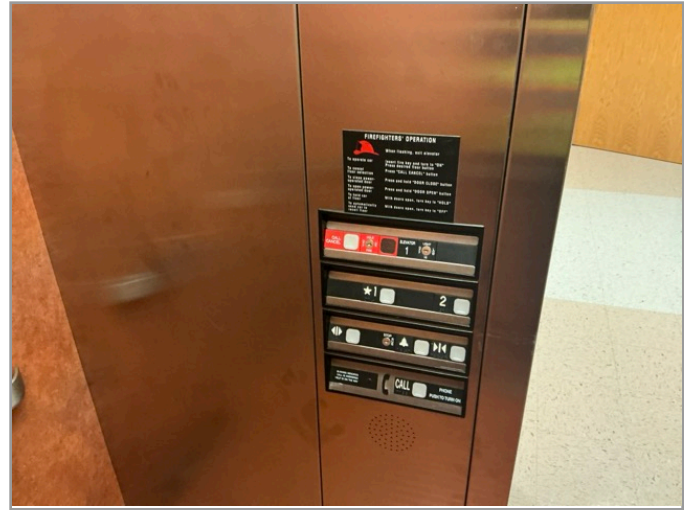
Elevators

Question		Yes	No	NA	Comments
1	Are hallway call buttons configured with the "UP" button above the "DOWN" button?	✗			
2	Is accessible floor identification signage present on the hoistway sidewalls on each level ?	✗			
3	Do the elevators have audible and visual arrival indicators at the lobby and hallway entrances?	✗			
4	Do the elevator hoistway and car interior appear to have a minimum compliant clear floor area ?	✗			
5	Do the elevator car doors have automatic re-opening devices to prevent closure on obstructions?	✗			
6	Do elevator car control buttons appear to be mounted at a compliant height ?	✗

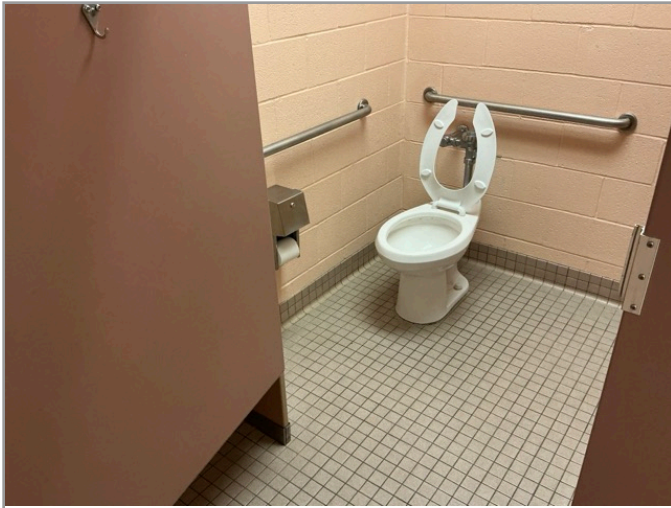
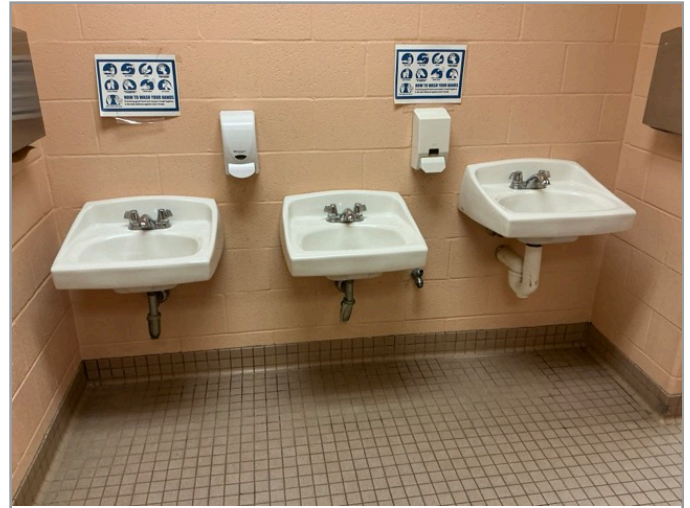
Public Restrooms

Question		Yes	No	NA	Comments
1	Do publicly accessible toilet rooms appear to have a minimum compliant floor area ?	✗			
2	Does the lavatory appear to be mounted at a compliant height and with compliant knee area ?	✗			
3	Does the lavatory faucet have compliant handles ?	✗			
4	Is the plumbing piping under lavatories configured to protect against contact ?	✗			
5	Are grab bars provided at compliant locations around the toilet ?	✗			
6	Do toilet stall doors appear to provide the minimum compliant clear width ?	✗

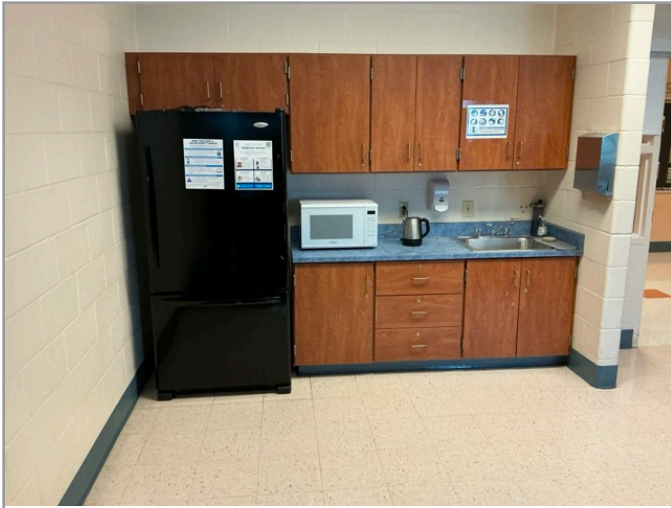
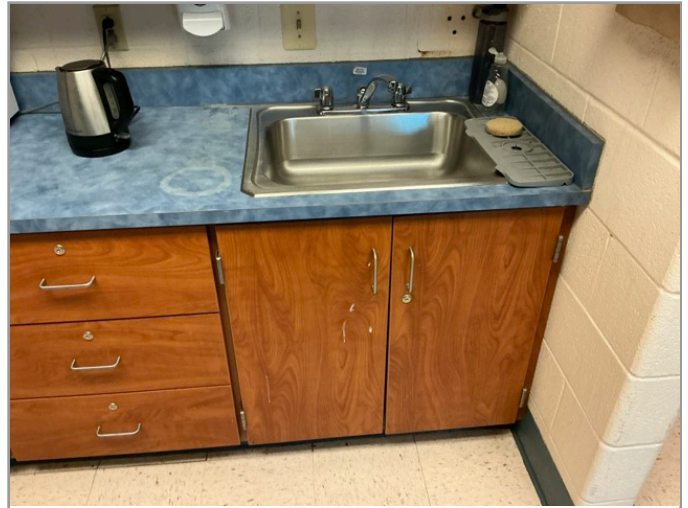
Kitchens/Kitchenettes

Question		Yes	No	NA	Comments
1	Do kitchens/kitchenettes appear to have a minimum compliant path of travel or area of maneuverability ?	✗			
2	Are the appliances centered for a parallel or forward approach with adequate clear floor space ?			✗	
3	Is there an accessible countertop/preparation space of proper width and height ?	✗			Side approach only
4	Is there an accessible sink space of proper width and height ?	✗			Side approach only
5	Does the sink faucet have compliant handles ?	✗			
6	Is the plumbing piping under the sink configured to protect against contact ?			✗	Plumbing in cabinet below

7	Are the cooktop/range controls front-mounted (or in a location that does not require reaching across the burners) ?			X	
---	---	--	--	---	--

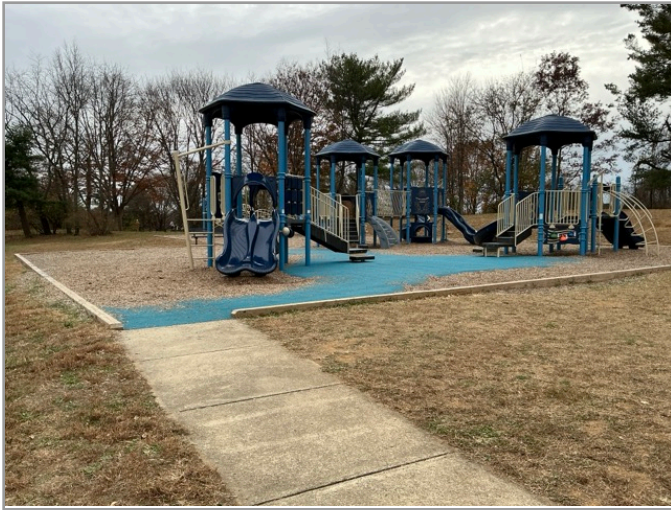
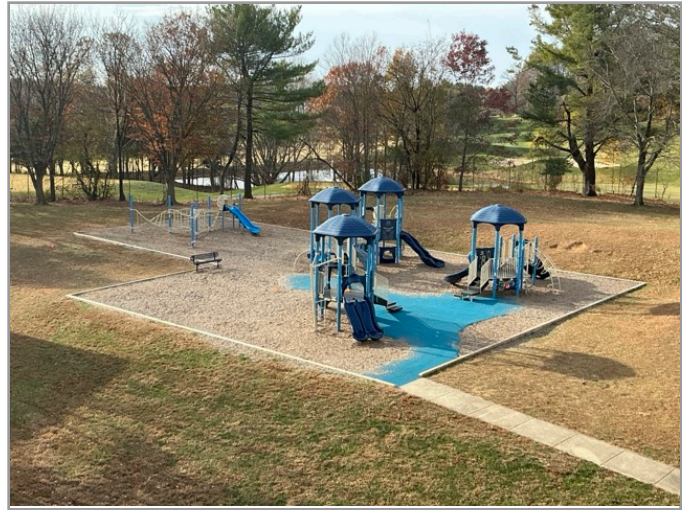
Playgrounds & Swimming Pools

Question		Yes	No	NA	Comments
1	Is there an accessible route to the play area / s?	✘			
2	Has the play area been reviewed for accessibility ?	✘			
3	Are publicly accessible swimming pools equipped with an entrance lift ?			✘
