FACILITY CONDITION ASSESSMENT

Spark M. Matsunaga Elementary School

172559.25R000-075.354

June 3, 2026

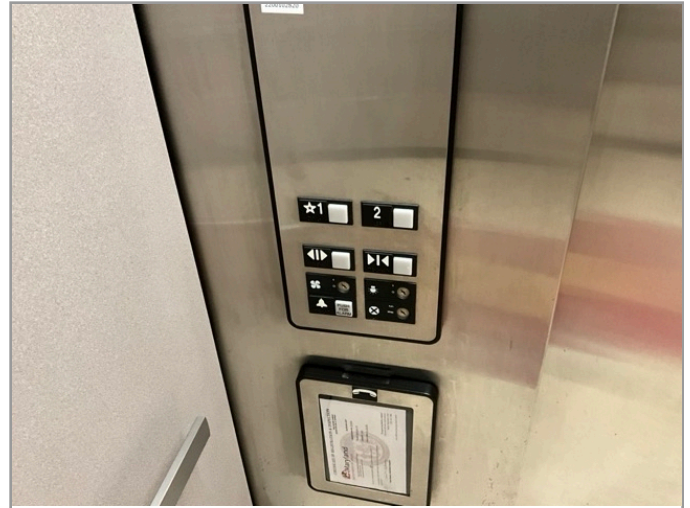
IN-CAB CONTROLS

Question		Yes	No	NA	Comments
1	Are hallway call buttons configured with the "UP" button above the "DOWN" button?	✗			
2	Is accessible floor identification signage present on the hoistway sidewalls on each level ?	✗			
3	Do the elevators have audible and visual arrival indicators at the lobby and hallway entrances?	✗			
4	Do the elevator hoistway and car interior appear to have a minimum compliant clear floor area ?	✗			
5	Do the elevator car doors have automatic re-opening devices to prevent closure on obstructions?	✗			
6	Do elevator car control buttons appear to be mounted at a compliant height ?	✗

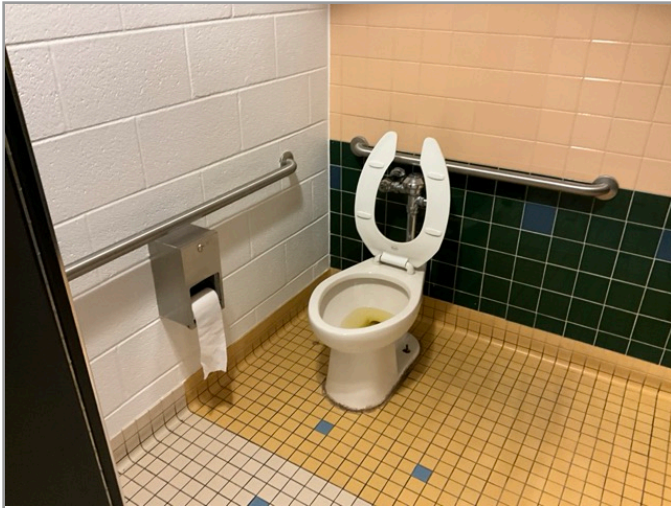
TOILET STALL OVERVIEW

Question		Yes	No	NA	Comments
1	Do publicly accessible toilet rooms appear to have a minimum compliant floor area ?	✘			
2	Does the lavatory appear to be mounted at a compliant height and with compliant knee area ?	✘			
3	Does the lavatory faucet have compliant handles ?	✘			
4	Is the plumbing piping under lavatories configured to protect against contact ?		✘		Missing cover
5	Are grab bars provided at compliant locations around the toilet ?	✘			
6	Do toilet stall doors appear to provide the minimum compliant clear width ?	✘

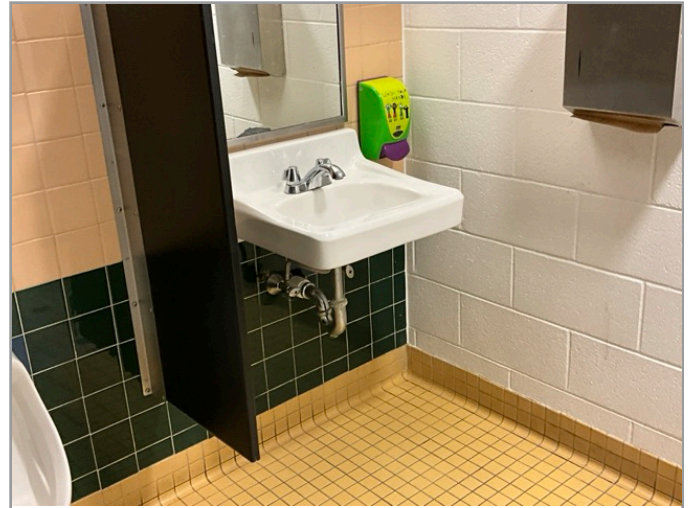
SINK, FAUCET HANDLES AND ACCESSORIES

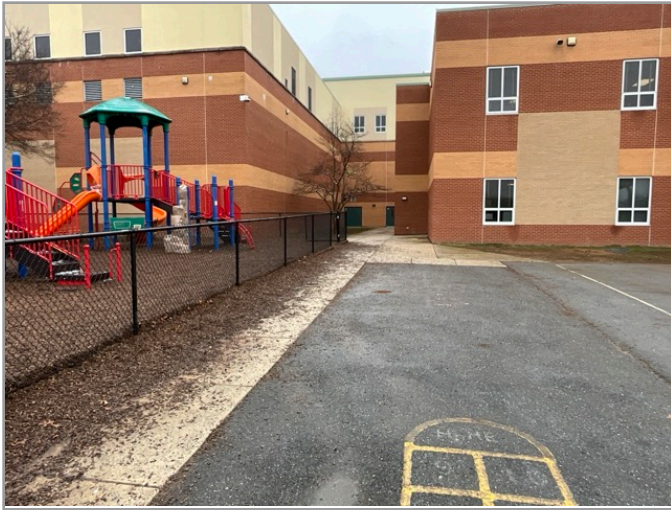
ACCESSIBLE ROUTE TO PLAYGROUND

Question		Yes	No	NA	Comments
1	Is there an accessible route to the play area / s?	✘			
2	Has the play area been reviewed for accessibility ?			✘	Unknown
3	Are publicly accessible swimming pools equipped with an entrance lift ?			✘

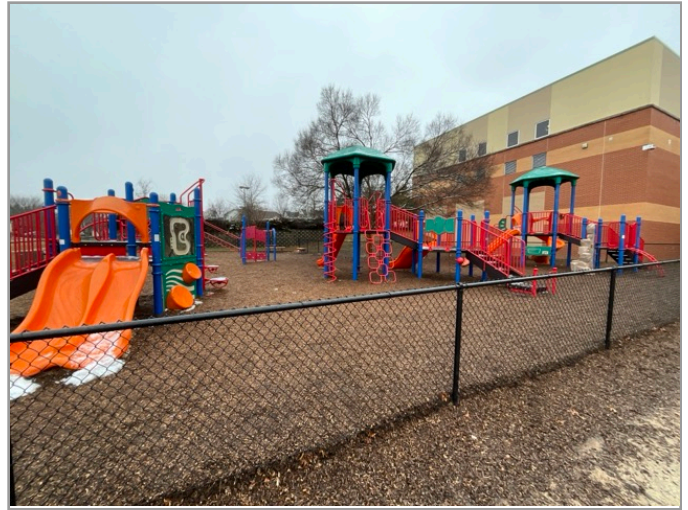
OVERVIEW OF PLAYGROUND
