FACILITY CONDITION ASSESSMENT

Montgomery County Public Schools
45 West Gude Drive, Suite 4000
Rockville, MD 20850

Mill Creek Towne Elementary School
17700 Park Mill Drive
Rockville, MD 20855

August 20, 2025

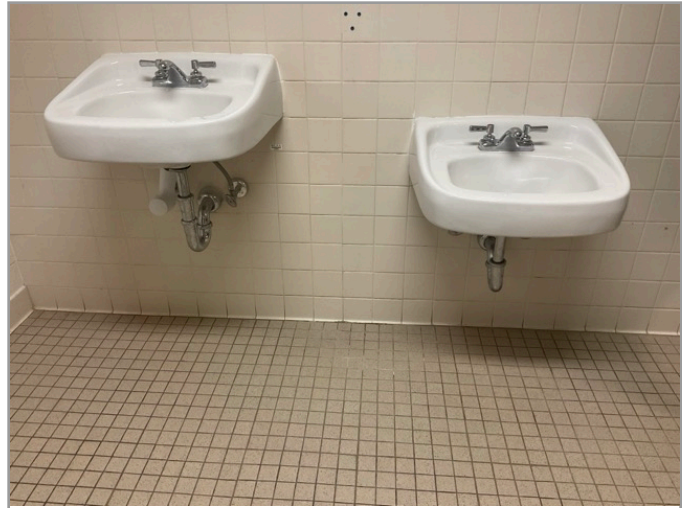
RESTROOM SINKS

UF L3 Code	Location	Condition	Asset/Component/Repair	Quantity	RUL	ID
F1020	Site General	Fair	Covered Walkway, Wood	3,200 SF	20	9286983
Accessibility						
Y1050	Restrooms	NA	ADA Restrooms, Lavatory, Pipe Wraps/Insulation, Install	18	0	9286936
