FACILITY CONDITION ASSESSMENT

Montgomery County Public Schools
45 West Gude Drive, Suite 4000
Rockville, MD 20850

Oak View Elementary School
400 East Wayne Avenue
Silver Spring, MD 20901

August 20, 2025

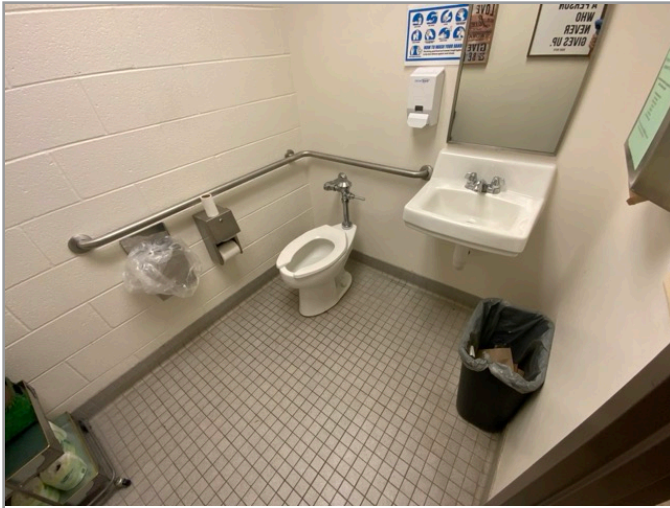
TOILET STALL OVERVIEW

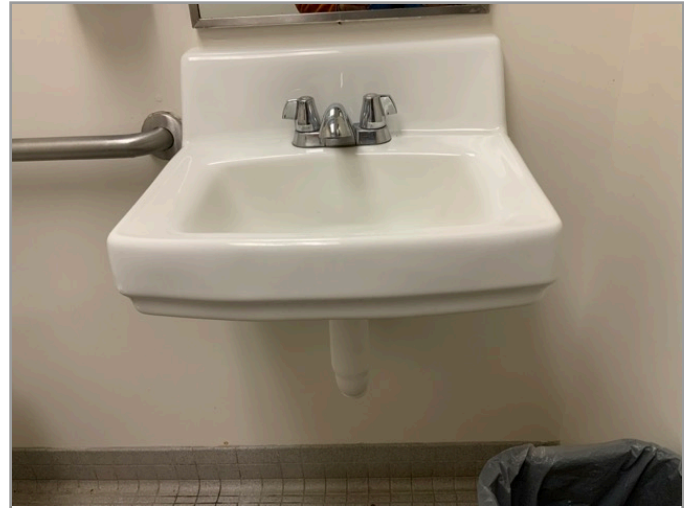
SINK, FAUCET HANDLES AND ACCESSORIES

Question		Yes	No	NA	Comments
1	Do publicly accessible toilet rooms appear to have a minimum compliant floor area ?	✗			
2	Does the lavatory appear to be mounted at a compliant height and with compliant knee area ?	✗			
3	Does the lavatory faucet have compliant handles ?		✗		Faucet handles on sink are not paddle type.
4	Is the plumbing piping under lavatories configured to protect against contact ?	✗			
5	Are grab bars provided at compliant locations around the toilet ?	✗			
6	Do toilet stall doors appear to provide the minimum compliant clear width ?	✗
