# FACILITY CONDITION ASSESSMENT

## **Montgomery County Public Schools**

Lois P. Rockwell Elementary School  
24555 Cutsail Drive  
Damascus, MD 20872

*May 26, 2026*

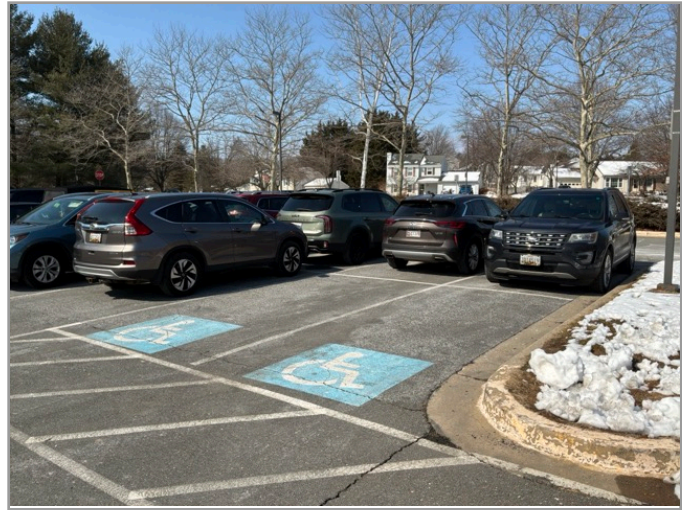
2ND AREA OF ACCESSIBLE PARKING

Question		Yes	No	NA	Comments
1	Does the required number of standard ADA designated spaces appear to be provided ?	✘			
2	Does the required number of van-accessible designated spaces appear to be provided ?		✘		No van accessible signage
3	Are accessible spaces on the shortest accessible route to an accessible building entrance ?	✘			
4	Does parking signage include the International Symbol of Accessibility ?		✘		Two spaces missing signage
5	Does each accessible space have an adjacent access aisle ?		✘		Two spaces missing access aisle
6	Do parking spaces and access aisles appear to be relatively level and without obstruction ?	✘

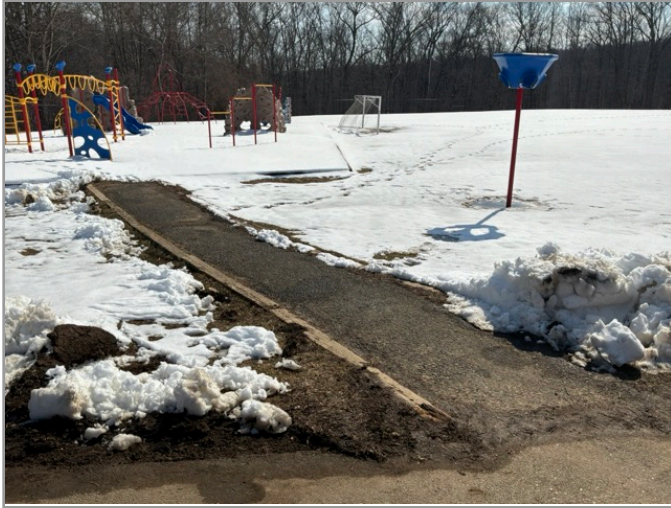
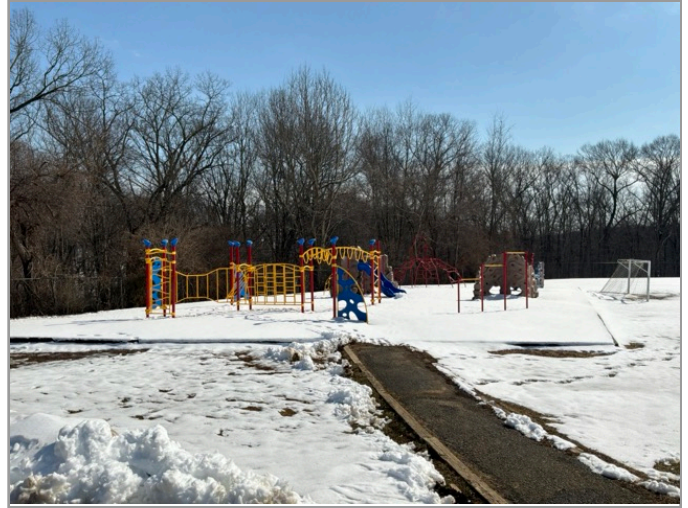
ACCESSIBLE ROUTE TO PLAYGROUND

OVERVIEW OF PLAYGROUND

Question		Yes	No	NA	Comments
1	Is there an accessible route to the play area / s?		✘		Sloped and missing handrails, main playground surface is not compliant
2	Has the play area been reviewed for accessibility ?			✘	
3	Are publicly accessible swimming pools equipped with an entrance lift ?			✘
