FACILITY CONDITION ASSESSMENT

Montgomery County Public Schools

Rolling Terrace Elementary School
705 Bayfield Street
Takoma Park, MD 20912

August 15, 2025

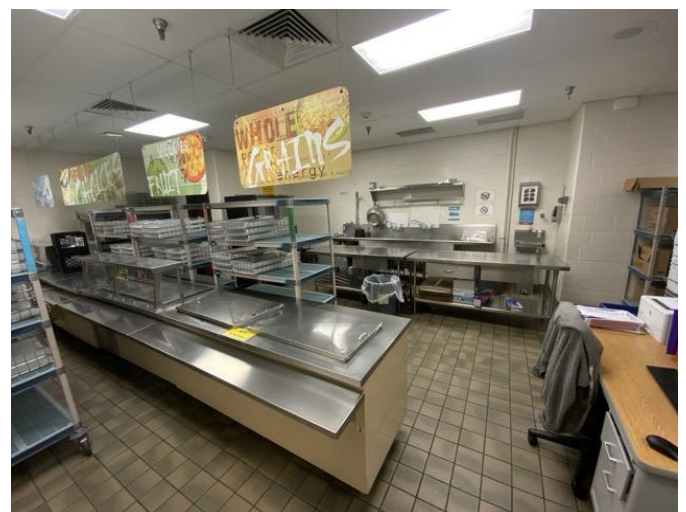
18 - COMMERCIAL KITCHEN

The commercial kitchen equipment appears to be primarily recently replaced units with a few pieces of original equipment still in place. Lifecycle replacement for most equipment is not anticipated in the near term but is anticipated for older units and budgeting has been included in the cost tables accordingly.

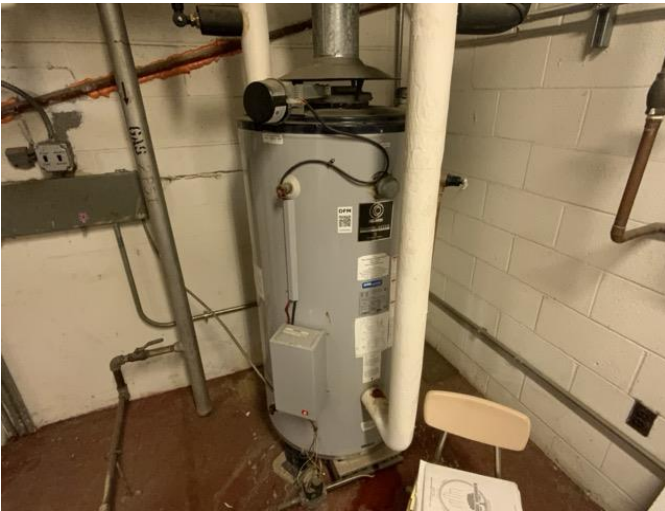
21 - WATER HEATER

Hot water for plumbing is provided by an electric water heater in the Health Center addition and a gas water heater in the main mechanical room. Water heaters appear to be recent replacements and are in fair condition. The plumbing infrastructure is all the original installation for the main building and for the additions. Fixtures are estimated to be at least 20 years old and lifecycle replacement is anticipated in the near term except for the addition.

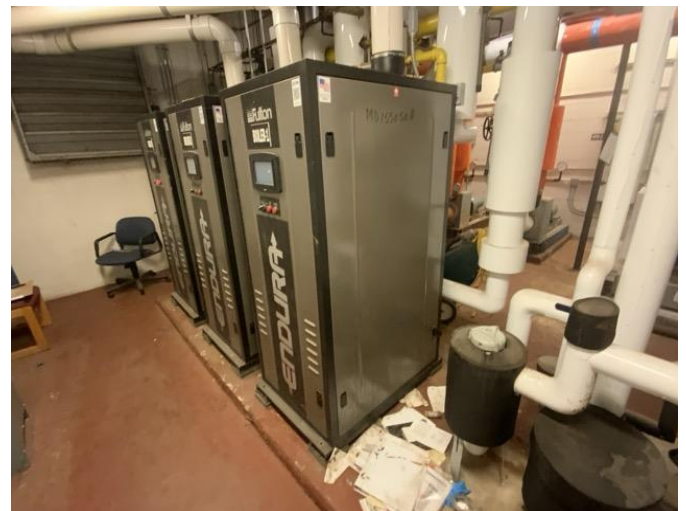
24 - GAS BOILERS

In the main building primary heating and cooling are provided by a central system of gas boilers and chillers serving air handling units and fan coil units throughout the building. In addition, some spaces are served by rooftop package units and there are two ERUs in the penthouse mechanical rooms. The POC reports that the chillers, boilers, and air handling units were replaced in a major HVAC renovation in 2015. The Health Center has its own rooftop package units providing tempered air to spaces.

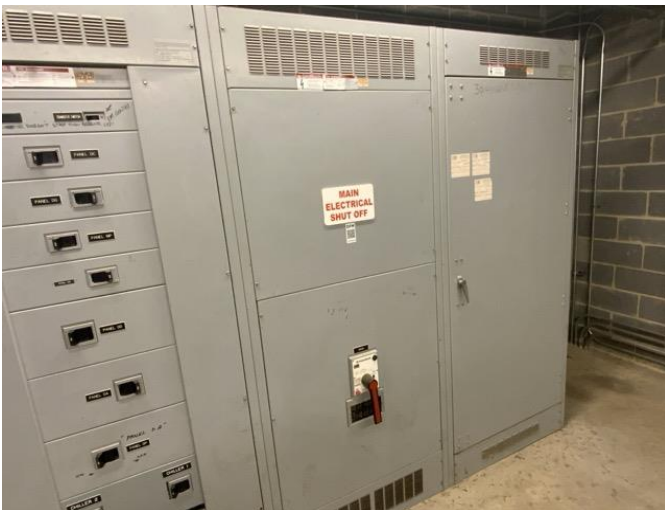
33 - SWITCHBOARD

The main electrical service enters the building through three 277/480V, 1600AMP switchboards in the main electrical room on the 2nd floor. The switchboards appear to be in fair condition but are outdated and lifecycle replacement in the near term is anticipated. There are many subpanels and transformers in electrical closets throughout the building. The electrical service in the Health Center addition is controlled by smaller distribution panels and a step-down transformer. The building is also equipped with an emergency generator and two ATS units.
