# FACILITY CONDITION ASSESSMENT

Sequoyah Elementary School  
17301 Bowie Mill Road  
Derwood, MD 20855

*May 1, 2026*

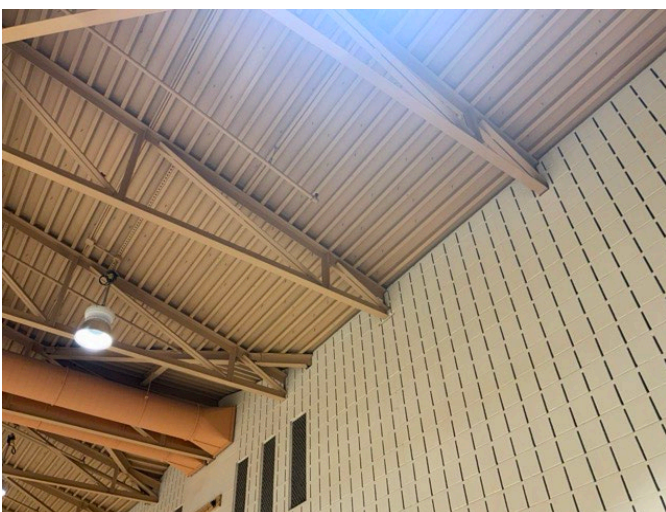
5 - STRUCTURAL OVERVIEW

The two story building generally appears structurally sound, however, there was one area of concern mentioned by the POC, focused in the south stairwell and the hallway floor at the Media center where cracking was observed. Budgetary amounts to repair the issues have been included in the cost tables and an engineering study has been recommended to investigate cause. The structure is primarily open web steel joists supporting metal deck roof structure and all supported by CMU bearing walls with brick veneer. The main roof is a built-up system as indicated on construction documents. The built-up roof was neither accessed nor photographed due to unsafe conditions posed by snow and ice. The sloping standing seam roofs were also obscured by snow and ice and not photographed on the first visit. A subsequent visit on March 23, 2026 was made where the roof conditions were assessed. Near-term lifecycle replacement of the metal roof and built-up roof is not anticipated.

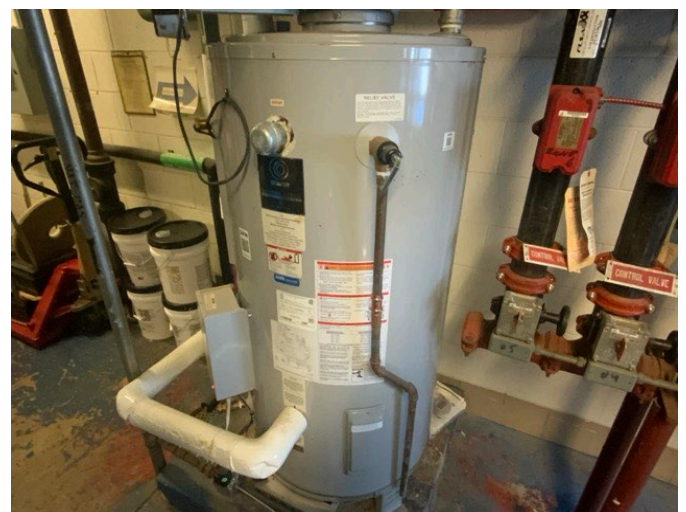
12 - GAS FIRE WATER HEATER

Hot water for plumbing is provided by a gas fired condensing water heater which is in the main mechanical room. Water heater appears to be a relatively recent replacement and is in fair condition. The plumbing infrastructure is estimated to be original to the building and is approaching the end of its useful life and near-term lifecycle replacement is anticipated.

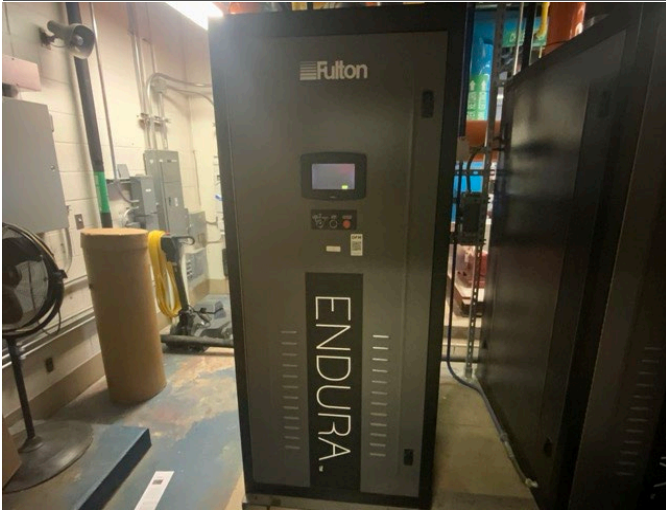
13 - CONDENSING BOILER

Primary heating and cooling are provided by a central system of gas boilers and an air-cooled chiller serving roof mounted packaged units and ERUs throughout the building. The central system also serves unit ventilators and fan coil units in the classrooms, ceiling mounted cabinet heaters in the common areas and unit heaters storage or utility rooms. All mechanical equipment was reportedly replaced in 2020. Rooftop equipment was not assessed individually, on the first visit, due to unsafe conditions caused by snow and ice. A second visit allowed assessment of each piece of equipment. Most of the rooftop HVAC equipment was installed around 2020 and is in good condition. Lifecycle replacement of equipment is not anticipated until late term.

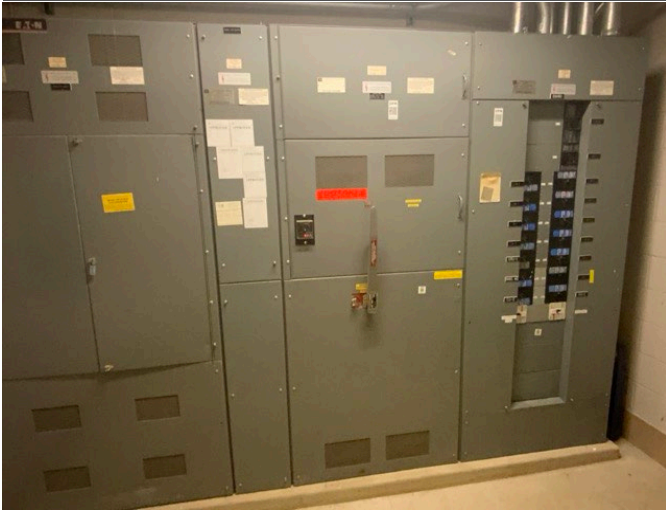
25 - ELECTRICAL SWITCHBOARD

The electrical service is controlled by switchboards and distribution panels in the main electrical room on the first floor. In addition, there are main distribution panels and subpanels in the common hallways throughout the building. A significant portion of the electrical wiring and equipment in conjunction with the HVAC renovation was replaced. The building is also equipped with an emergency generator with automatic transfer switch. The generator appears to be in good condition having been recently installed in 2020. Lifecycle replacement within the reserve term is not anticipated .

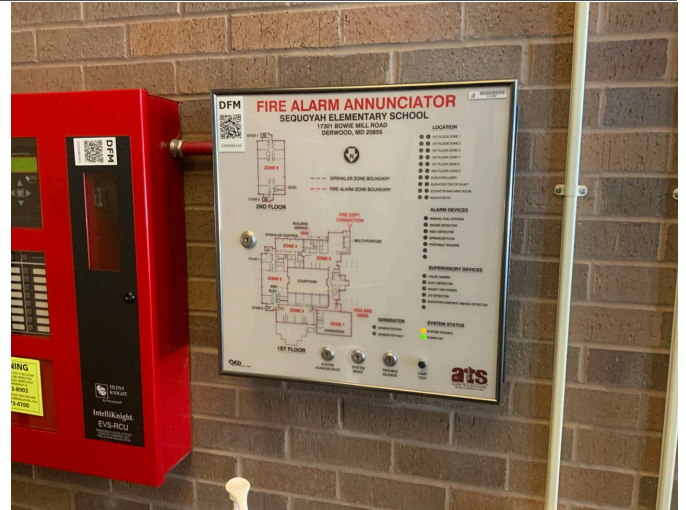
26 - FIRE ALARM SYSTEM

A fully addressable fire alarm system is present with the main fire alarm panel in the main mechanical room. The panel is estimated to be 11 years old and lifecycle replacement is anticipated in the near-term. The building is also protected by an automatic fire suppression system, most of which appears to be original.

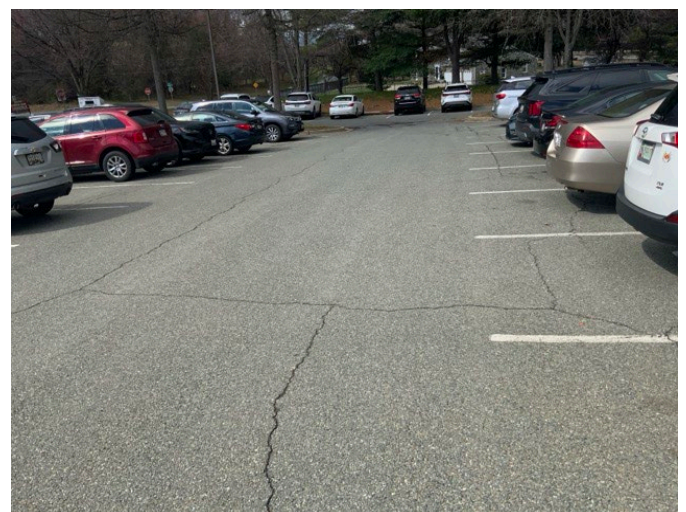
30 - ASPHALT PARKING LOT

The asphalt parking lots are estimated to be the original installation with widespread alligator, longitudinal, and transverse cracking visible and lifecycle replacement is anticipated for the near term. Pavement striping is also in fair condition although some fading is visible. Visible concrete sidewalk pavement appears in fair condition.

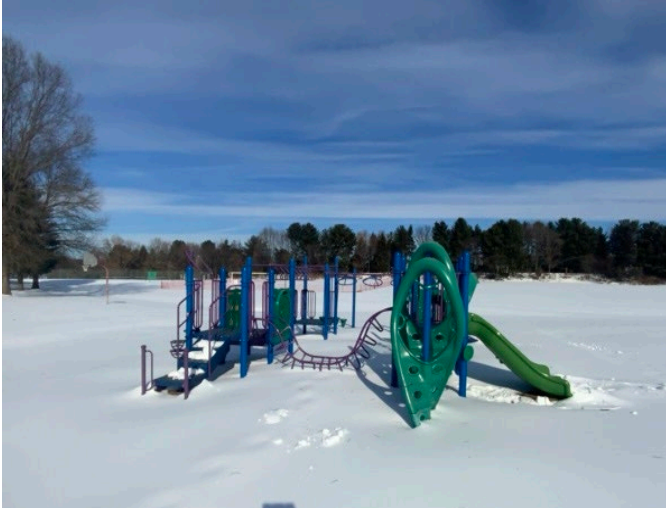
31 - PLAY STRUCTURE

Site lighting is with pole-mounted LED for some fixtures and wall packs. Athletic courts and paving on the east side were not visible due to snow and ice coverage. Playground equipment appeared in fair condition and near-term lifecycle replacement is anticipated.
