FACILITY CONDITION ASSESSMENT

Montgomery County Public Schools

Stone Mill Elementary School
14323 Stonebridge View Drive
North Potomac, MD 20878

February 26, 2026

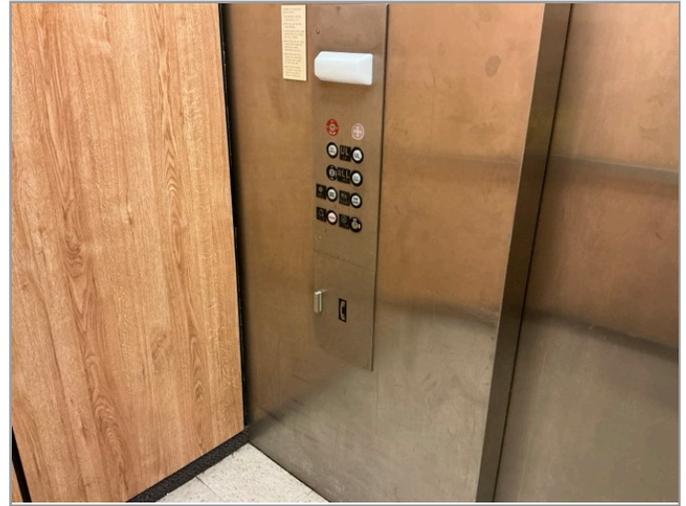
IN-CAB CONTROLS

Question		Yes	No	NA	Comments
1	Are hallway call buttons configured with the "UP" button above the "DOWN" button?	✘			
2	Is accessible floor identification signage present on the hoistway sidewalls on each level ?	✘			
3	Do the elevators have audible and visual arrival indicators at the lobby and hallway entrances?	✘			
4	Do the elevator hoistway and car interior appear to have a minimum compliant clear floor area ?	✘			
5	Do the elevator car doors have automatic re-opening devices to prevent closure on obstructions?	✘			
6	Do elevator car control buttons appear to be mounted at a compliant height ?	✘

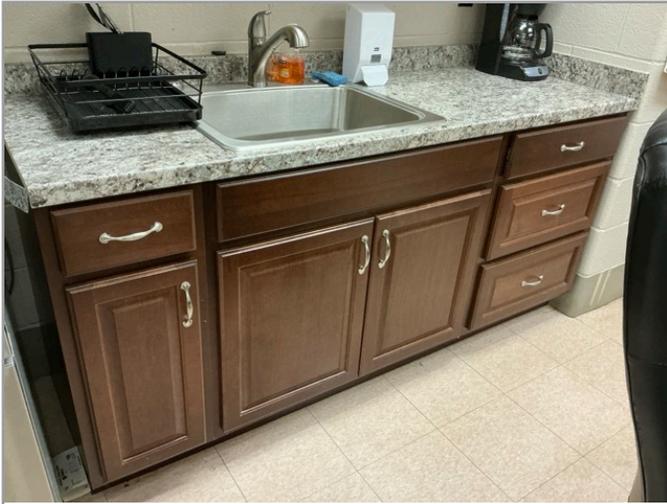
KITCHEN CABINETS

Question		Yes	No	NA	Comments
1	Do kitchens/kitchenettes appear to have a minimum compliant path of travel or area of maneuverability ?	✗			
2	Are the appliances centered for a parallel or forward approach with adequate clear floor space ?	✗			
3	Is there an accessible countertop/preparation space of proper width and height ?		✗		
4	Is there an accessible sink space of proper width and height ?		✗		
5	Does the sink faucet have compliant handles ?	✗			
6	Is the plumbing piping under the sink configured to protect against contact ?			✗

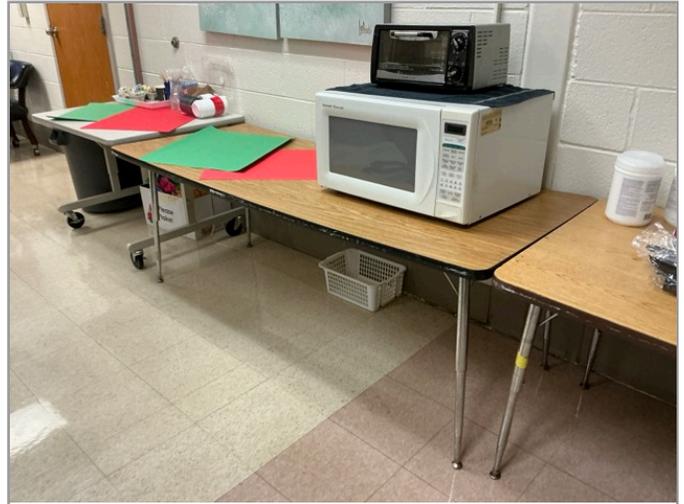
OVEN WITH CONTROLS

7	Are the cooktop/range controls front-mounted (or in a location that does not require reaching across the burners) ?				
---	---	--	--	--	--

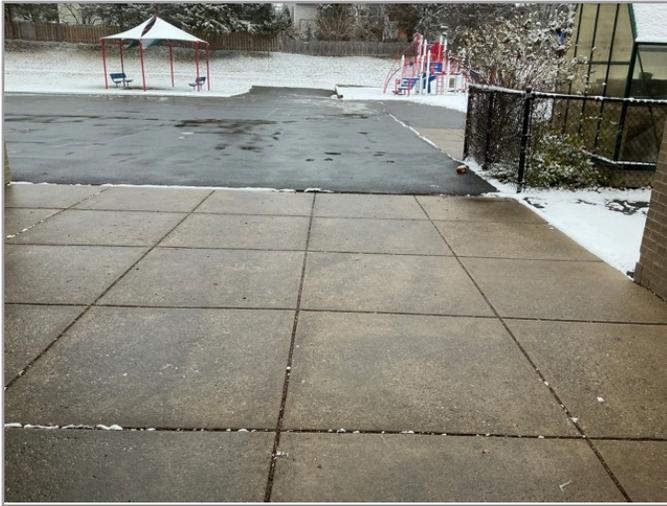
ACCESSIBLE ROUTE TO PLAYGROUND

Question		Yes	No	NA	Comments
1	Is there an accessible route to the play area / s?	✘			
2	Has the play area been reviewed for accessibility ?				Unknown
3	Are publicly accessible swimming pools equipped with an entrance lift ?			✘

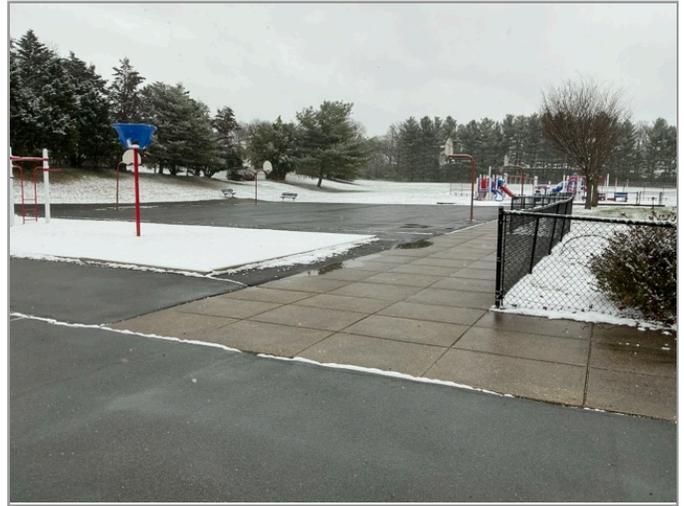
OVERVIEW OF PLAYGROUND
