# FACILITY CONDITION ASSESSMENT

Summit Hall Elementary School  
101 West Deer Park Road,  
Gaithersburg, MD 20877

172559.25R000-118.354

May 4, 2026

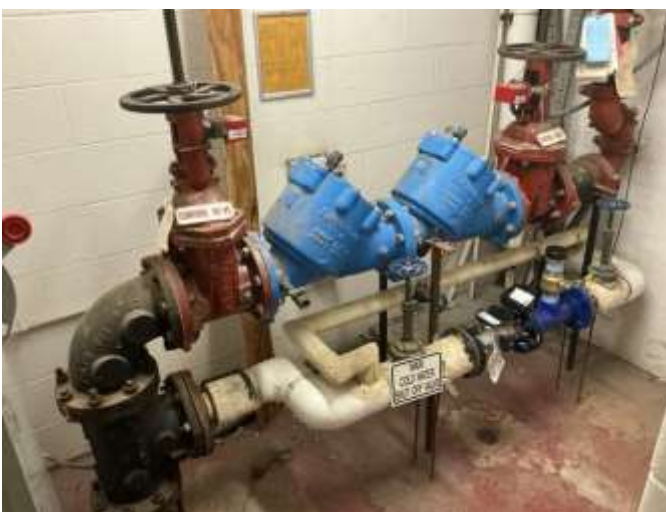
29 - FIRE SPRINKLER RISERS

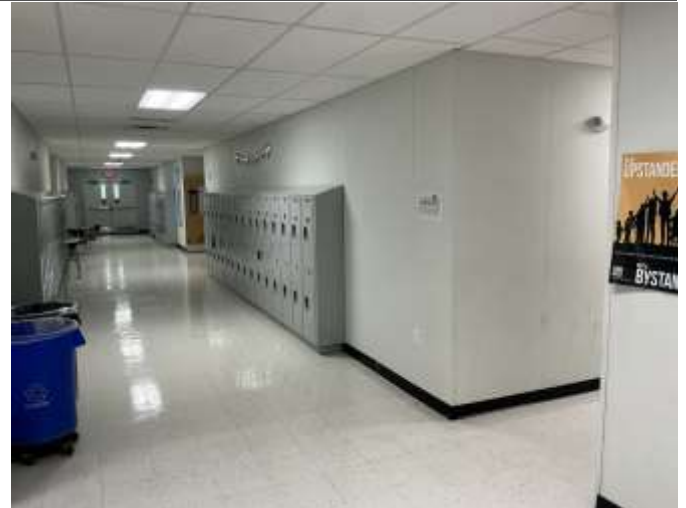
32 - TYPICAL MODULAR BUILDING HALLWAY

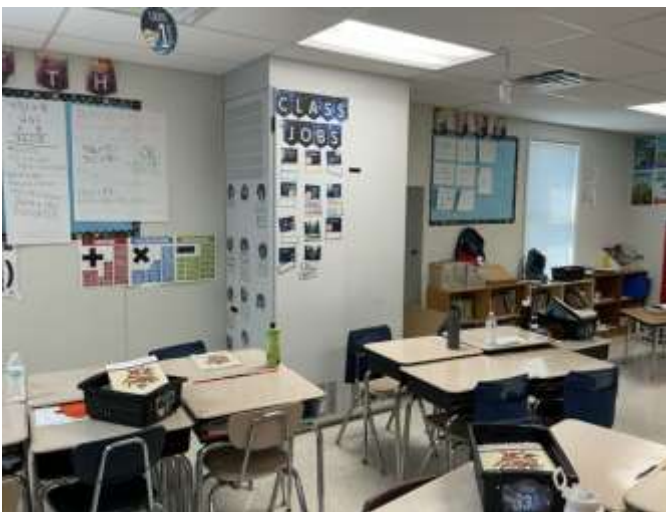
33 - TYPICAL MODULAR CLASSROOM / HEAT PUMP

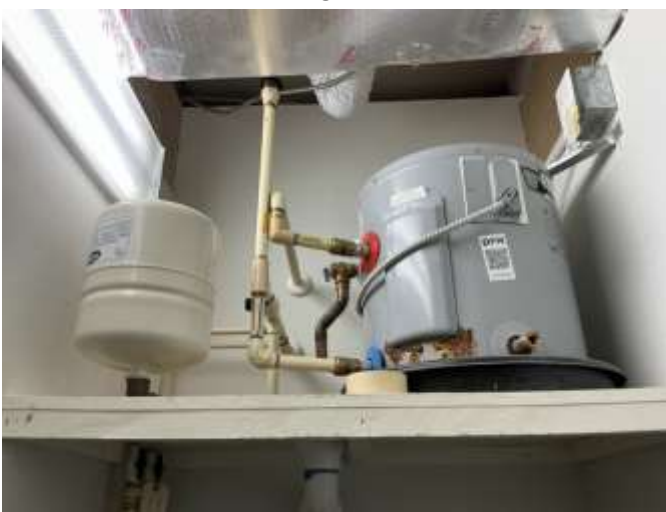
35 - MODULAR BUILDING WATER HEATER

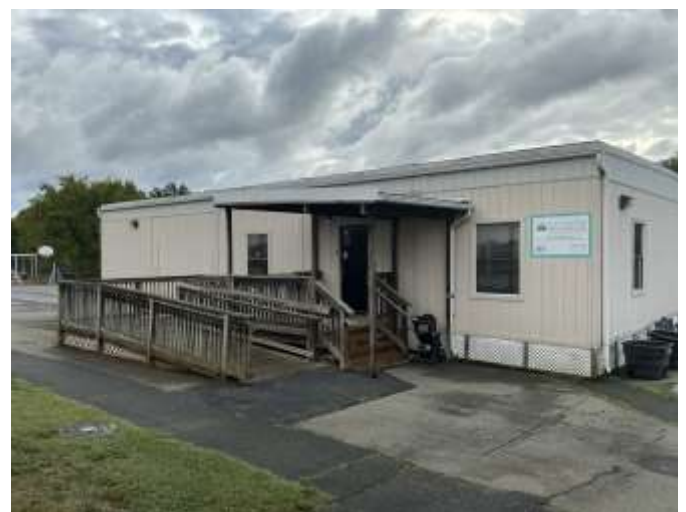
36 - JUDY CENTER MODULAR BUILDING
