FACILITY CONDITION ASSESSMENT

Waters Landing Elementary School
13100 Waters Landing Drive
Germantown, MD 20874

172559.25R000-125.354

May 4, 2026

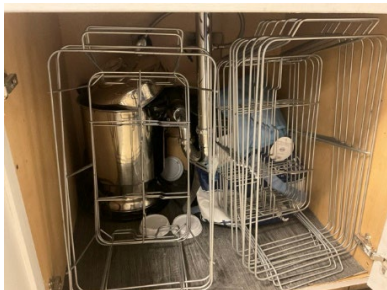
Staff Lounge Kitchen counter and sink ADA maneuverability - AssetCALC ID: 10220851

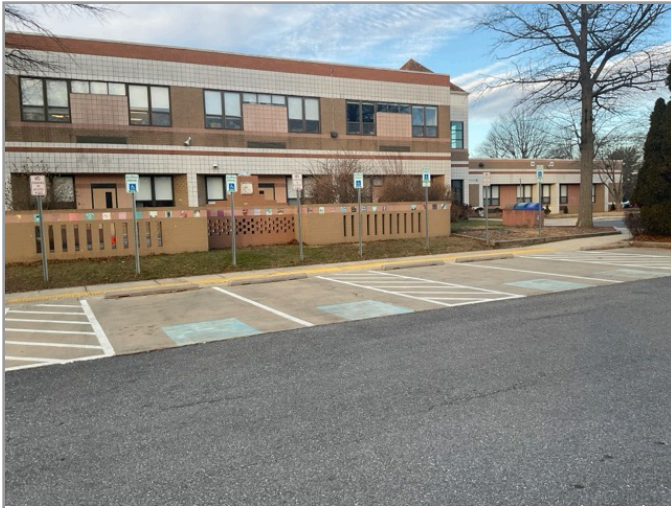
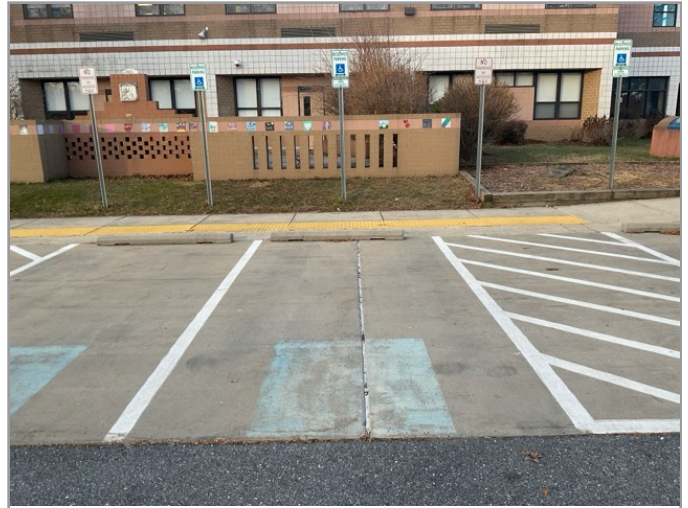
2ND AREA OF ACCESSIBLE PARKING

CLOSE-UP OF STALL

Question		Yes	No	NA	Comments
1	Does the required number of standard ADA designated spaces appear to be provided ?	✗			
2	Does the required number of van-accessible designated spaces appear to be provided ?	✗			
3	Are accessible spaces on the shortest accessible route to an accessible building entrance ?	✗			
4	Does parking signage include the International Symbol of Accessibility ?	✗			
5	Does each accessible space have an adjacent access aisle ?	✗			
6	Do parking spaces and access aisles appear to be relatively level and without obstruction ?	✗

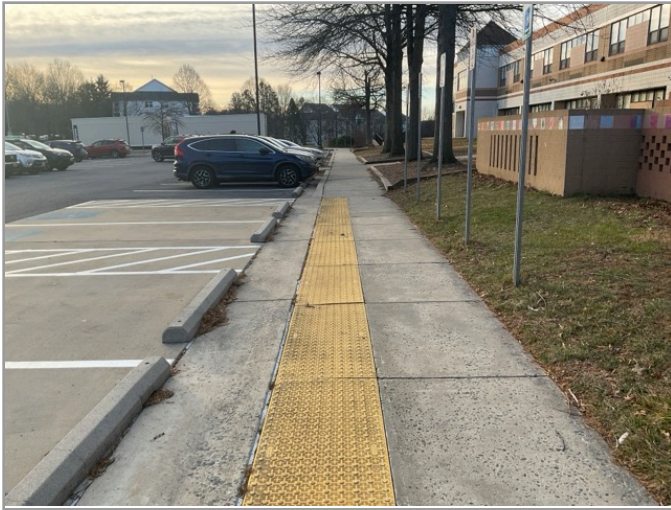
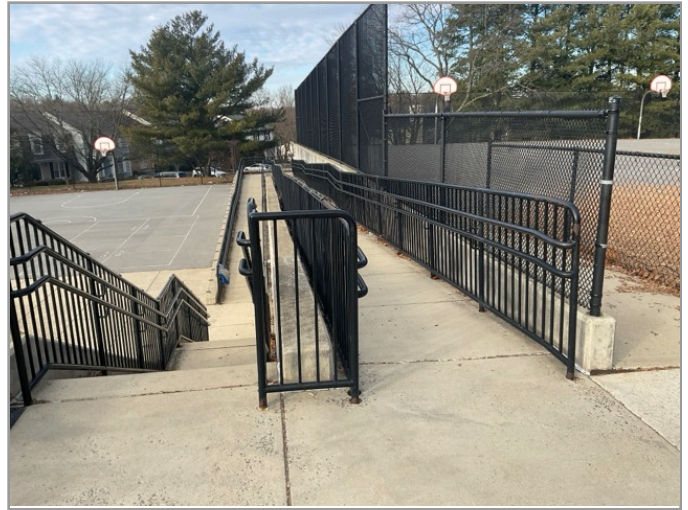
ACCESSIBLE PATH

ACCESSIBLE RAMP

Question		Yes	No	NA	Comments
1	Is an accessible route present from public transportation stops and municipal sidewalks on or immediately adjacent to the property ?	✗			
2	Does a minimum of one accessible route appear to connect all public areas on the exterior, such as parking and other outdoor amenities, to accessible building entrances ?	✗			
3	Are curb ramps present at transitions through raised curbs on all accessible routes?	✗			
4	Do curb ramps appear to have compliant slopes for all components ?	✗			
5	Do ramp runs on an accessible route appear to have compliant slopes ?	✗			
6	Do ramp runs on an accessible route appear to have a compliant rise and width ?	✗

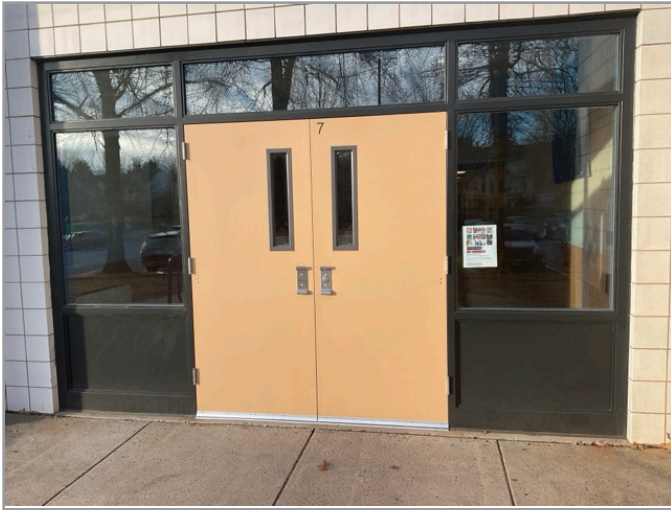
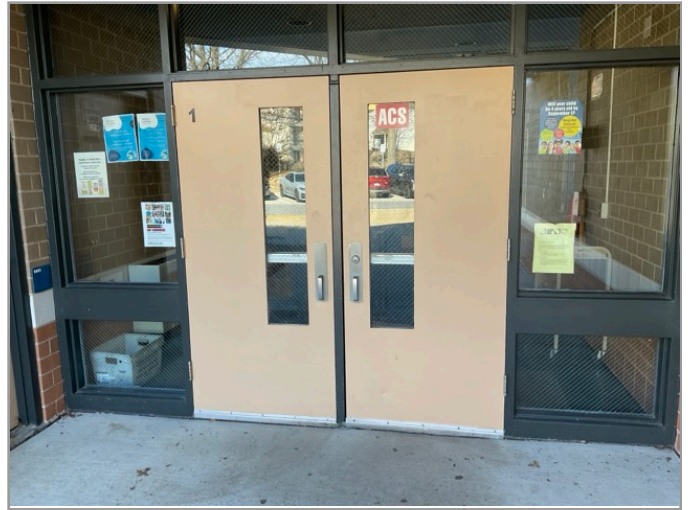
ACCESSIBLE ENTRANCE

ADDITIONAL ENTRANCE

Question		Yes	No	NA	Comments
1	Do a sufficient number of accessible entrances appear to be provided ?	X			
2	If the main entrance is not accessible, is an alternate accessible entrance provided?			X	
3	Is signage provided indicating the location of alternate accessible entrances ?			X	
4	Do doors at accessible entrances appear to have compliant maneuvering clearance area on each side ?	X			
5	Do doors at accessible entrances appear to have compliant hardware ?	X			
6	Do doors at accessible entrances appear to have a compliant clear opening width ?	X

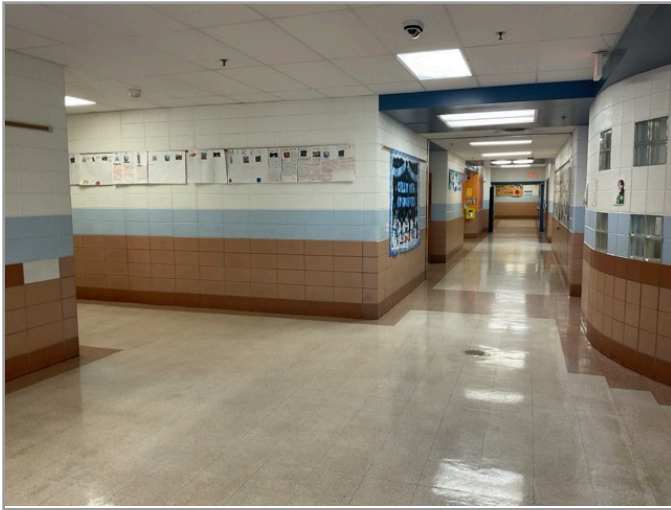
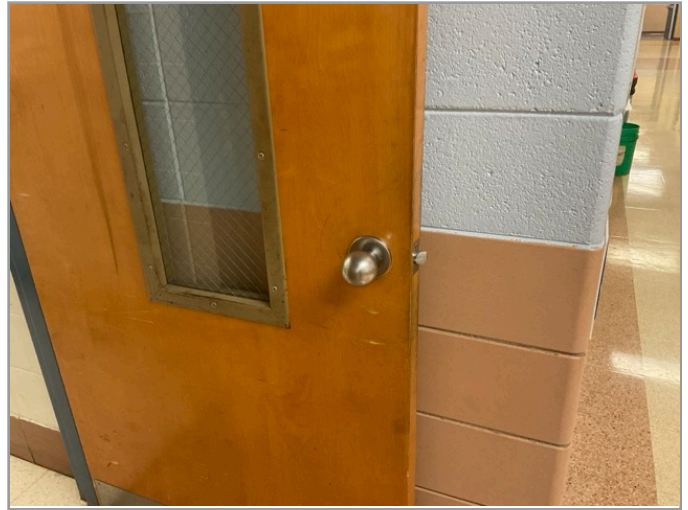
ACCESSIBLE INTERIOR PATH

DOOR HARDWARE

Question		Yes	No	NA	Comments
1	Does an accessible route appear to connect all public areas inside the building ?	✗			
2	Do accessible routes appear free of obstructions and/or protruding objects ?	✗			
3	Do ramps on accessible routes appear to have compliant slopes ?	✗			
4	Do ramp runs on an accessible route appear to have a compliant rise and width ?	✗			
5	Do ramps on accessible routes appear to have compliant end and intermediate landings ?	✗			
6	Do ramps on accessible routes appear to have compliant handrails ?	✗

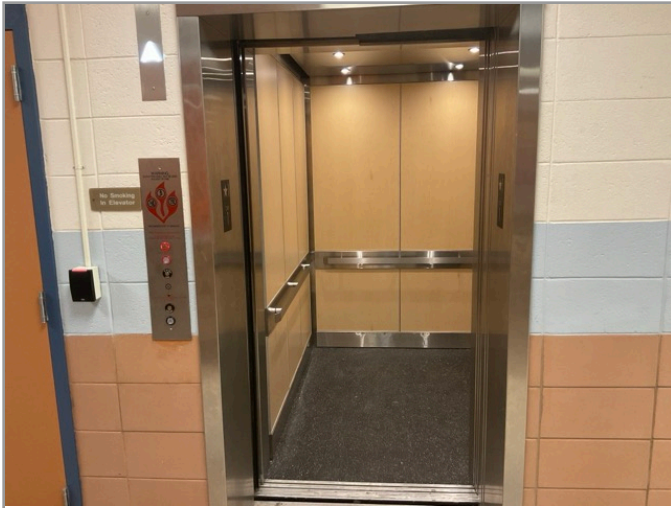
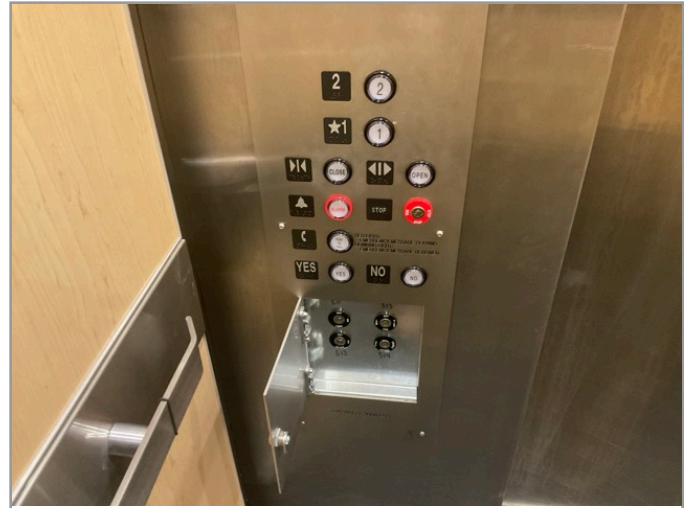
LOBBY LOOKING AT CAB

IN-CAB CONTROLS

Question	Yes	No	NA	Comments
1	Are hallway call buttons configured with the "UP" button above the "DOWN" button?	✗			
2	Is accessible floor identification signage present on the hoistway sidewalls on each level ?	✗			
3	Do the elevators have audible and visual arrival indicators at the lobby and hallway entrances?	✗			
4	Do the elevator hoistway and car interior appear to have a minimum compliant clear floor area ?	✗			
5	Do the elevator car doors have automatic re-opening devices to prevent closure on obstructions?	✗			
6	Do elevator car control buttons appear to be mounted at a compliant height ?	✗

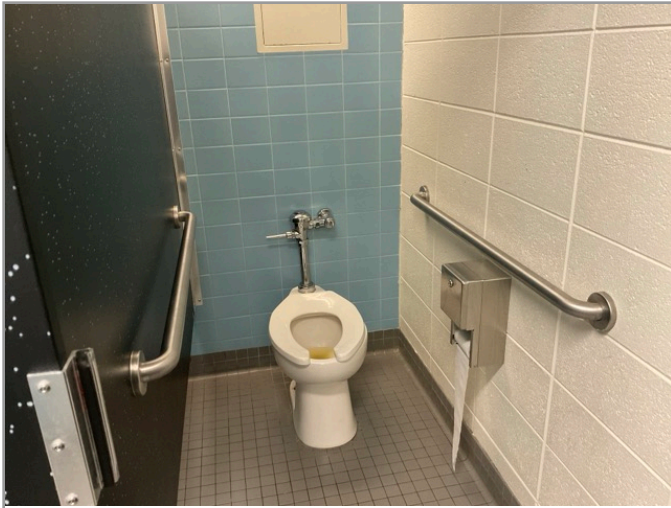
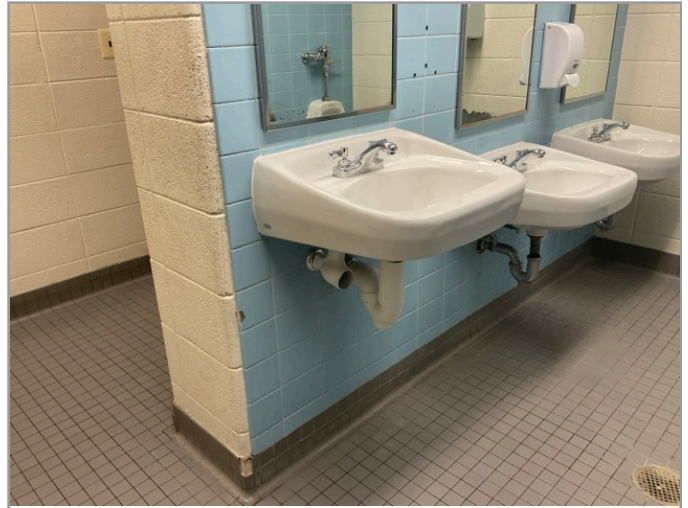
TOILET STALL OVERVIEW

SINK, FAUCET HANDLES AND ACCESSORIES

Question		Yes	No	NA	Comments
1	Do publicly accessible toilet rooms appear to have a minimum compliant floor area ?	✗			
2	Does the lavatory appear to be mounted at a compliant height and with compliant knee area ?	✗			
3	Does the lavatory faucet have compliant handles ?	✗			
4	Is the plumbing piping under lavatories configured to protect against contact ?		✗		
5	Are grab bars provided at compliant locations around the toilet ?		✗		
6	Do toilet stall doors appear to provide the minimum compliant clear width ?		✗

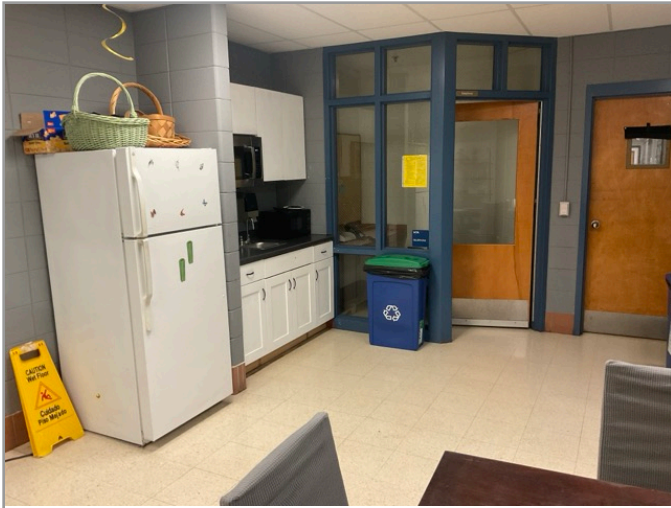
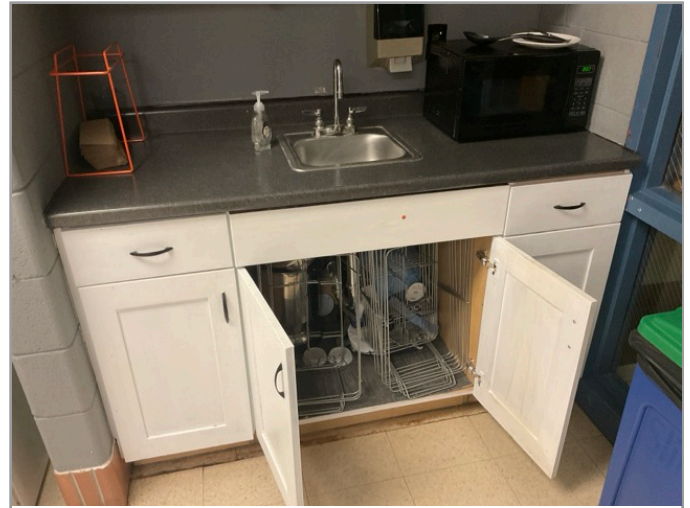
KITCHEN OVERVIEW

SINK CLEARANCE

Question		Yes	No	NA	Comments
1	Do kitchens/kitchenettes appear to have a minimum compliant path of travel or area of maneuverability ?	✗			
2	Are the appliances centered for a parallel or forward approach with adequate clear floor space ?	✗			
3	Is there an accessible countertop/preparation space of proper width and height ?	✗			
4	Is there an accessible sink space of proper width and height ?		✗		
5	Does the sink faucet have compliant handles ?	✗			
6	Is the plumbing piping under the sink configured to protect against contact ?		✗

7	Are the cooktop/range controls front-mounted (or in a location that does not require reaching across the burners) ?			X	
---	---	--	--	---	--

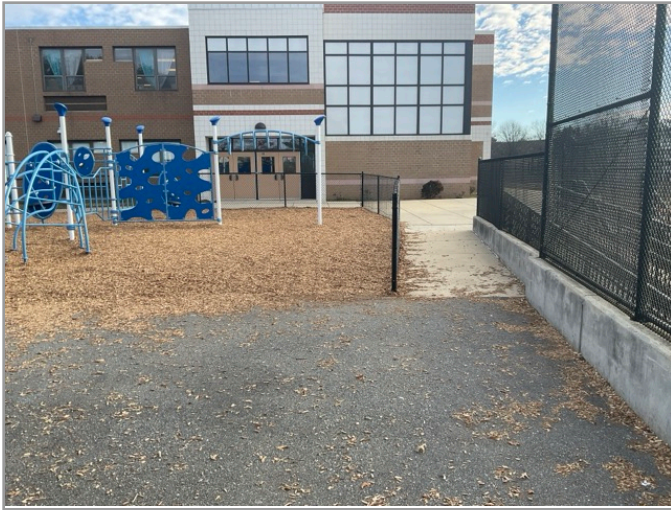
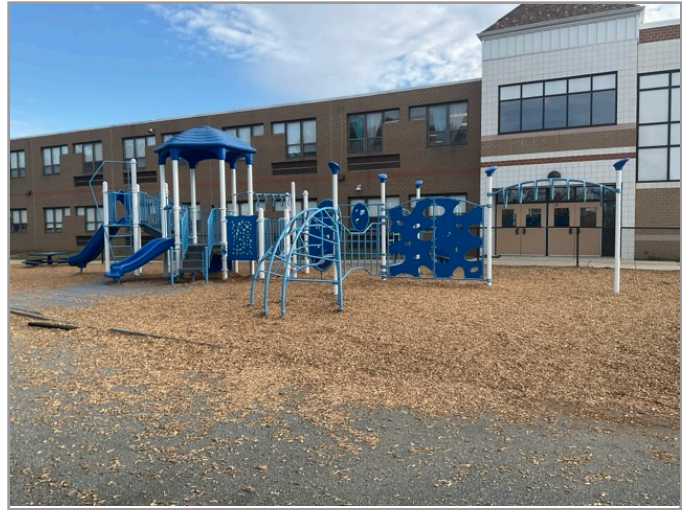
ACCESSIBLE ROUTE TO PLAYGROUND

OVERVIEW OF PLAYGROUND

Question		Yes	No	NA	Comments
1	Is there an accessible route to the play area / s?	X			
2	Has the play area been reviewed for accessibility ?	X			
3	Are publicly accessible swimming pools equipped with an entrance lift ?			X
