# FACILITY CONDITION ASSESSMENT

Weller Road Elementary School  
3301 Weller Road  
Silver Spring, MD 20906

172559.25R000-128.354

*January 6, 2026*

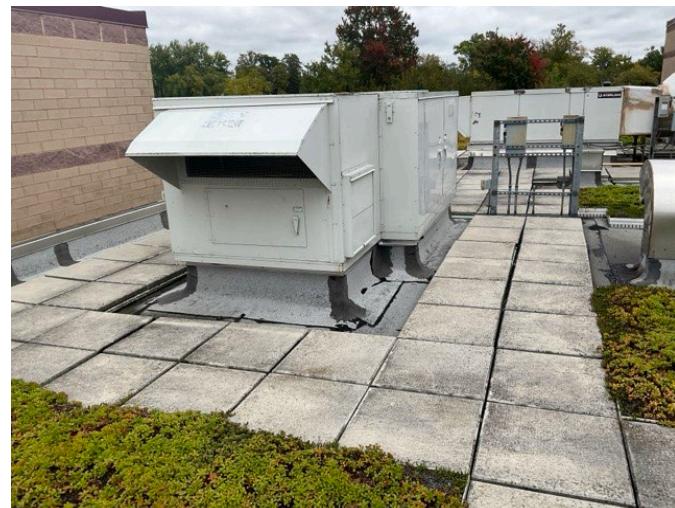
24 - ROOFTOP AIR HANDLER

Most of the MEPF systems were replaced during the 2013 renovation and are in fair condition. Primary heating and cooling are provided via geothermal heat pumps and air handlers. An energy recovery unit on the older 2007 roof is approaching end of life and should be budgeted for replacement in the short term. Ductless split systems and electric unit heaters provide supplemental heating and cooling. A natural gas-powered generator with automatic transfer switches provides emergency electrical power. The main electrical feed is a 2000 amp 277/480 volt service feeding the main switchboard. Domestic hot water is supplied by a 100-gallon gas water heater with adjacent storage tank. Restrooms have typical fixtures throughout. The building is protected by a fire alarm system and wet pipe sprinkler system, both in fair condition.

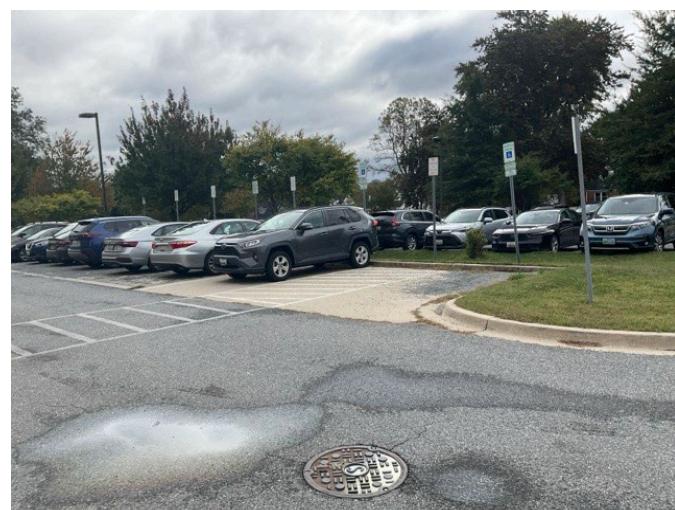
30 - PARKING LOTS

### Parking Lots in Poor condition.

Uniformat Code: G2020  
Recommendation: **Seal and Stripe in 2026**
