**BUREAU
VERITAS**

FACILITY CONDITION ASSESSMENT

Francis Scott Key Middle School
910 Schindler Drive
Silver Spring, MD 20903

May 26, 2026

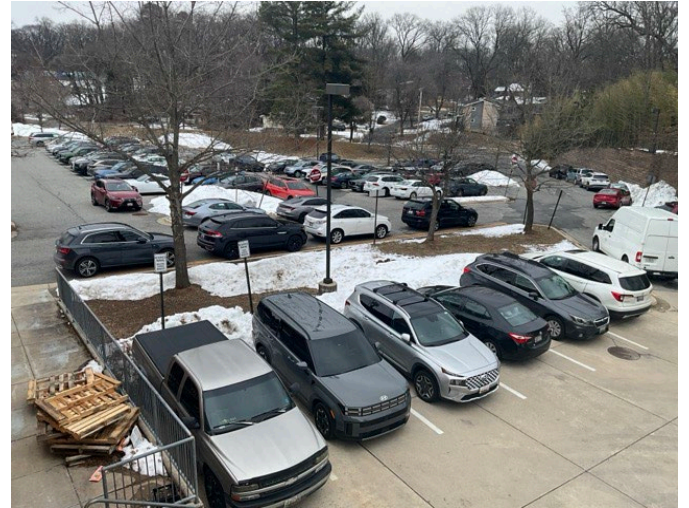
32 - MAIN PARKING AREA

The campus includes parking areas, outdoor athletic facilities, and landscaped open spaces. The parking lot pavement was observed to be in poor condition, with visible deterioration that may require resurfacing or repair. Recreational areas include basketball courts, a baseball field, and a soccer field. The basketball courts show surface cracking and deterioration, which should be addressed for safety purposes. The baseball and soccer fields appear to be in generally fair condition and remain suitable for use.
