FACILITY CONDITION ASSESSMENT

Dr. Martin Luther King, Jr. Middle School
13737 Wisteria Drive
Germantown, Maryland 20874

172559.25R000-151.354

May 8, 2026

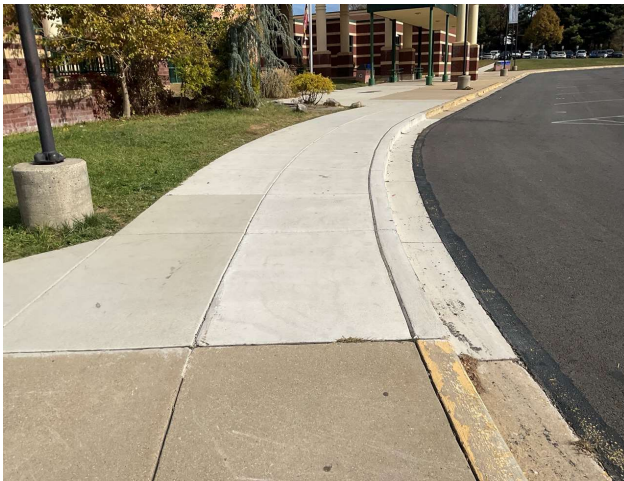
3 - SIDEWALK

There are isolated areas of spalling and cracking concrete sidewalks on east side concrete ramp and on the north and west sides of the building. - AssetCALC ID: 9960604
