# FACILITY CONDITION ASSESSMENT

**Montgomery County Public Schools**  
45 West Gude Drive, Suite 4000  
Rockville, MD 20850

Kingsview Middle School  
18909 Kingsview Road  
Germantown, MD 20874

May 8, 2026

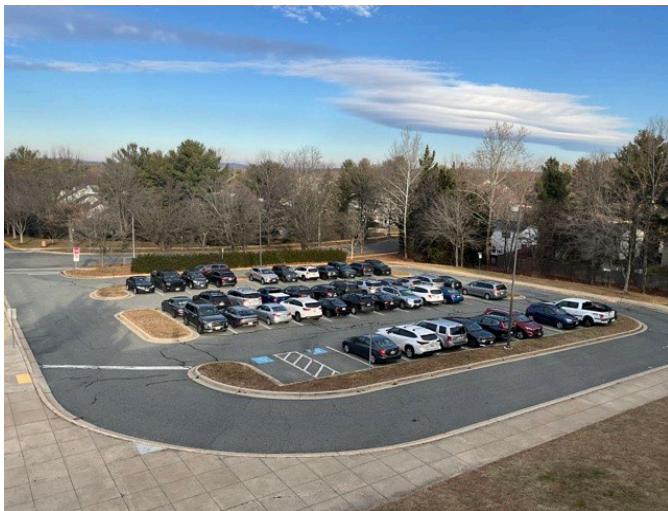
33 - MAIN PARKING AREA

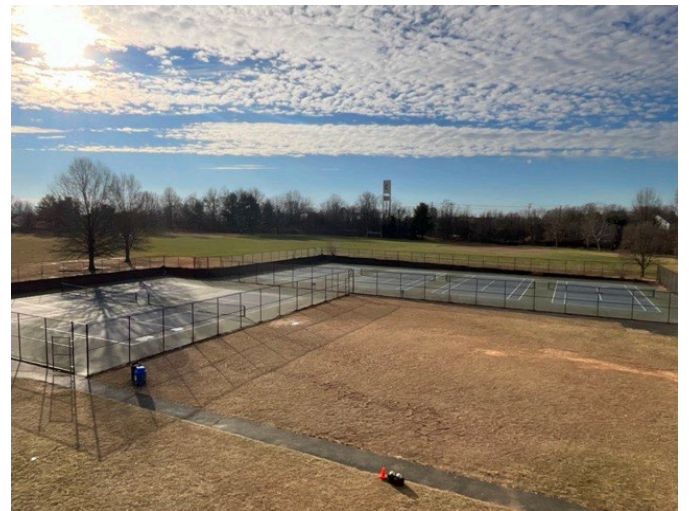
34 - TENNIS COURTS

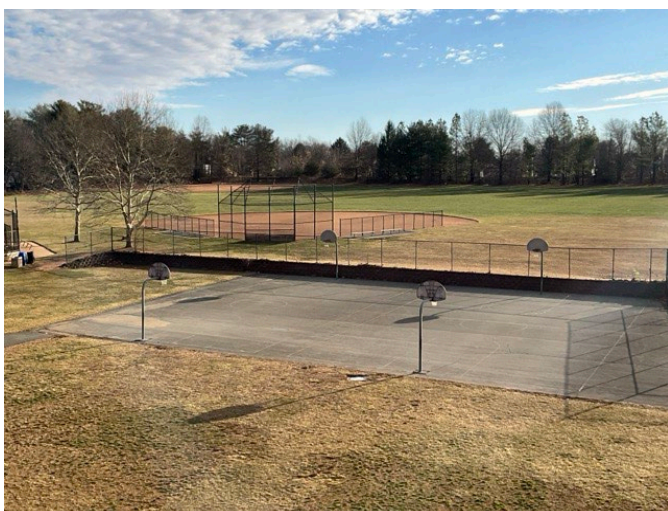
35 - SPORTS COURTS AND FIELD

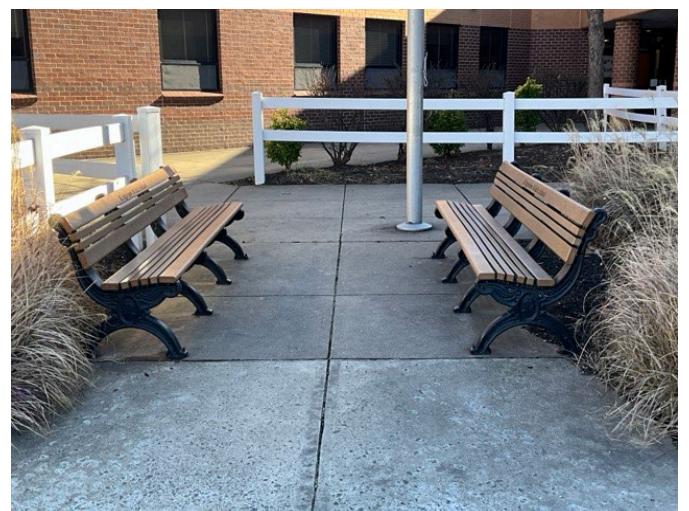
36 - SITE FURNISHING

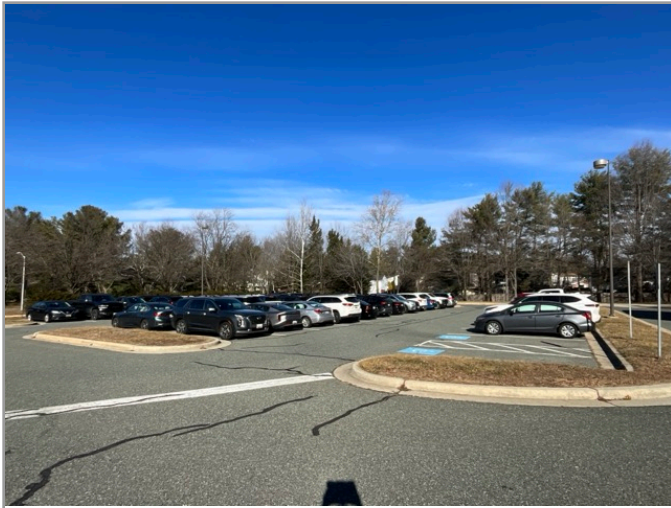
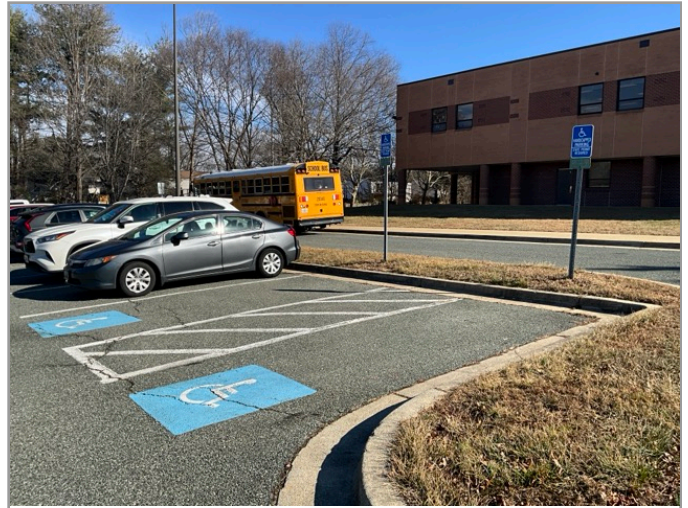
OVERVIEW OF ACCESSIBLE PARKING AREA

CLOSE-UP OF STALL

Question		Yes	No	NA	Comments
1	Does the required number of standard ADA designated spaces appear to be provided ?	✘			
2	Does the required number of van-accessible designated spaces appear to be provided ?	✘			
3	Are accessible spaces on the shortest accessible route to an accessible building entrance ?	✘			
4	Does parking signage include the International Symbol of Accessibility ?	✘			
5	Does each accessible space have an adjacent access aisle ?	✘			
6	Do parking spaces and access aisles appear to be relatively level and without obstruction ?	✘

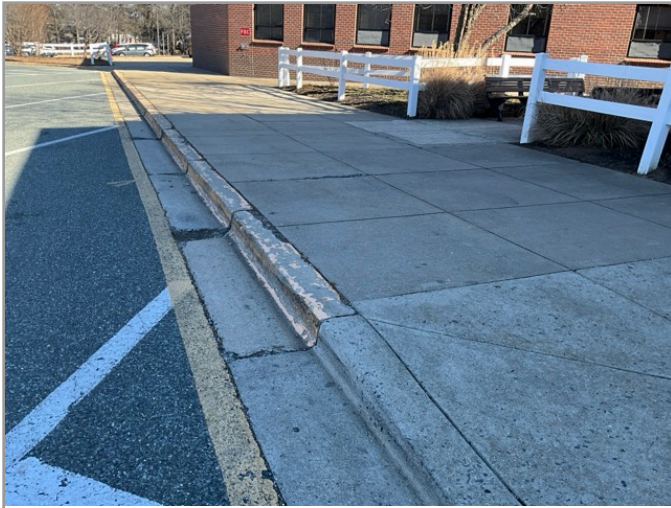
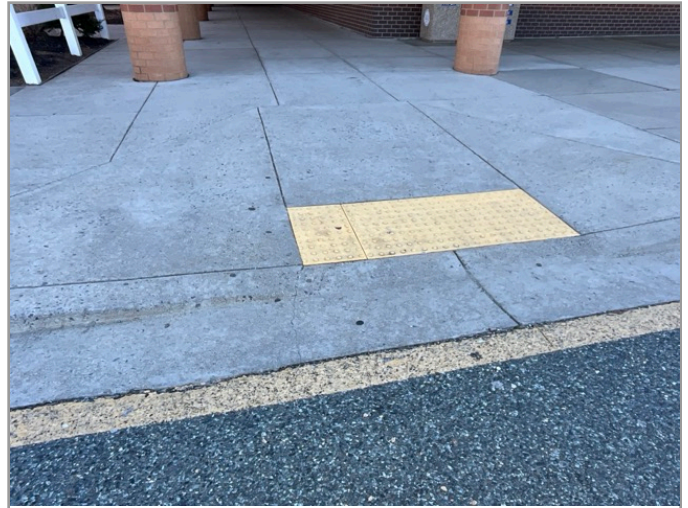
ACCESSIBLE PATH

CURB CUT

Question		Yes	No	NA	Comments
1	Is an accessible route present from public transportation stops and municipal sidewalks on or immediately adjacent to the property ?	✗			
2	Does a minimum of one accessible route appear to connect all public areas on the exterior, such as parking and other outdoor amenities, to accessible building entrances ?	✗			
3	Are curb ramps present at transitions through raised curbs on all accessible routes?	✗			
4	Do curb ramps appear to have compliant slopes for all components ?	✗			
5	Do ramp runs on an accessible route appear to have compliant slopes ?	✗			
6	Do ramp runs on an accessible route appear to have a compliant rise and width ?	✗

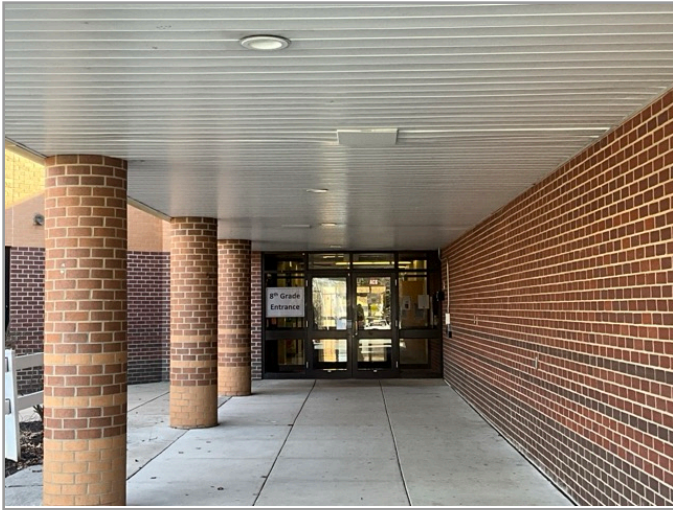
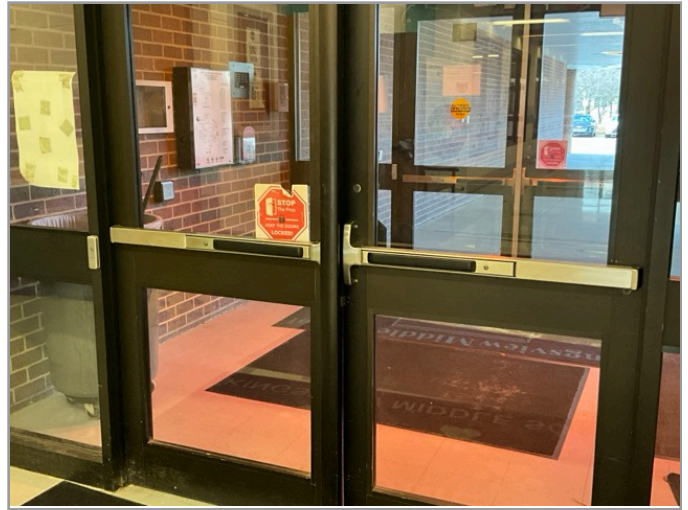
MAIN ENTRANCE

DOOR HARDWARE

Question		Yes	No	NA	Comments
1	Do a sufficient number of accessible entrances appear to be provided ?	✗			
2	If the main entrance is not accessible, is an alternate accessible entrance provided?	✗			
3	Is signage provided indicating the location of alternate accessible entrances ?	✗			
4	Do doors at accessible entrances appear to have compliant maneuvering clearance area on each side ?	✗			
5	Do doors at accessible entrances appear to have compliant hardware ?	✗			
6	Do doors at accessible entrances appear to have a compliant clear opening width ?	✗

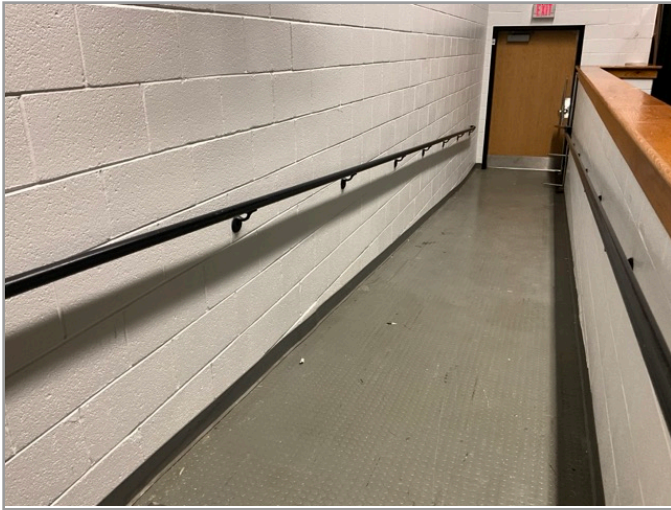
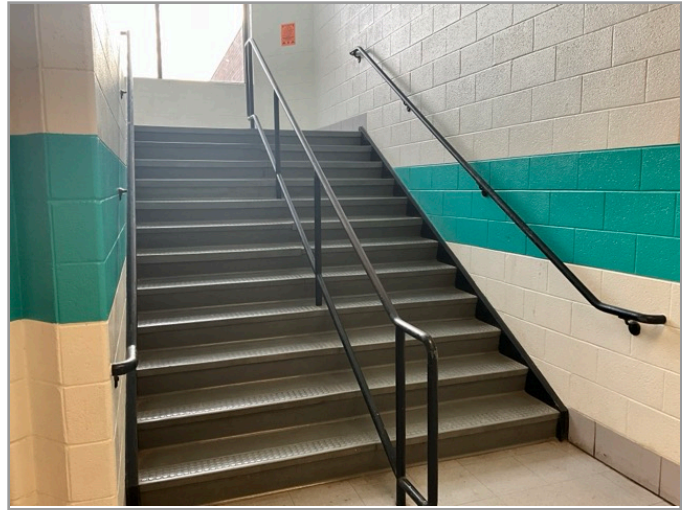
ACCESSIBLE INTERIOR RAMP

STAIR RAILS

Question		Yes	No	NA	Comments
1	Does an accessible route appear to connect all public areas inside the building ?	✗			
2	Do accessible routes appear free of obstructions and/or protruding objects ?	✗			
3	Do ramps on accessible routes appear to have compliant slopes ?	✗			
4	Do ramp runs on an accessible route appear to have a compliant rise and width ?	✗			
5	Do ramps on accessible routes appear to have compliant end and intermediate landings ?	✗			
6	Do ramps on accessible routes appear to have compliant handrails ?	✗

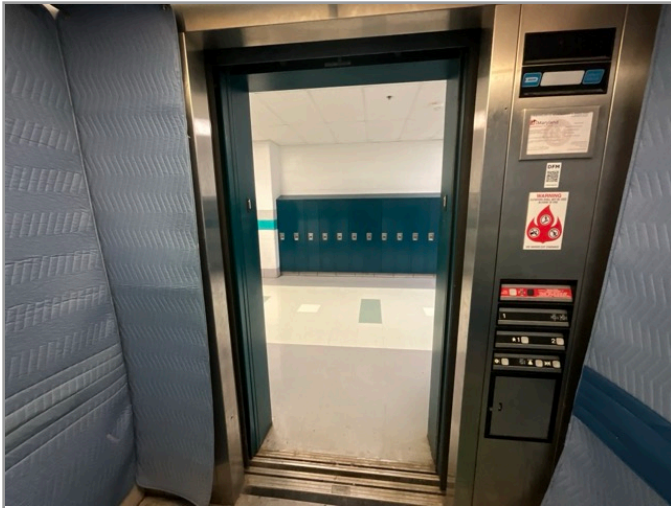
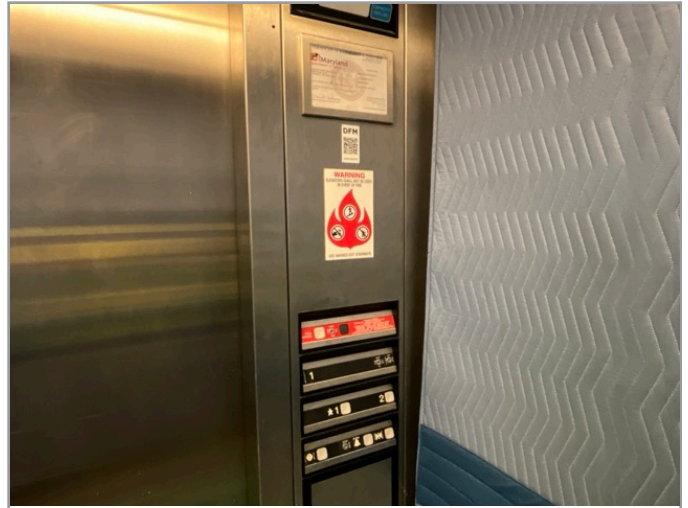
FROM CAB LOOKING INTO LOBBY

EMERGENCY CALL PANEL

Question		Yes	No	NA	Comments
1	Are hallway call buttons configured with the "UP" button above the "DOWN" button?	✗			
2	Is accessible floor identification signage present on the hoistway sidewalls on each level ?	✗			
3	Do the elevators have audible and visual arrival indicators at the lobby and hallway entrances?	✗			
4	Do the elevator hoistway and car interior appear to have a minimum compliant clear floor area ?	✗			
5	Do the elevator car doors have automatic re-opening devices to prevent closure on obstructions?	✗			
6	Do elevator car control buttons appear to be mounted at a compliant height ?	✗

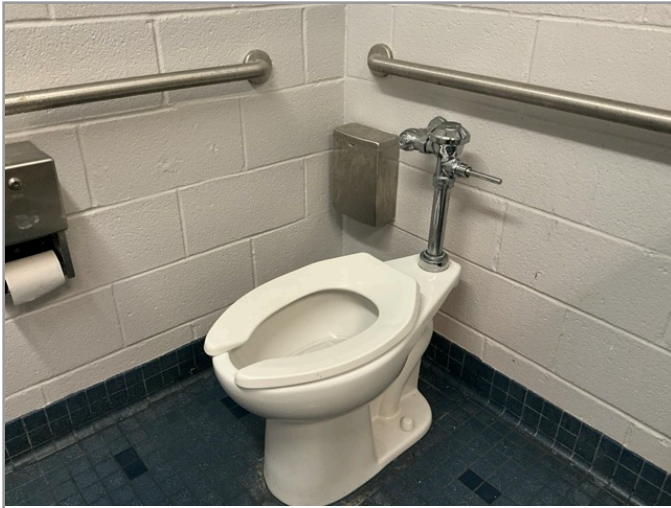
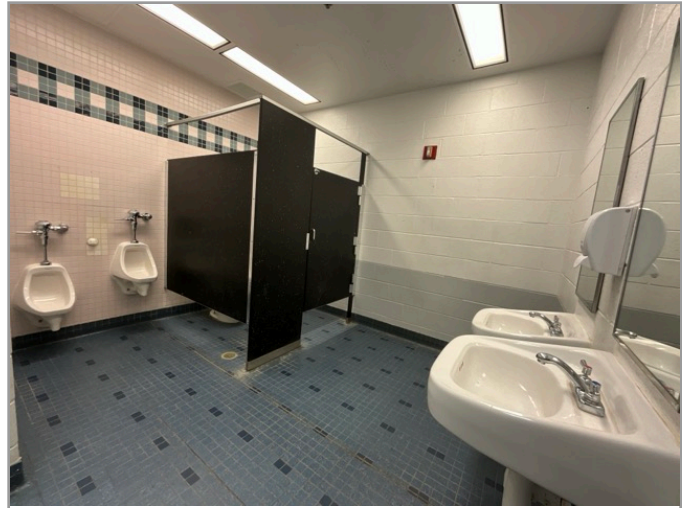
TOILET STALL OVERVIEW

SINK, FAUCET HANDLES AND ACCESSORIES

Question		Yes	No	NA	Comments
1	Do publicly accessible toilet rooms appear to have a minimum compliant floor area ?	✗			
2	Does the lavatory appear to be mounted at a compliant height and with compliant knee area ?	✗			
3	Does the lavatory faucet have compliant handles ?	✗			
4	Is the plumbing piping under lavatories configured to protect against contact ?	✗			
5	Are grab bars provided at compliant locations around the toilet ?	✗			
6	Do toilet stall doors appear to provide the minimum compliant clear width ?	✗

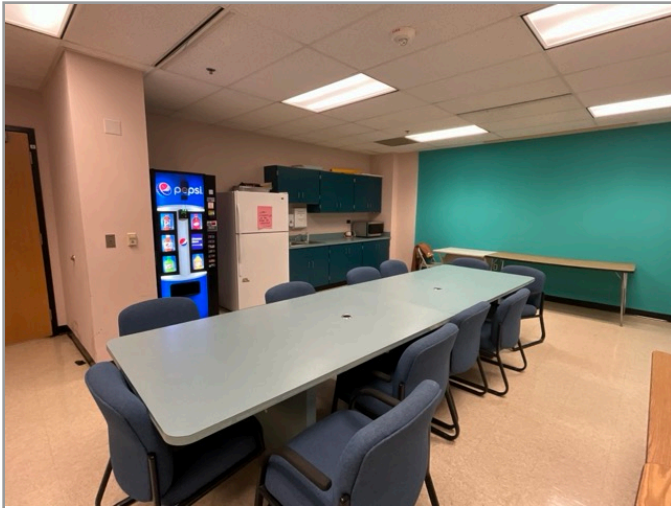
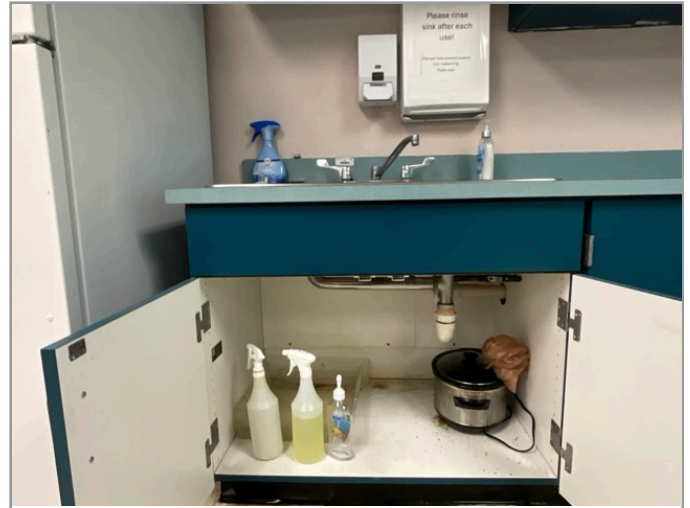
BREAKROOM OVERVIEW

SINK CLEARANCE

Question		Yes	No	NA	Comments
1	Do kitchens/kitchenettes appear to have a minimum compliant path of travel or area of maneuverability ?	✗			
2	Are the appliances centered for a parallel or forward approach with adequate clear floor space ?	✗			
3	Is there an accessible countertop/preparation space of proper width and height ?	✗			
4	Is there an accessible sink space of proper width and height ?		✗		
5	Does the sink faucet have compliant handles ?	✗			
6	Is the plumbing piping under the sink configured to protect against contact ?		✗

7	Are the cooktop/range controls front-mounted (or in a location that does not require reaching across the burners) ?	✘			
---	---	---	--	--	--

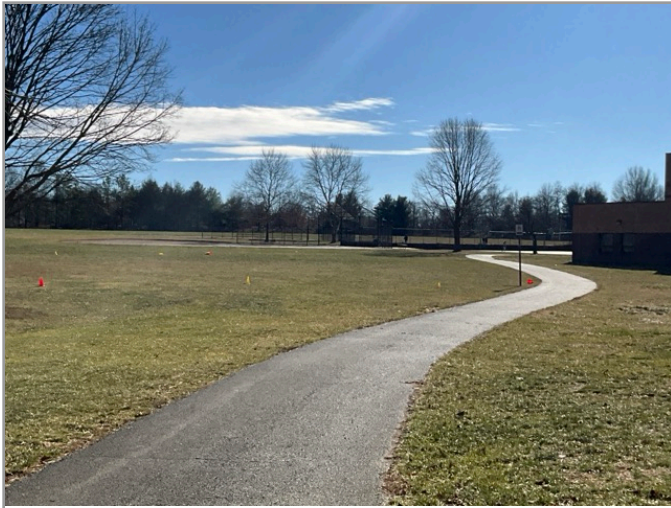
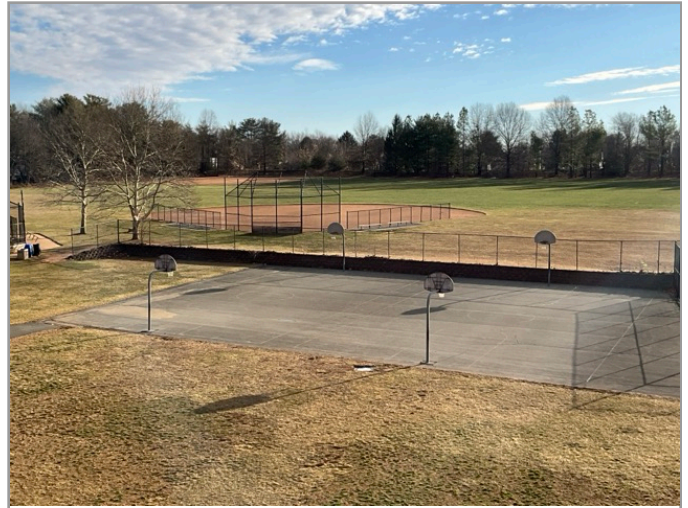
ACCESSIBLE ROUTE TO PLAYGROUND

OVERVIEW OF PLAYGROUND

Question		Yes	No	NA	Comments
1	Is there an accessible route to the play area / s?	✗			
2	Has the play area been reviewed for accessibility ?	✗			
3	Are publicly accessible swimming pools equipped with an entrance lift ?	✗
