FACILITY CONDITION ASSESSMENT

Rosa M. Parks Middle School
19200 Olney Mill Road
Olney, MD 20832

172559.25R000-160.354

May 8, 2026

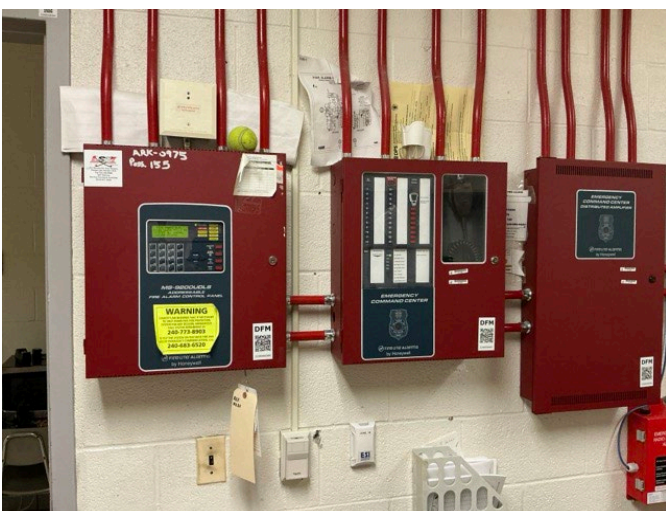
29 - FIRE ALARM PANEL

The fire alarm systems appear somewhat antiquated and not up to current standards. Due to the age of the components, a full modernization project is recommended. The central alarm panel appears to be original. Based on its age and because replacement parts and components for this type of equipment may be obsolete, the alarm panel requires replacement.
