FACILITY CONDITION ASSESSMENT

Springbrook High School
201 Valley Brook Drive
Silver Spring, MD 20904

Bureau Veritas
6021 University Boulevard, Suite 200
Ellicott City, MD 21043
800.733.0660
www.bvna.com

May 15, 2026

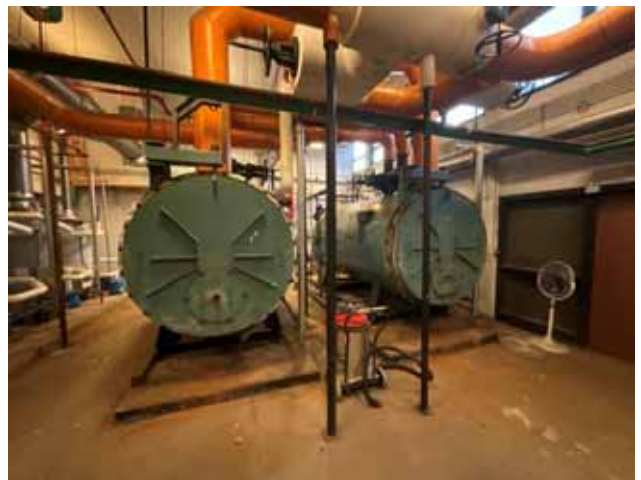
30 - BOILERS

The boiler is exceedingly aged and has heavily rusted areas - AssetCALC ID: 10314739

Uniformat Code: D3020
Recommendation: **Replace in 2027**
