# FACILITY CONDITION ASSESSMENT

## **Montgomery County Public Schools**

Longview School  
13900 Bromfield Road  
Germantown, MD 20874

*May 28, 2026*

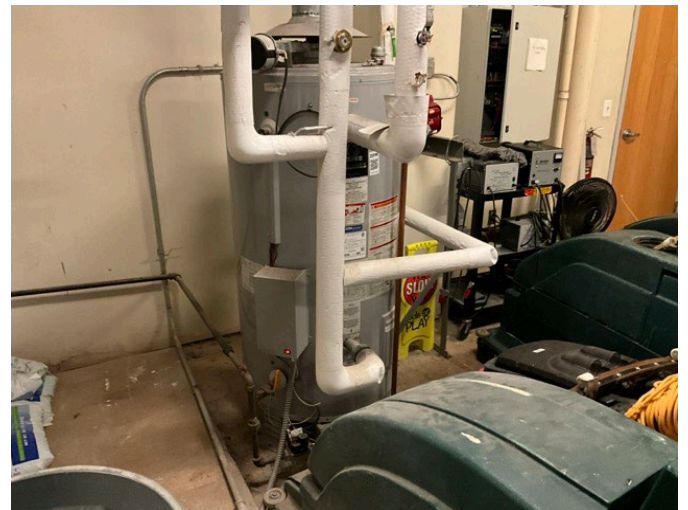
10 - WATER HEATER

The plumbing systems are also a mix of original and replacement, and plumbing appears adequate for the facility, with equipment and fixtures generally updated as needed. A 2020 water heater provides hot water throughout. No significant leaks or pressure issues were reported.

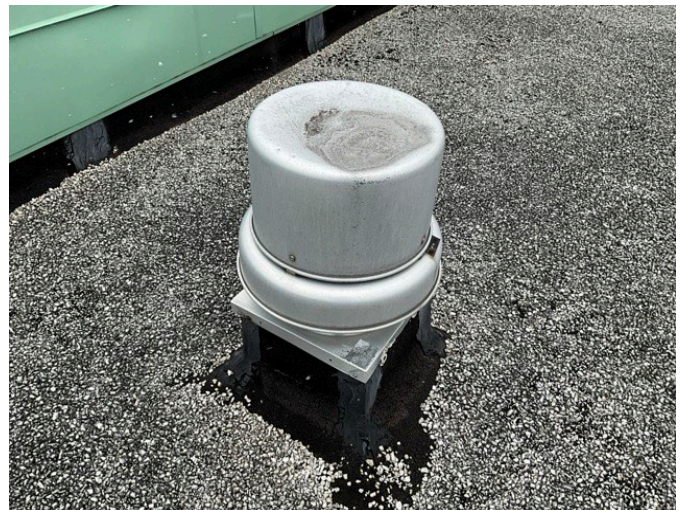
16 - EXHAUST

The unit is at the end of its expected life and all are scheduled to be replaced this summer - AssetCALC ID: 10559271

Uniformat Code: D3060  
Recommendation: **Replace in 2026**

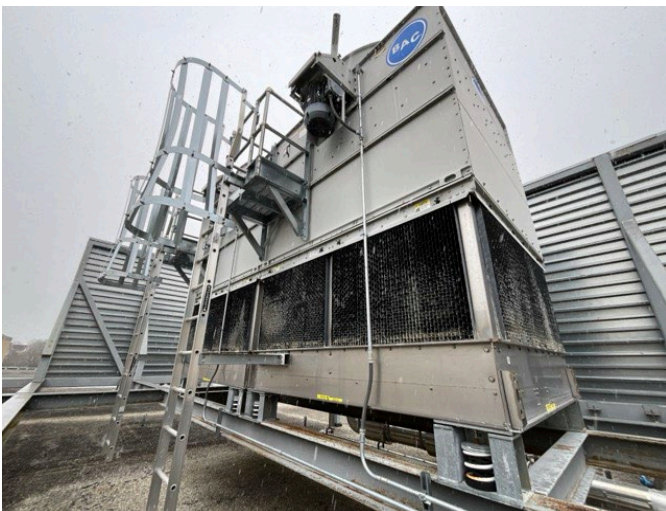
17 - COOLING TOWER

A boiler and cooling tower provide tempered water for cooling and heating throughout the building. Two conference rooms currently do not have functioning HVAC. The whole HVAC system is planned to be replaced in summer of 2026. Numerous roof-mounted units are nearing or past the end of their expected useful life, and while generally still functional, will benefit from replacement in the summer.

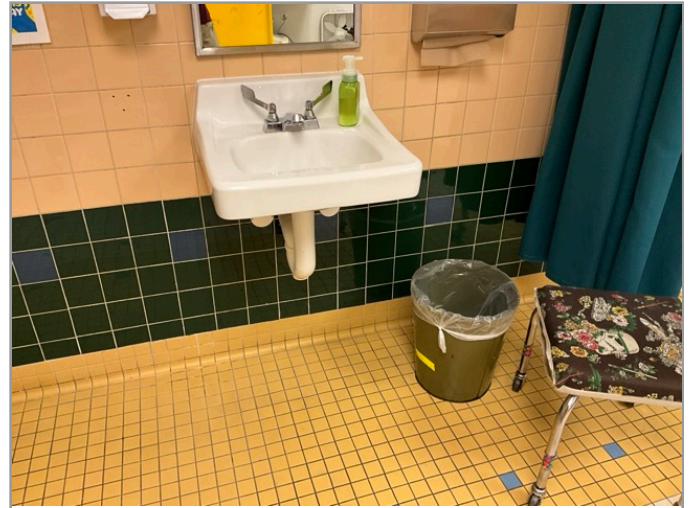
Sink drainpipe cover is missing for ADA compliance - AssetCALC ID: 10559300

SINK, FAUCET HANDLES AND ACCESSORIES

Uniformat Code: Y1050  
Recommendation: **Install in 2026**
