FACILITY CONDITION ASSESSMENT

Montgomery County Public Schools
45 West Gude Drive, Suite 4000
Rockville, MD 20850

Lathrop E. Smith Center
5110 Meadowside Lane
Rockville, MD 20855

June 2, 2026

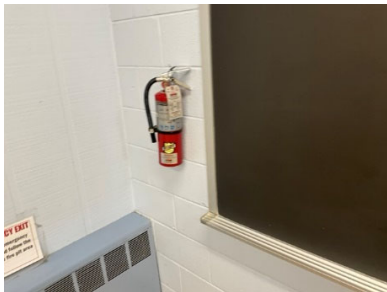
Fire Suppression System

The building lacks a fire suppression system and the school is likely; based on code at the time of original construction. A comprehensive building renovation would likely trigger full compliance to current codes, and a budgetary cost for a full fire suppression retrofit is included in the initial five-year plan. - AssetCALC ID: 10440273

Full System Install/Retrofit, Medium
 Density/Complexity
 Dorm Baltimore Oriol Lathrop E. Smith Center
 Throughout Building

Uniformat Code: D4010
 Recommendation: **Renovate in 2030**
