FACILITY CONDITION ASSESSMENT

Montgomery County Public Schools

Grosvenor Center
5701 Grosvenor Lane
Bethesda, MD 20814

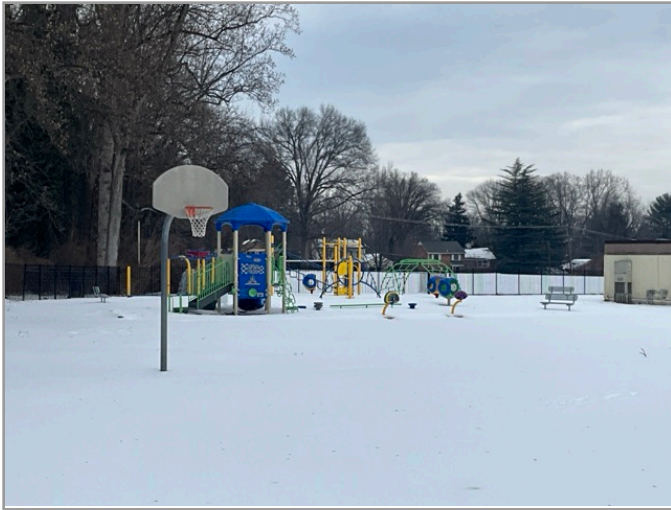
ACCESSIBLE ROUTE TO PLAYGROUND

Question		Yes	No	NA	Comments
1	Is there an accessible route to the play area / s?			✗	Can't tell due to snow, assumed yes
2	Has the play area been reviewed for accessibility ?			✗	Unknown
3	Are publicly accessible swimming pools equipped with an entrance lift ?			✗
