# FACILITY CONDITION ASSESSMENT

**Montgomery County Public Schools**  
45 West Gude Drive, Suite 4000  
Rockville, MD 20850

Concord Center  
7210 Hidden Creek Road  
Bethesda, MD 20817

May 28, 2026

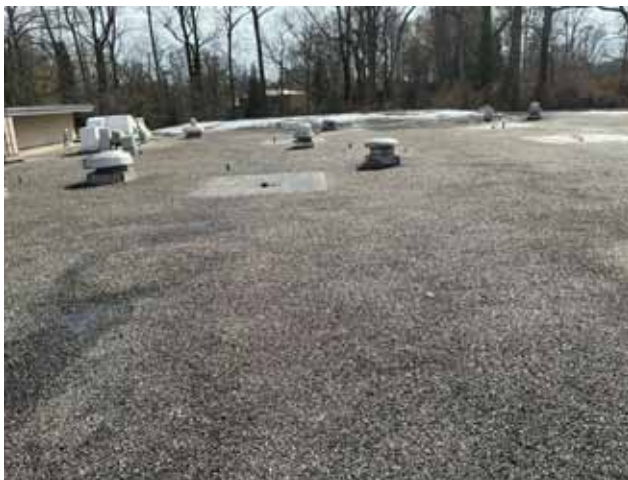
5 - ROOFING

In general, the structure appears to be sound, with no significant areas of settlement or structural-related deficiencies observed. The field of the roof has isolated areas of topping degradation. The roof membrane requires replacement. The windows are in fair condition with no window leaks reported. The interior finishes were observed to be in fair condition throughout the building. Typical lifecycle replacements of the interior and exterior finishes are budgeted and anticipated.

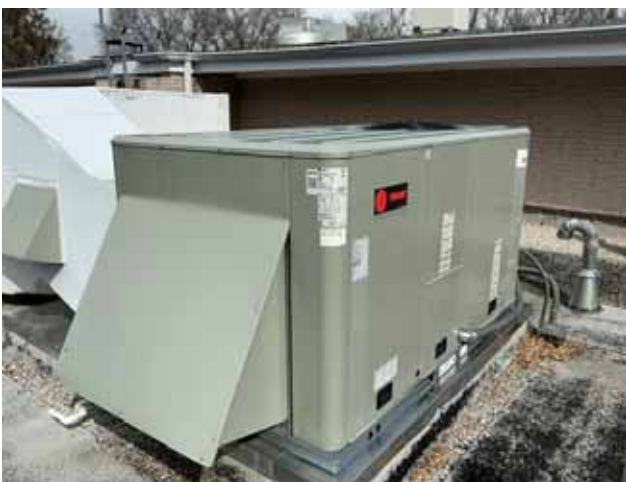
17 - PACKAGED UNIT

Heating and cooling are provided by split system units and package units. There are unit ventilators throughout the classrooms. The majority of the HVAC components are outdated and in need of replacement. Upgrading HVAC components should improve comfort space and efficiency.

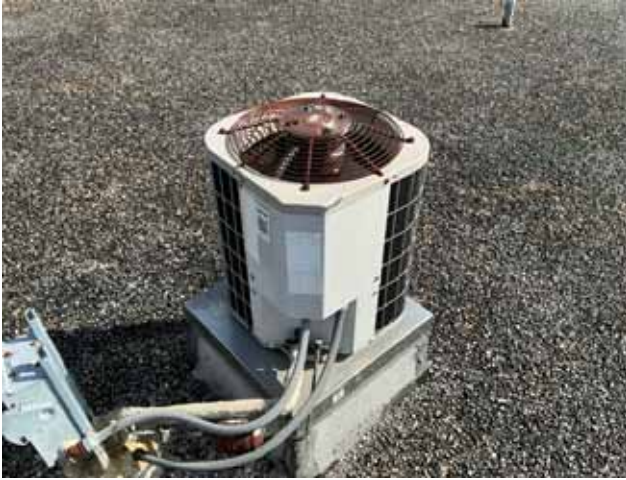
19 - SPLIT SYSTEM

Split system is exceedingly aged, corroded, and uses R22 outdated refrigerant. - AssetCALC ID: 10429286

Uniformat Code: D3030  
Recommendation: **Replace in 2027**

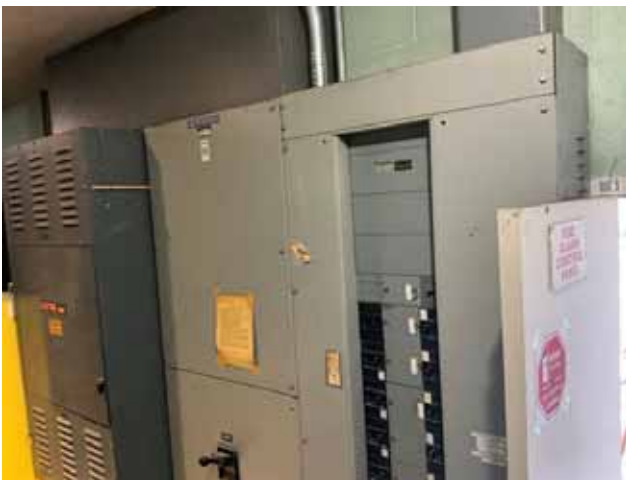
23 - SWITCHBOARD

The vast majority of electrical components within the building, including the circuit breaker panels, switchboards, and wiring, are original to the 1988 construction. A full modernization/upgrade is recommended to the aging interior electrical infrastructure.

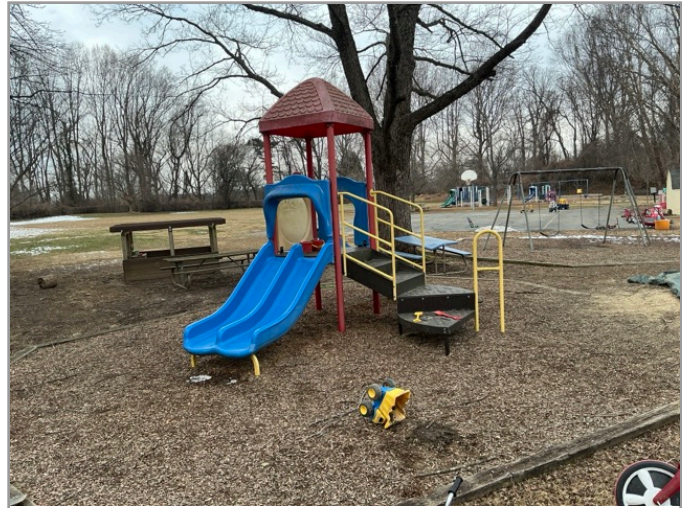
OVERVIEW OF PLAYGROUND
