# FACILITY CONDITION ASSESSMENT

**Montgomery County Public Schools**  
45 West Gude Drive, Suite 4000  
Rockville, MD 20850

Lynnbrook Center  
8001 Lynbrook Drive  
Bethesda, MD 20814

*August 11, 2025*

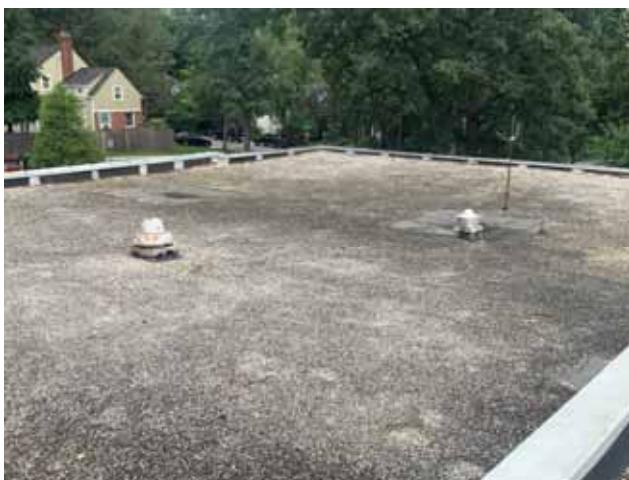
5 - MAIN ROOF

In general, the structure appears to be sound, with no significant areas of settlement or structural-related deficiencies observed. The roof is outdated with a history of roof leaks reported. The roof is recommended for short-term replacement. The interior finishes are in fair condition. Typical lifecycle-based interior and exterior finish replacements are budgeted and anticipated.

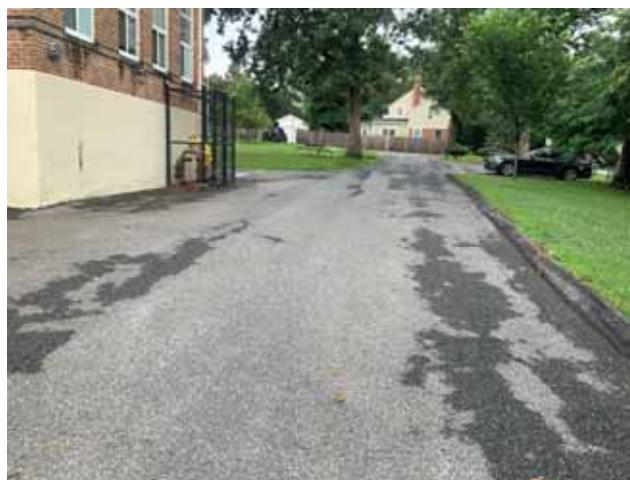
6 - PARKING LOT

In general, the site has been well maintained. Sidewalks have minor cracks, and asphalt pavement has been regularly maintained with seal coating and striping, with only a few areas of significant cracking in the main parking lot. The majority of the site lighting consists of energy inefficient metal halide and high-pressure sodium fixtures and lamps.

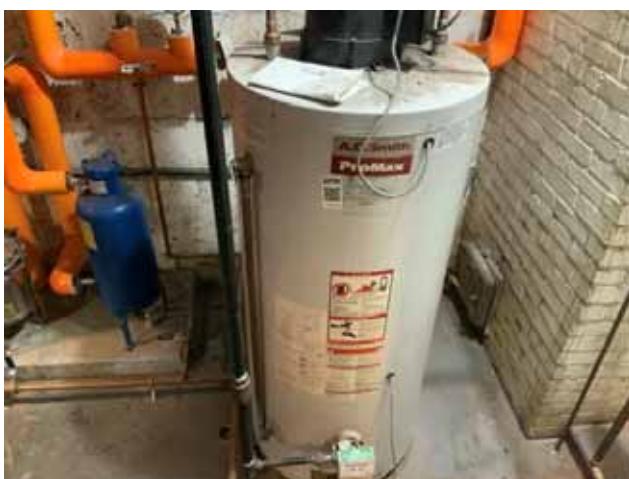
23 - WATER HEATER

Most of the domestic water lines are galvanized iron original to the 1942 construction. To date there has been no history of chronic leaks or water pressure problems. However, it is quite common for galvanized iron piping to develop problems due to long-term corrosion with thinning walls and/or interior mineral deposit accumulation, especially once it has aged 40 or 50 years. As such, Bureau Veritas recommends replacing all the plumbing supply lines with copper.

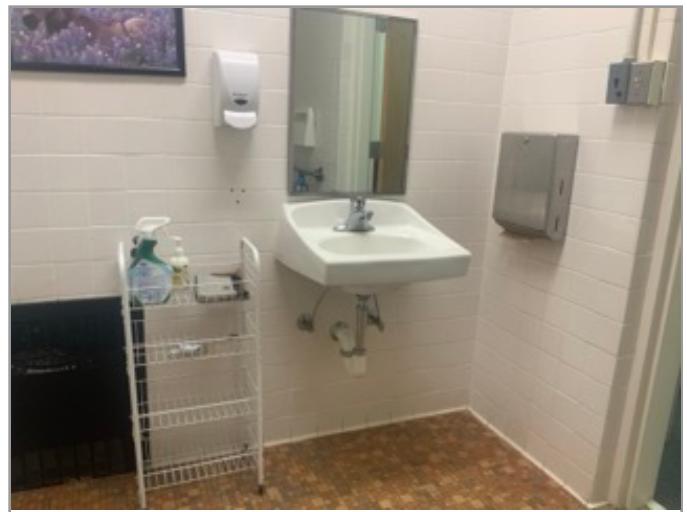
TOILET STALL OVERVIEW

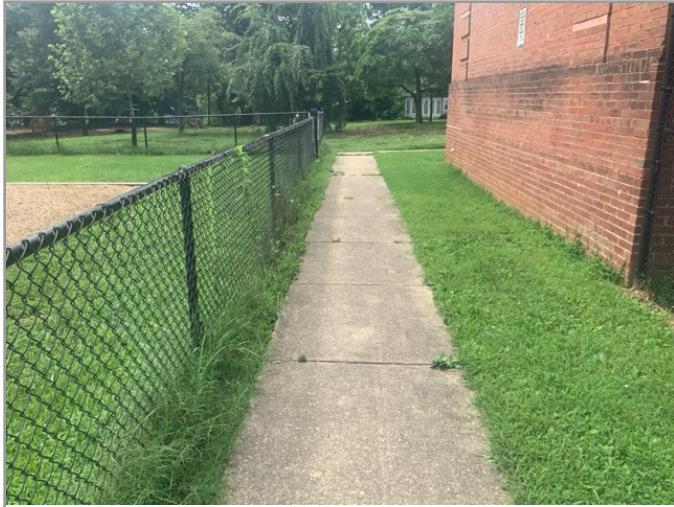
ACCESSIBLE ROUTE TO PLAYGROUND

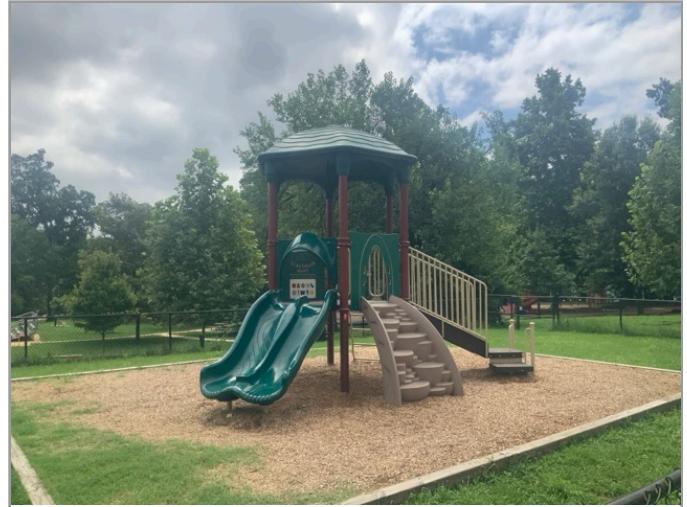
OVERVIEW OF PLAYGROUND
