# FACILITY CONDITION ASSESSMENT

## **Montgomery County Public Schools**

Montrose Center  
12301 Academy Way  
Rockville, MD 20852

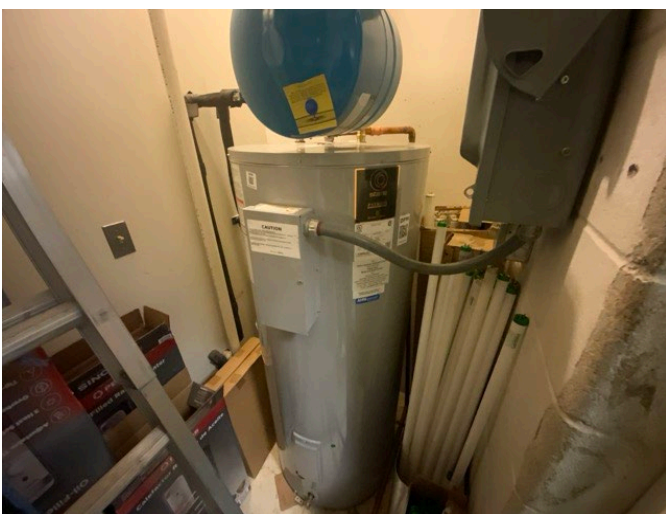
11 - ELECTRIC WATER HEATER

Hot water for plumbing is provided by an electric water heater which is in the main mechanical room. The water heater appears to have been installed in 2025 and is in very good condition. The plumbing infrastructure is estimated to be from the 1983 renovation and functioning adequately.

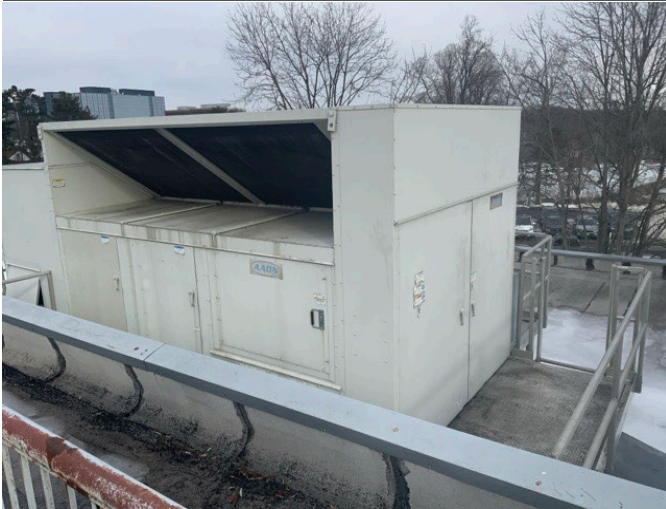
13 - ROOFTOP PACKAGED UNIT

Primary heating and cooling are provided by roof mounted packaged units and ductless split systems. Rooftop units send warm or cool air to VAV units which provide tempered air to the various rooms of the facility. All package units date to 2016 and rated fair; however, the VAV boxes have exceeded EUL and should be replaced in the near term. Lifecycle replacement of equipment is not anticipated until late term.

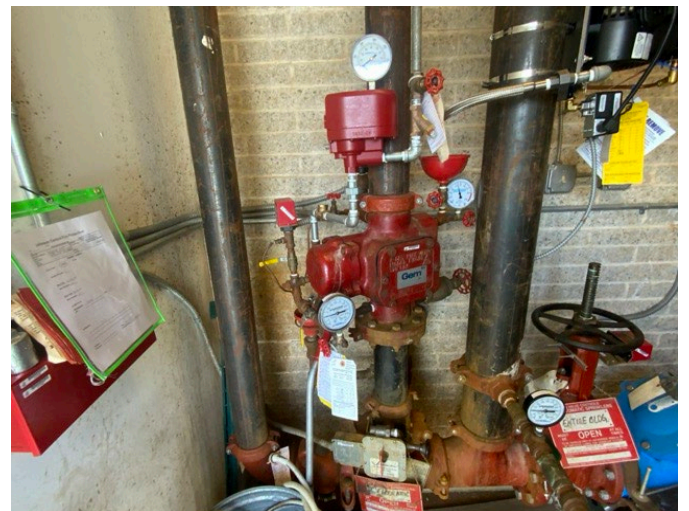
16 - SPRINKLER RISERS

A fully addressable fire alarm system is present with the main fire alarm panel in the Main Mechanical Room. The fire alarm panel is estimated to be five years old and lifecycle replacement is anticipated in the mid-term. The building is also protected by an automatic fire suppression system, most of which appears to be original.

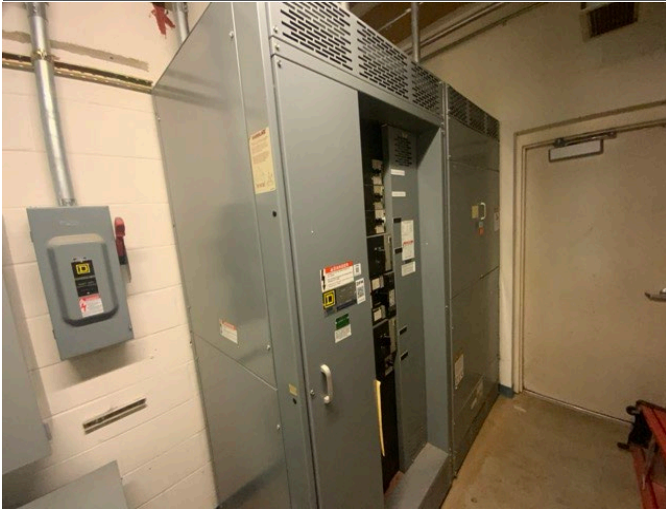
19 - ELECTRICAL SWITCHBOARD

The electrical service is controlled by a switchboard and distribution panels in the main electrical room on the first floor. In addition, there are several distribution panels and subpanels in the common hallways throughout the building. A significant portion of the electrical wiring and equipment, in conjunction with the HVAC renovation, was replaced. The building is also equipped with an emergency generator with automatic transfer switches. The generator appears to be in good condition having been recently installed in 2020. Lifecycle replacement within the reserve term is not anticipated.

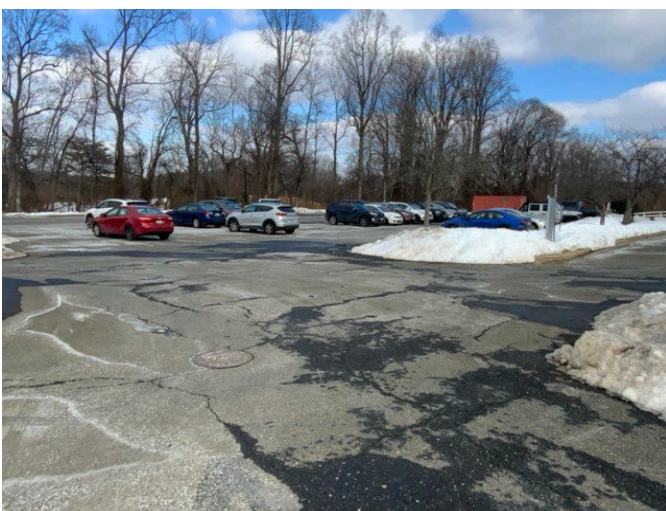
23 - PARKING AREA OVERVIEW

The asphalt parking lots are estimated to have been last maintained in 2000 and widespread longitudinal and transverse cracking is visible. Lifecycle replacement is anticipated for the near term. Pavement striping is also in fair condition although some fading is visible. Concrete sidewalk pavement appears in fair condition with some areas of patching evident where underground utilities were run.

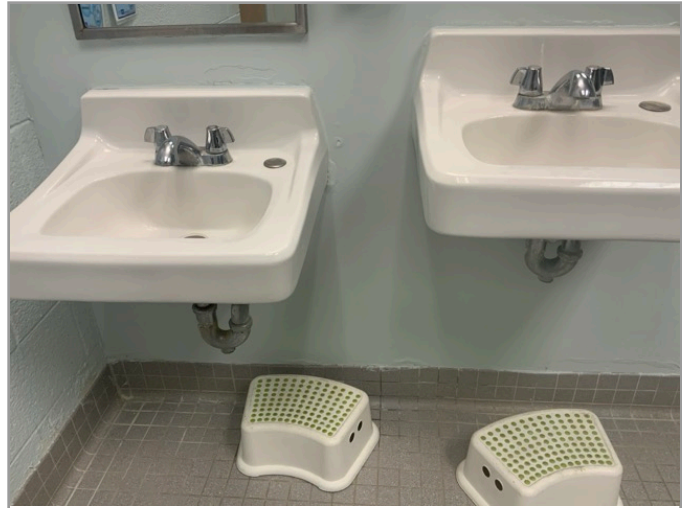
SINK, FAUCET HANDLES AND ACCESSORIES

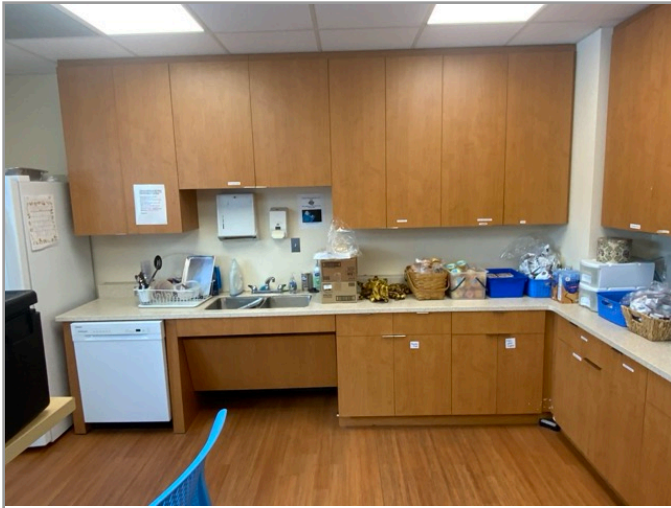
KITCHEN OVERVIEW

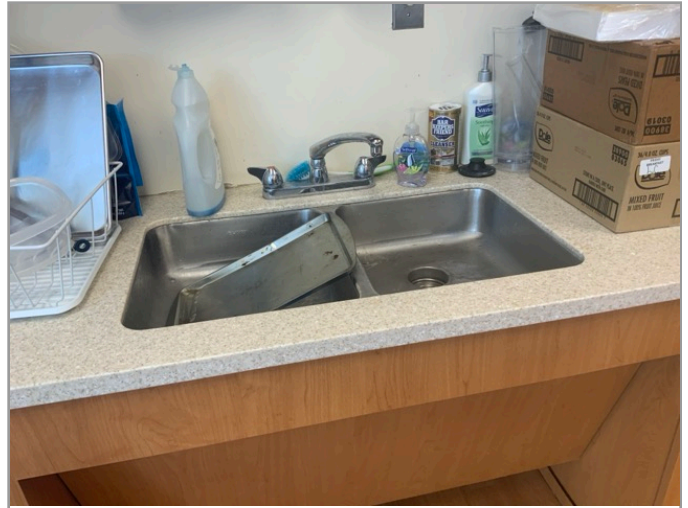
SINK CLEARANCE

Question	Yes	No	NA	Comments
1 Do kitchens/kitchenettes appear to have a minimum compliant path of travel or area of maneuverability ?	✗			
2 Are the appliances centered for a parallel or forward approach with adequate clear floor space ?			✗	
3 Is there an accessible countertop/preparation space of proper width and height ?	✗			
4 Is there an accessible sink space of proper width and height ?	✗			
5 Does the sink faucet have compliant handles ?	✗			
6 Is the plumbing piping under the sink configured to protect against contact ?	✗

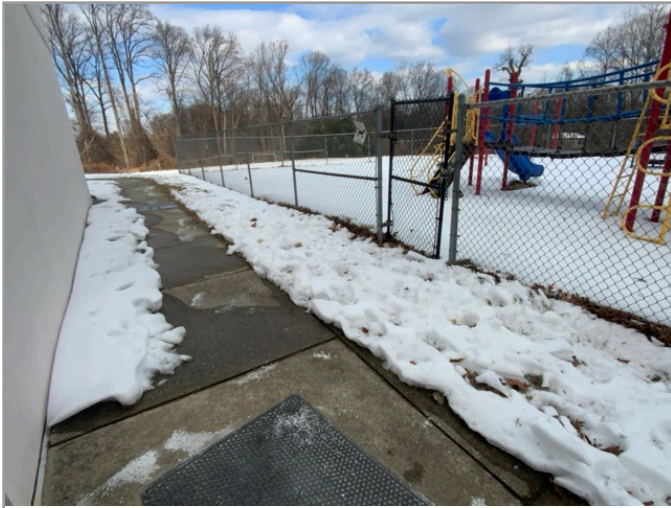
ACCESSIBLE ROUTE TO PLAYGROUND

Question		Yes	No	NA	Comments
1	Is there an accessible route to the play area / s?	✘			
2	Has the play area been reviewed for accessibility ?		✘		
3	Are publicly accessible swimming pools equipped with an entrance lift ?			✘

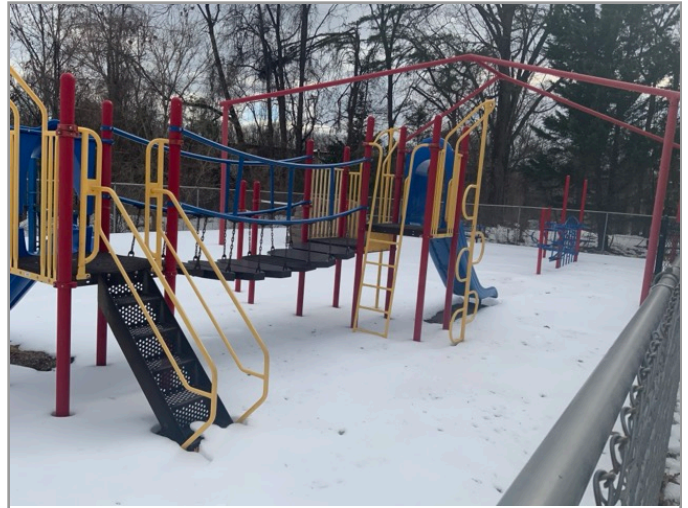
OVERVIEW OF PLAYGROUND
