FACILITY CONDITION ASSESSMENT

prepared for

Montgomery County Public Schools
45 West Gude Drive, Suite 4000
Rockville, MD 20850

Rocking Horse Road Center
4910 Macon Road
Rockville, MD 20852

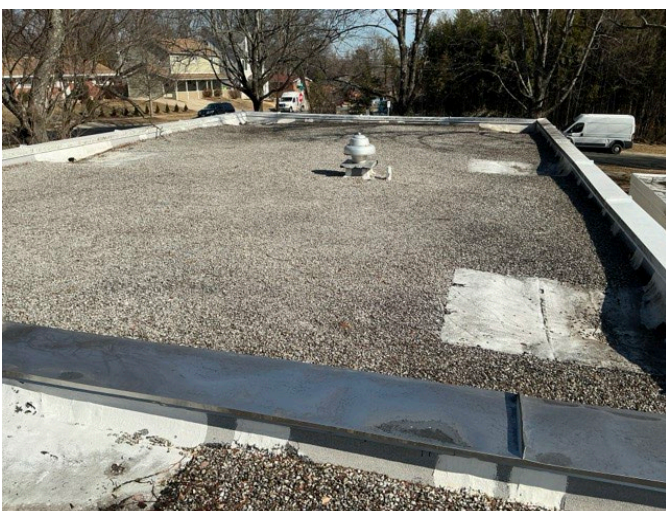
5 - ROOFING

In general, the structure appears to be sound, with no significant areas of settlement or structural-related deficiencies observed. The field of the roof has isolated areas of topping degradation. The damaged portions of the membrane must be replaced. Roof leaks have occurred within the past year, and some of these leaks remain active. All active leaks must be repaired. The windows are older wood and are separating, binding, and hard to close; some have been replaced, but the rest will require replacement in the short term. The casework throughout the building is outdated and should be replaced. The interior finishes were observed to be in fair condition overall throughout the building. Typical lifecycle replacements of the interior and exterior finishes are budgeted and anticipated.

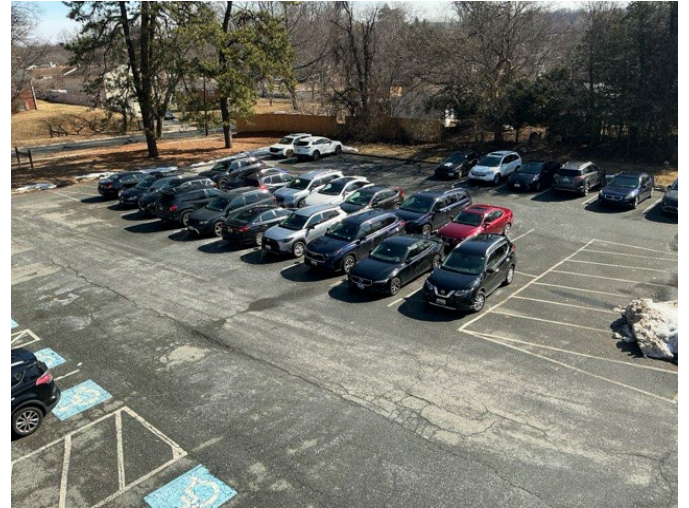
8 - PARKING LOT

Site maintenance appears to be fair, and site improvements and landscaping are generally in fair condition. The parking lot has developed numerous potholes and heavy surface wear and should be milled and overlaid. The sidewalk has isolated areas of cracking and uneven pavement. To prevent trip hazards, sidewalk repairs are recommended. A significant portion of the site lighting has been upgraded to LED, and it is recommended that the remaining lighting is upgraded to improve energy efficiency.

Cracked asphalt pavement throughout parking lot - AssetCALC ID: 10429098

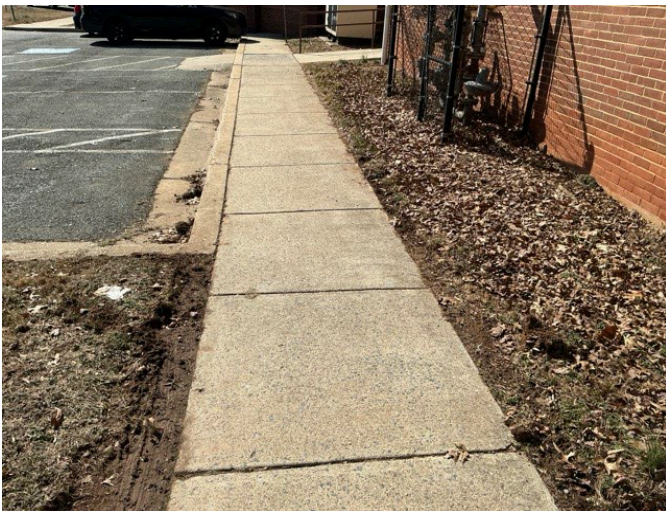
9 - SIDEWALK

Uneven sidewalk pavement, Trip hazard - AssetCALC ID: 10429197

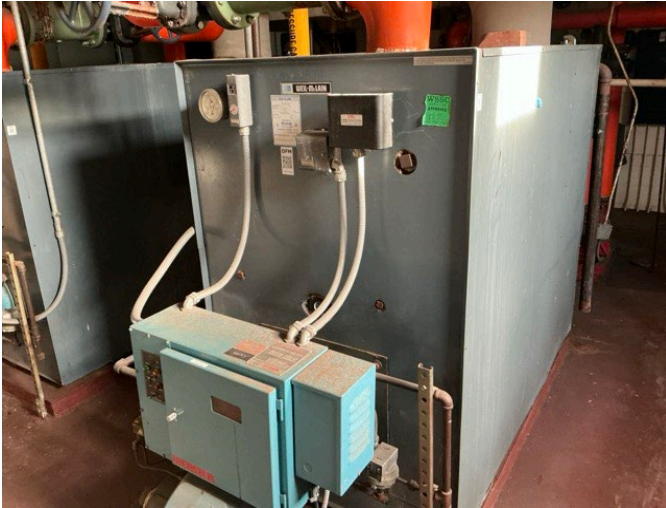
19 - BOILER

Heating is provided by central system with boilers feeding radiators and cooling is provided by split system units and package units. There are unit ventilators throughout the classrooms. Majority of the HVAC components are outdated and in need of replacement. Upgrading HVAC components may improve comfort space and efficiency.

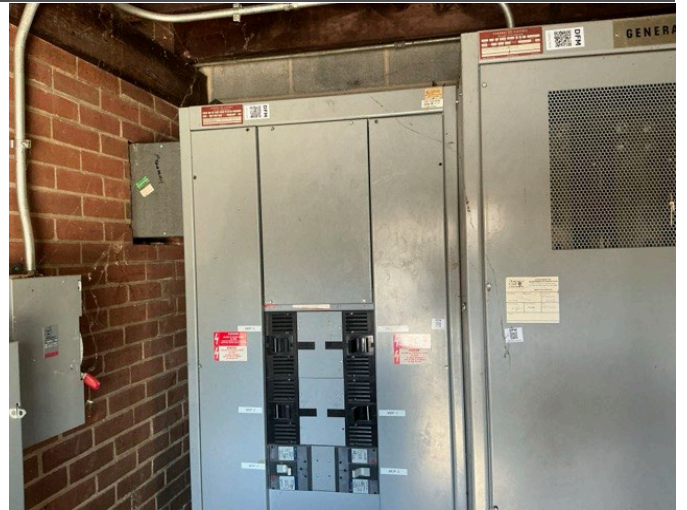
26 - SWITCHBOARD

The vast majority of electrical components within the building, including the circuit breaker panels, switchboards, and wiring, are original to the 1963 construction. A full modernization/upgrade is recommended to the aging interior electrical infrastructure.

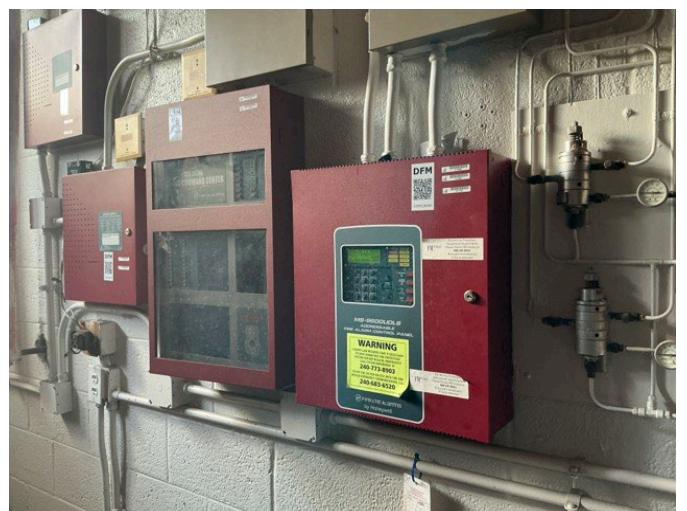
30 - FIRE ALARM PANEL

The central alarm panel appears to be more than 15 years old. Based on its age and because replacement parts and components for this type of equipment may be obsolete, the alarm panel requires replacement.

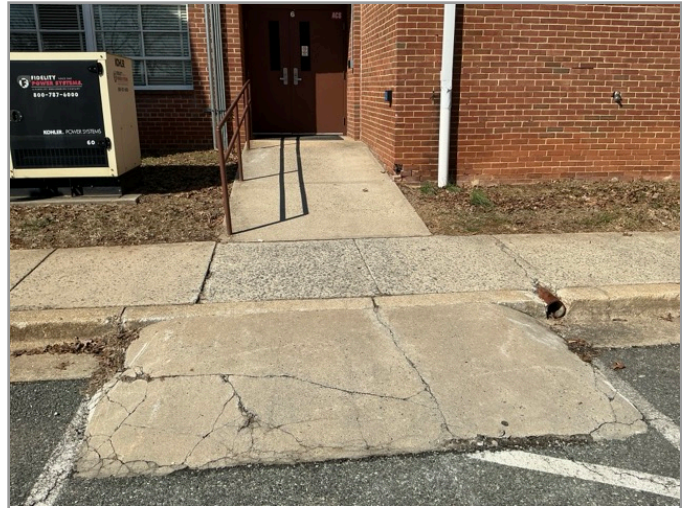
ACCESSIBLE RAMP

Question		Yes	No	NA	Comments
1	Is an accessible route present from public transportation stops and municipal sidewalks on or immediately adjacent to the property ?	X			
2	Does a minimum of one accessible route appear to connect all public areas on the exterior, such as parking and other outdoor amenities, to accessible building entrances ?	X			
3	Are curb ramps present at transitions through raised curbs on all accessible routes?	X			
4	Do curb ramps appear to have compliant slopes for all components ?	X			
5	Do ramp runs on an accessible route appear to have compliant slopes ?	X			
6	Do ramp runs on an accessible route appear to have a compliant rise and width ?	X

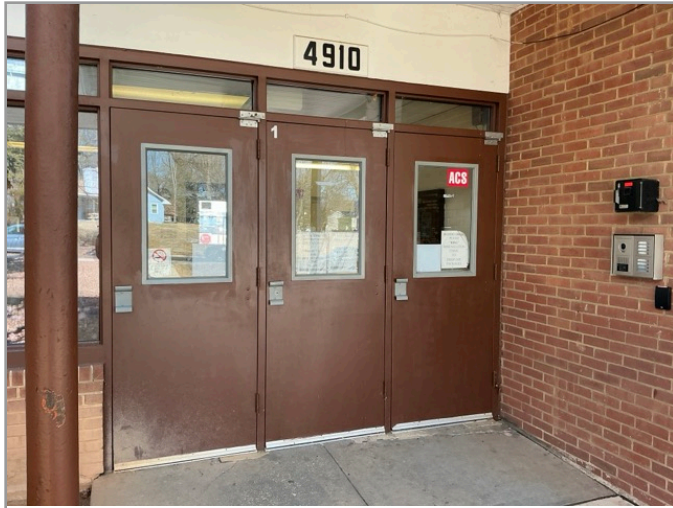
MAIN ENTRANCE

Question		Yes	No	NA	Comments
1	Do a sufficient number of accessible entrances appear to be provided ?	✗			
2	If the main entrance is not accessible, is an alternate accessible entrance provided?	✗			
3	Is signage provided indicating the location of alternate accessible entrances ?	✗			
4	Do doors at accessible entrances appear to have compliant maneuvering clearance area on each side ?	✗			
5	Do doors at accessible entrances appear to have compliant hardware ?	✗			
6	Do doors at accessible entrances appear to have a compliant clear opening width ?	✗

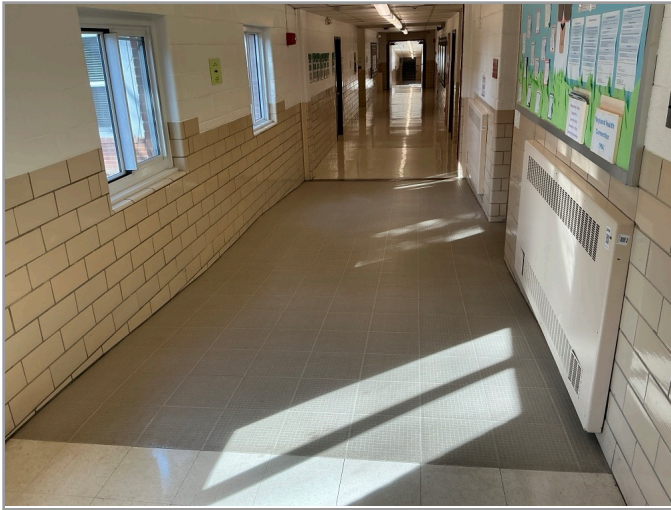
ACCESSIBLE INTERIOR PATH

Question		Yes	No	NA	Comments
1	Does an accessible route appear to connect all public areas inside the building ?	✘			
2	Do accessible routes appear free of obstructions and/or protruding objects ?	✘			
3	Do ramps on accessible routes appear to have compliant slopes ?	✘			
4	Do ramp runs on an accessible route appear to have a compliant rise and width ?	✘			
5	Do ramps on accessible routes appear to have compliant end and intermediate landings ?	✘			
6	Do ramps on accessible routes appear to have compliant handrails ?	✘

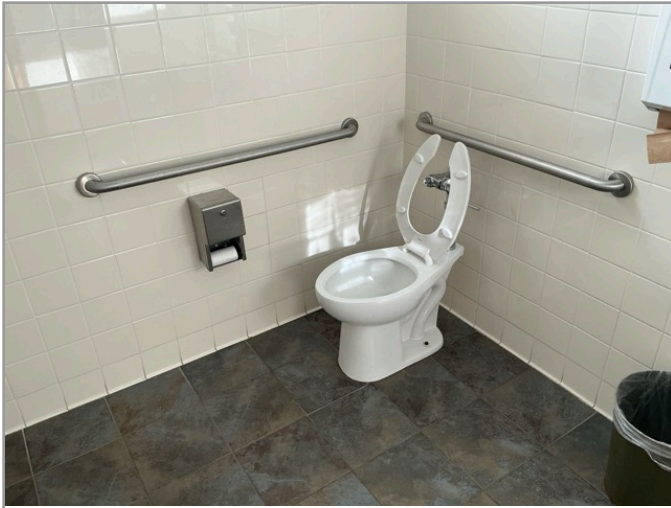
TOILET STALL OVERVIEW

Question		Yes	No	NA	Comments
1	Do publicly accessible toilet rooms appear to have a minimum compliant floor area ?	✗			
2	Does the lavatory appear to be mounted at a compliant height and with compliant knee area ?	✗			
3	Does the lavatory faucet have compliant handles ?	✗			
4	Is the plumbing piping under lavatories configured to protect against contact ?	✗			
5	Are grab bars provided at compliant locations around the toilet ?	✗			
6	Do toilet stall doors appear to provide the minimum compliant clear width ?	✗
