# FACILITY CONDITION ASSESSMENT

**Montgomery County Public Schools**  
45 West Gude Drive, Suite 4000  
Rockville, MD 20850

Rollingwood Center  
3200 Woodbine Street  
Chevy Chase, MD 20815

*June 1, 2026*

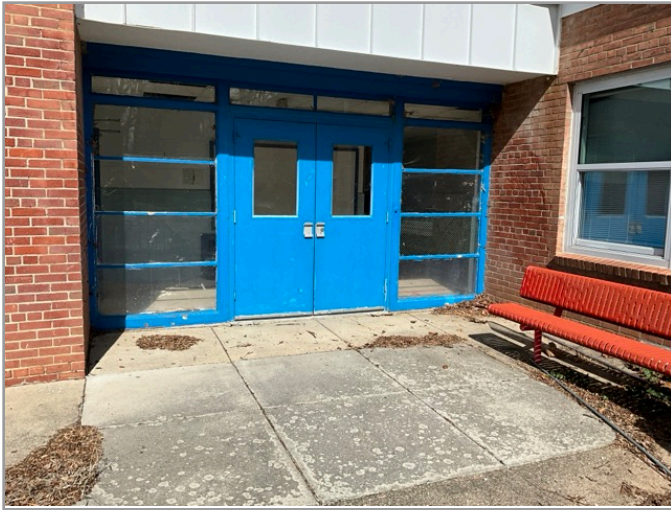
ACCESSIBLE ENTRANCE

Question		Yes	No	NA	Comments
1	Do a sufficient number of accessible entrances appear to be provided ?	✗			
2	If the main entrance is not accessible, is an alternate accessible entrance provided?	✗			
3	Is signage provided indicating the location of alternate accessible entrances ?	✗			
4	Do doors at accessible entrances appear to have compliant maneuvering clearance area on each side ?	✗			
5	Do doors at accessible entrances appear to have compliant hardware ?	✗			
6	Do doors at accessible entrances appear to have a compliant clear opening width ?	✗

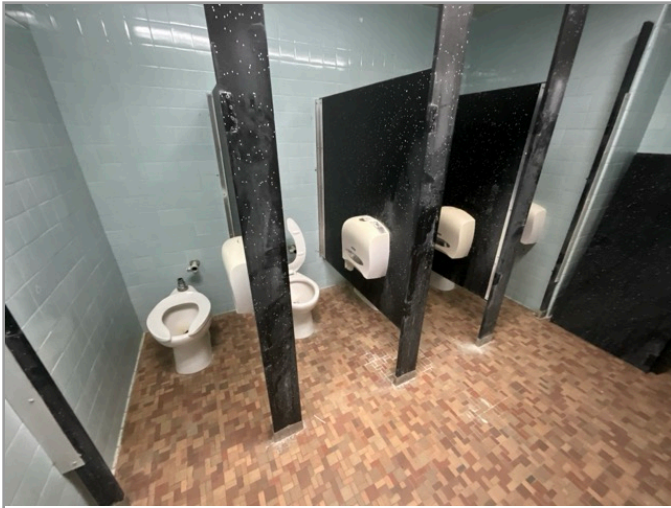
TOILET STALL OVERVIEW

Question		Yes	No	NA	Comments
1	Do publicly accessible toilet rooms appear to have a minimum compliant floor area ?		✗		No ADA stalls
2	Does the lavatory appear to be mounted at a compliant height and with compliant knee area ?	✗			
3	Does the lavatory faucet have compliant handles ?	✗			
4	Is the plumbing piping under lavatories configured to protect against contact ?		✗		Not covered
5	Are grab bars provided at compliant locations around the toilet ?			✗	
6	Do toilet stall doors appear to provide the minimum compliant clear width ?			✗
