FACILITY CONDITION ASSESSMENT

Montgomery County Public Schools
45 West Gude Drive, Suite 4000
Rockville, MD 20850

Edward U. Taylor Center
19501 White Ground Road
Boyd's, MD 20841

May 28, 2026

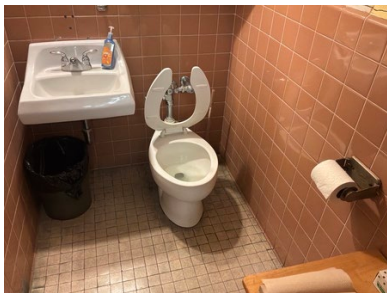
Damage to wall finishes and aging vinyl tiles observed throughout building. - AssetCALC ID: 10440444

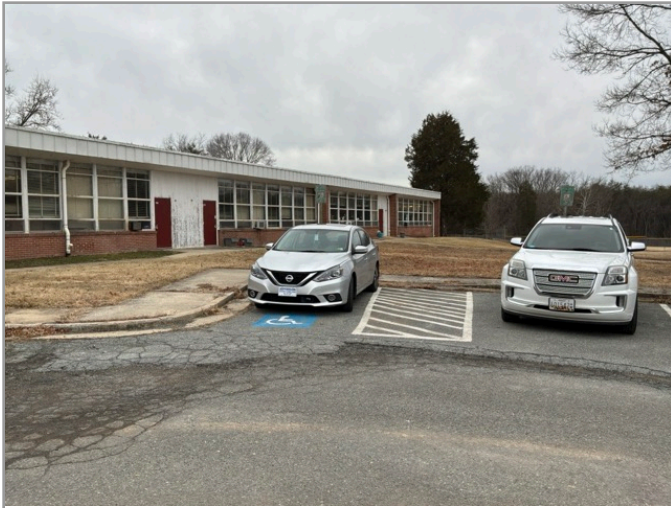
OVERVIEW OF ACCESSIBLE PARKING AREA

Question		Yes	No	NA	Comments
1	Does the required number of standard ADA designated spaces appear to be provided ?	✗			
2	Does the required number of van-accessible designated spaces appear to be provided ?		✗		No van accessible spaces
3	Are accessible spaces on the shortest accessible route to an accessible building entrance ?	✗			
4	Does parking signage include the International Symbol of Accessibility ?	✗			
5	Does each accessible space have an adjacent access aisle ?	✗			
6	Do parking spaces and access aisles appear to be relatively level and without obstruction ?	✗

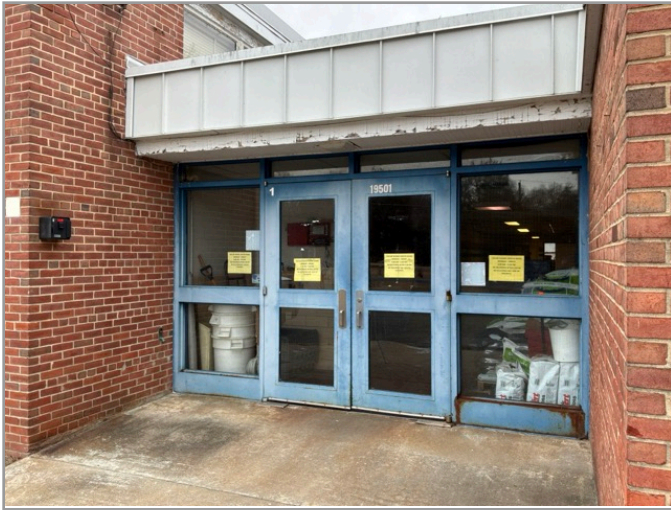
MAIN ENTRANCE

Question		Yes	No	NA	Comments
1	Do a sufficient number of accessible entrances appear to be provided ?	✗			
2	If the main entrance is not accessible, is an alternate accessible entrance provided?			✗	
3	Is signage provided indicating the location of alternate accessible entrances ?			✗	
4	Do doors at accessible entrances appear to have compliant maneuvering clearance area on each side ?	✗			
5	Do doors at accessible entrances appear to have compliant hardware ?	✗			
6	Do doors at accessible entrances appear to have a compliant clear opening width ?	✗

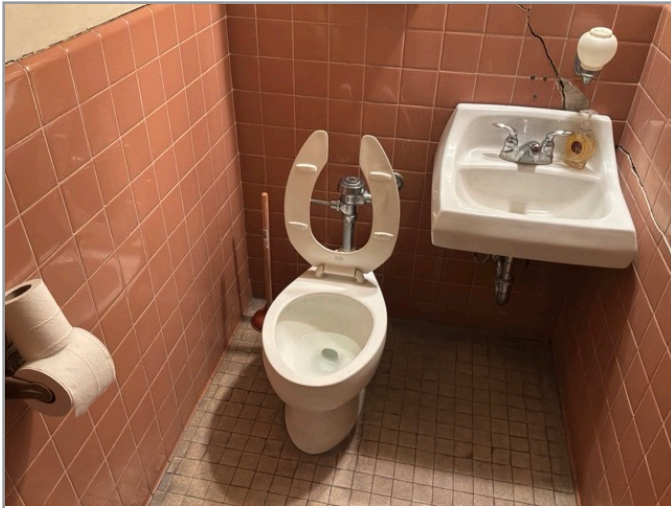
TOILET STALL OVERVIEW

Question		Yes	No	NA	Comments
1	Do publicly accessible toilet rooms appear to have a minimum compliant floor area ?		✗		Restrooms are not accessible
2	Does the lavatory appear to be mounted at a compliant height and with compliant knee area ?	✗			
3	Does the lavatory faucet have compliant handles ?	✗			
4	Is the plumbing piping under lavatories configured to protect against contact ?		✗		No pipe wraps
5	Are grab bars provided at compliant locations around the toilet ?		✗		No grab bars
6	Do toilet stall doors appear to provide the minimum compliant clear width ?			✗

UF L3 Code	Location	Condition	Component/Attributes/Capacity	Quantity	RUL	ID
Y1030	Throughout Building	NA	ADA Entrances & Doors, Hardware, Lever Handle, Install	20	1	10442073
Y1050	Restrooms	NA	ADA Restrooms, Restroom Layout, Full Reconfiguration, Renovate	2	1	10440451

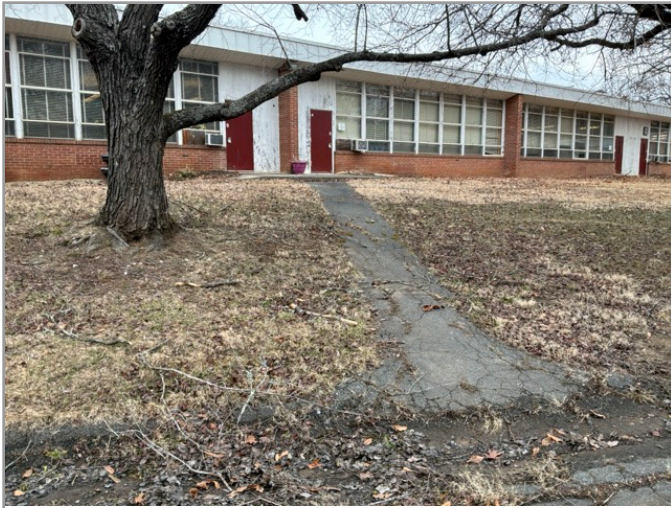
ACCESSIBLE ROUTE TO PLAYGROUND

Question		Yes	No	NA	Comments
1	Is there an accessible route to the play area / s?		✘		No handrails on route, playground surface is not compliant
2	Has the play area been reviewed for accessibility ?		✘		
3	Are publicly accessible swimming pools equipped with an entrance lift ?			✘

Y1080	Site Playground Areas	NA	ADA Site & Recreational, Playing Surface, to Compliant, Replace/Install	1,700 SF	1	10442074
