**BUREAU
VERITAS**

FACILITY CONDITION ASSESSMENT

Montgomery County Public Schools

Tuckerman Center
8224 Lochinver Lane
Potomac, MD 20854

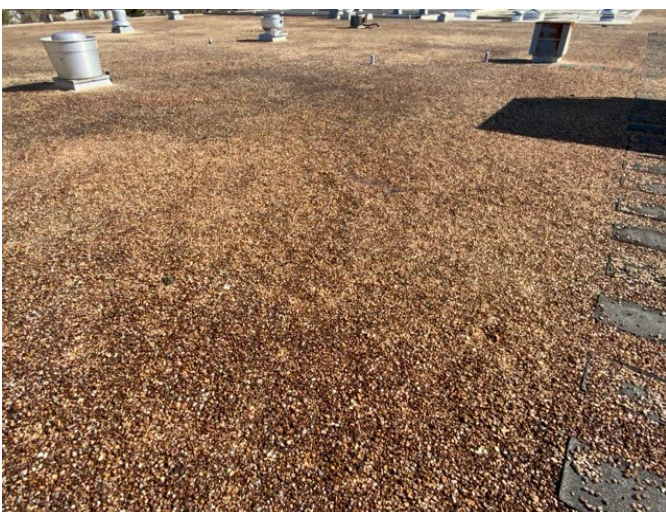
5 - BUILT UP ROOFING

The 1 and 2 -story structure with basement generally appears structurally sound. The structure is primarily open web steel joists supporting metal deck roof structure and all supported by CMU bearing walls with a variety of finishes including solid brick, brick veneer, metal and wood siding. The main roof is a PVC/TPO membrane roof while the older roof is covered with built up roofing. Near term lifecycle replacement of the built-up roof is anticipated.

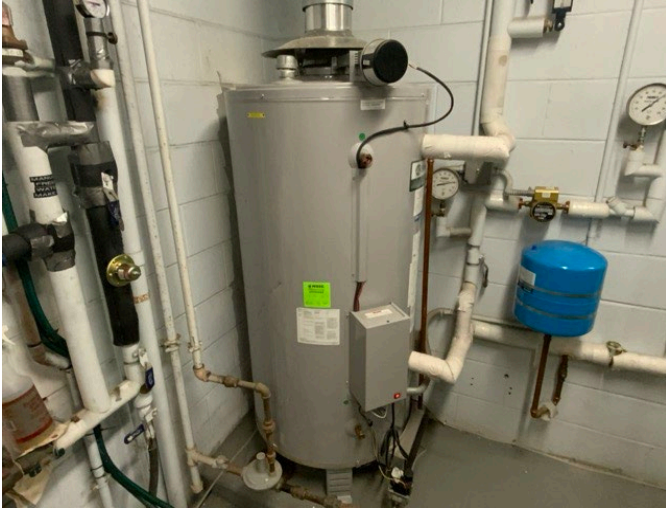
13 - WATER HEATER

Hot water for plumbing is provided by a gas fired condensing water heater which is in the main mechanical room. Water heater appears to be a relatively recent replacement and is in fair condition. The plumbing infrastructure is estimated to have been mostly replaced in the 2000 renovations.

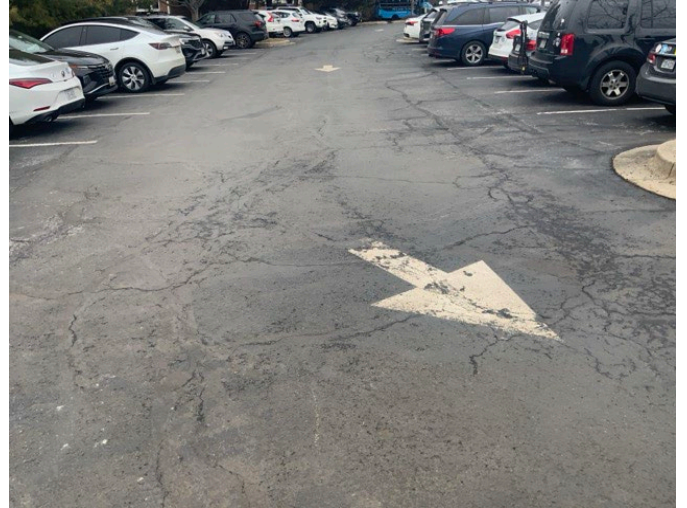
26 - ASPHALT PARKING LOT

The asphalt parking lots, installed in 2000, exhibit widespread longitudinal and transverse cracking visible and lifecycle replacement is anticipated for the near term. Pavement striping is also in fair condition although some fading is visible. Visible concrete sidewalk pavement appears in fair condition.

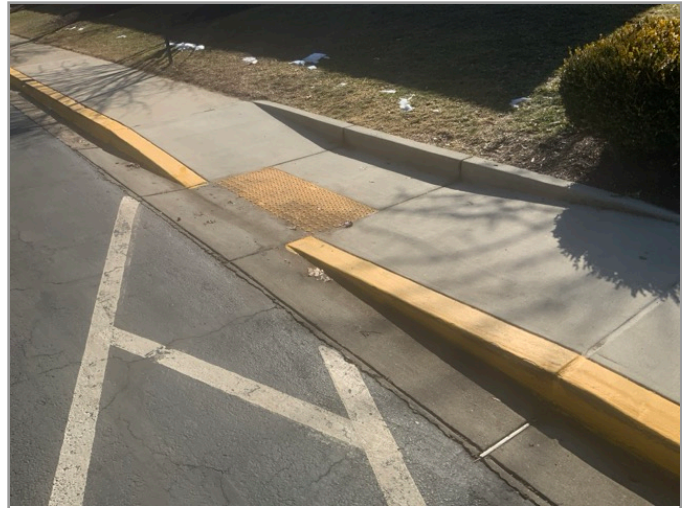
CURB CUT

Question		Yes	No	NA	Comments
1	Is an accessible route present from public transportation stops and municipal sidewalks on or immediately adjacent to the property ?	✗			
2	Does a minimum of one accessible route appear to connect all public areas on the exterior, such as parking and other outdoor amenities, to accessible building entrances ?	✗			
3	Are curb ramps present at transitions through raised curbs on all accessible routes?	✗			
4	Do curb ramps appear to have compliant slopes for all components ?			✗	
5	Do ramp runs on an accessible route appear to have compliant slopes ?			✗	
6	Do ramp runs on an accessible route appear to have a compliant rise and width ?			✗

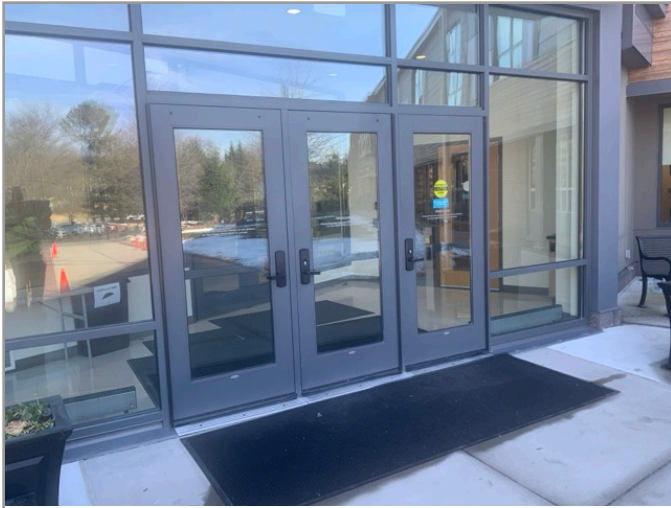
ACCESSIBLE ENTRANCE

Question		Yes	No	NA	Comments
1	Do a sufficient number of accessible entrances appear to be provided ?	✗			
2	If the main entrance is not accessible, is an alternate accessible entrance provided?	✗			
3	Is signage provided indicating the location of alternate accessible entrances ?			✗	
4	Do doors at accessible entrances appear to have compliant maneuvering clearance area on each side ?	✗			
5	Do doors at accessible entrances appear to have compliant hardware ?	✗			
6	Do doors at accessible entrances appear to have a compliant clear opening width ?	✗

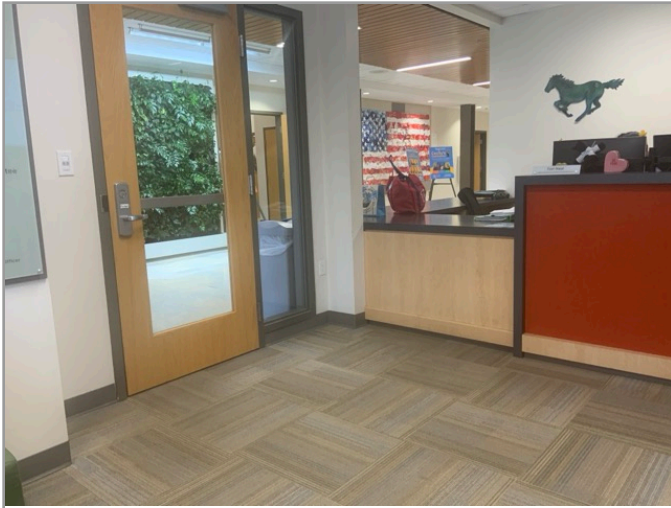
ACCESSIBLE INTERIOR PATH

Question		Yes	No	NA	Comments
1	Does an accessible route appear to connect all public areas inside the building ?	✗			
2	Do accessible routes appear free of obstructions and/or protruding objects ?	✗			
3	Do ramps on accessible routes appear to have compliant slopes ?	✗			
4	Do ramp runs on an accessible route appear to have a compliant rise and width ?	✗			
5	Do ramps on accessible routes appear to have compliant end and intermediate landings ?	✗			
6	Do ramps on accessible routes appear to have compliant handrails ?	✗

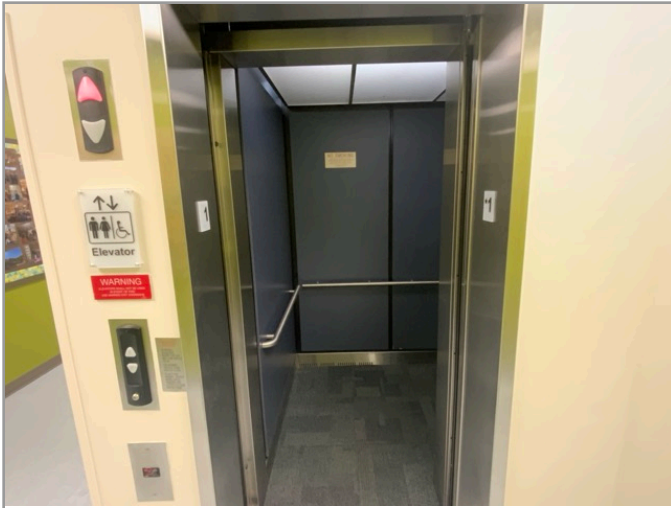
LOBBY LOOKING AT CAB

Question		Yes	No	NA	Comments
1	Are hallway call buttons configured with the "UP" button above the "DOWN" button?	✗			
2	Is accessible floor identification signage present on the hoistway sidewalls on each level ?			✗	
3	Do the elevators have audible and visual arrival indicators at the lobby and hallway entrances?	✗			
4	Do the elevator hoistway and car interior appear to have a minimum compliant clear floor area ?	✗			
5	Do the elevator car doors have automatic re-opening devices to prevent closure on obstructions?	✗			
6	Do elevator car control buttons appear to be mounted at a compliant height ?	✗

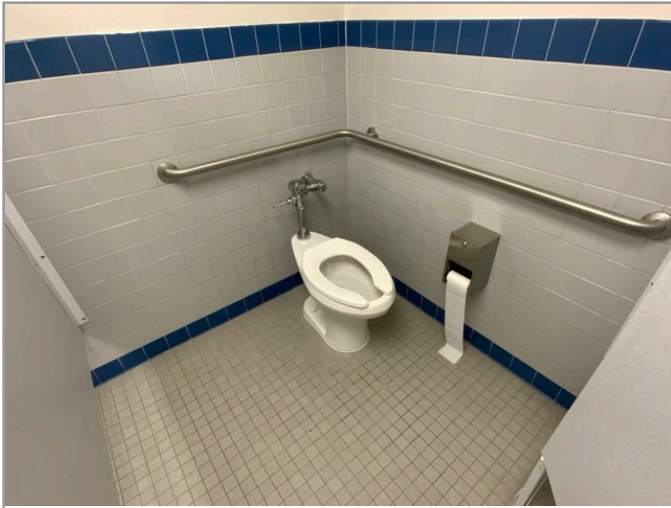
TOILET STALL OVERVIEW

Question		Yes	No	NA	Comments
1	Do publicly accessible toilet rooms appear to have a minimum compliant floor area ?	X			
2	Does the lavatory appear to be mounted at a compliant height and with compliant knee area ?	X			
3	Does the lavatory faucet have compliant handles ?	X			Push to activate
4	Is the plumbing piping under lavatories configured to protect against contact ?	X			
5	Are grab bars provided at compliant locations around the toilet ?	X			
6	Do toilet stall doors appear to provide the minimum compliant clear width ?	X

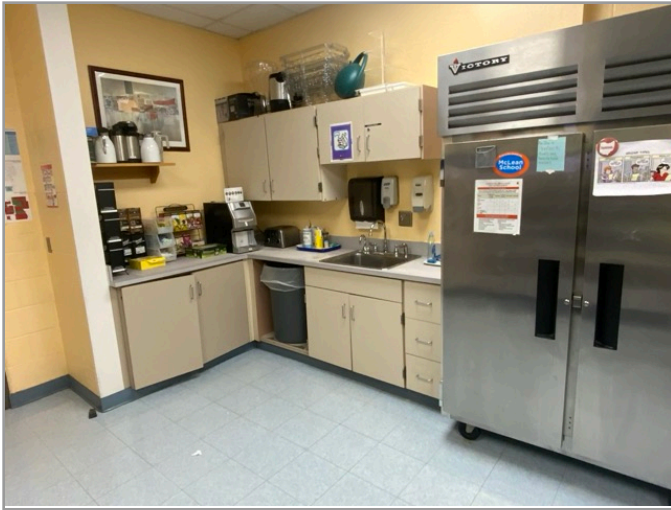
KITCHEN OVERVIEW

Question		Yes	No	NA	Comments
1	Do kitchens/kitchenettes appear to have a minimum compliant path of travel or area of maneuverability ?	✗			
2	Are the appliances centered for a parallel or forward approach with adequate clear floor space ?		✗		
3	Is there an accessible countertop/preparation space of proper width and height ?		✗		
4	Is there an accessible sink space of proper width and height ?	✗			
5	Does the sink faucet have compliant handles ?	✗			
6	Is the plumbing piping under the sink configured to protect against contact ?	✗

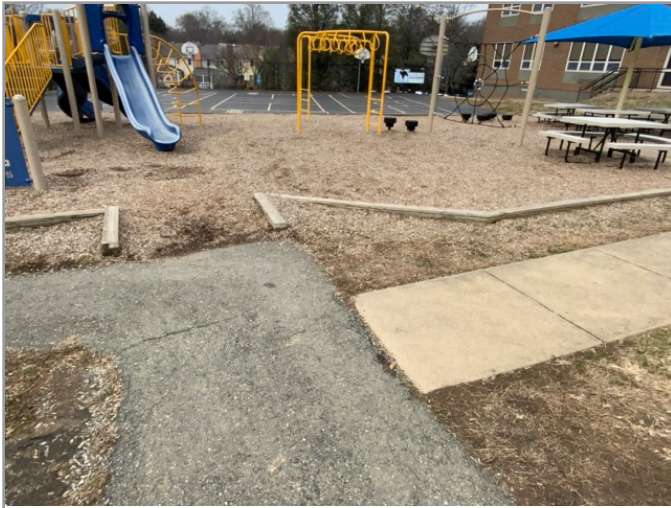
ACCESSIBLE ROUTE TO PLAYGROUND

Question		Yes	No	NA	Comments
1	Is there an accessible route to the play area / s?	✗			
2	Has the play area been reviewed for accessibility ?			✗	
3	Are publicly accessible swimming pools equipped with an entrance lift ?			✗
