# FACILITY CONDITION ASSESSMENT

Former Carl Sandburg Learning Center  
451 Meadow Hall Drive  
Rockville, MD 20851

*August 12, 2025*

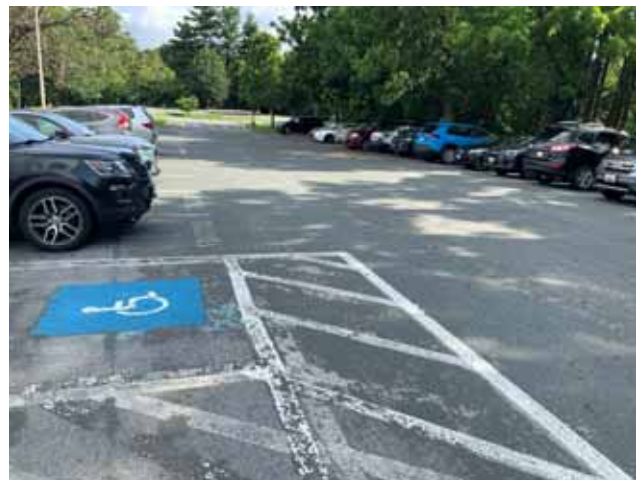
6 - MAIN PARKING LOT

Site maintenance appears to be excellent, and site improvements and landscaping are generally in good condition. Sidewalks are free of cracks and heaving, and asphalt pavement has been regularly maintained with seal coating and striping, with only a few areas of significant cracking in the main parking lot and athletic sports court. The majority of the site lighting consists of energy inefficient metal halide and high-pressure sodium fixtures and lamps.

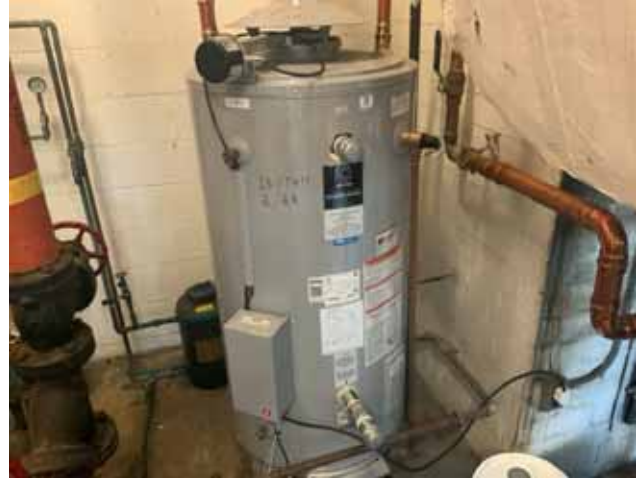
20 - WATER HEATER

Plumbing systems generally consist of copper supply piping and cast-iron waste pipe. The plumbing infrastructure is original to the construction of the property. Although there have been no reported chronic problems to date, the plumbing systems may begin to leak and fail due to the age of the piping. A budget for required repairs or partial replacements is included.

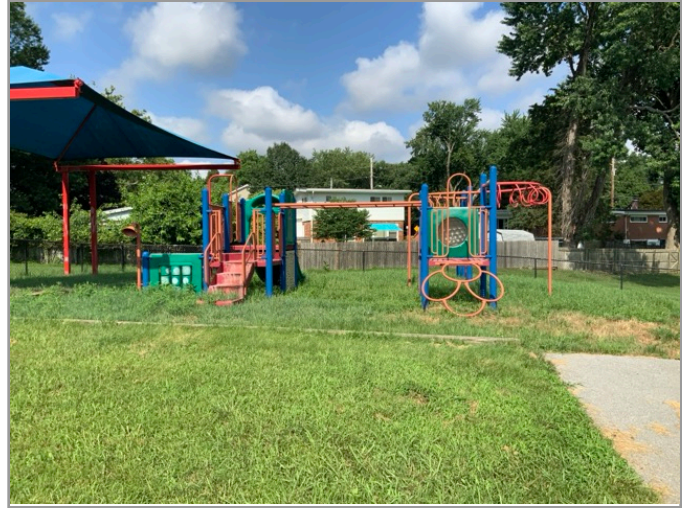
OVERVIEW OF PLAYGROUND
