FACILITY CONDITION ASSESSMENT

Montgomery County Public Schools
45 West Gude Drive, Suite 4000
Rockville, MD 20850

Clearspring Elementary School
9930 Moyer Road
Damascus, MD 20872

Bureau Veritas
6021 University Boulevard, Suite 200
Ellicott City, MD 21043
800.733.0660
www.bvna.com

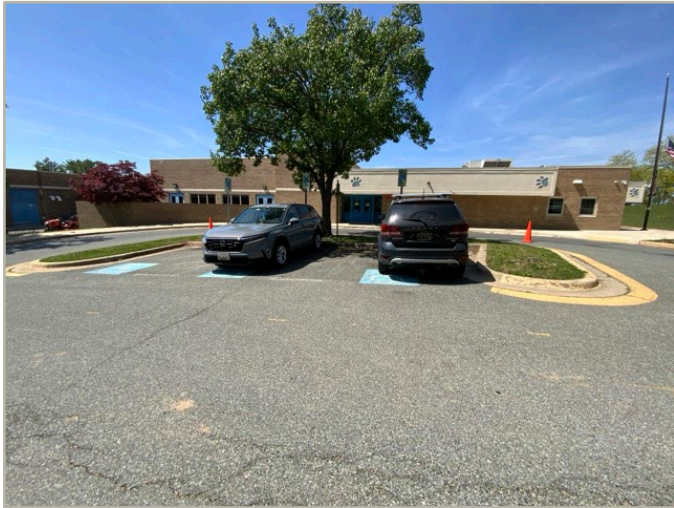
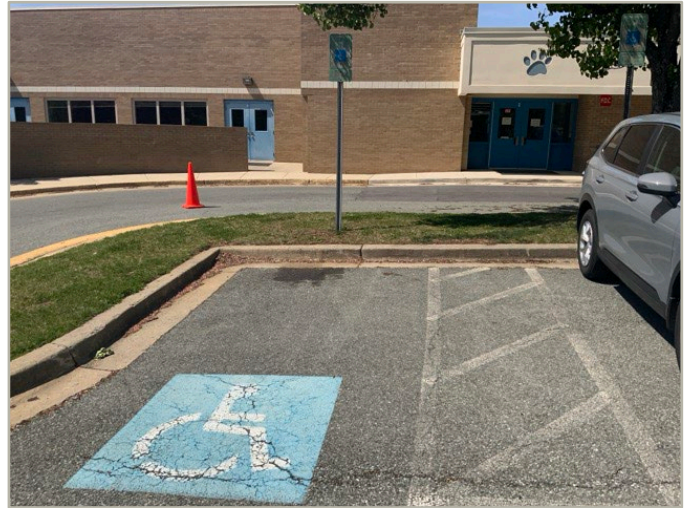
OVERVIEW OF ACCESSIBLE PARKING AREA

CLOSE-UP OF STALL

Question		Yes	No	NA	Comments
1	Does the required number of standard ADA designated spaces appear to be provided?	X			
2	Does the required number of van-accessible designated spaces appear to be provided?	X			
3	Are accessible spaces on the shortest accessible route to an accessible building entrance?	X			
4	Does parking signage include the International Symbol of Accessibility?	X			
5	Does each accessible space have an adjacent access aisle?	X			
6	Do parking spaces and access aisles appear to be relatively level and without obstruction?	X

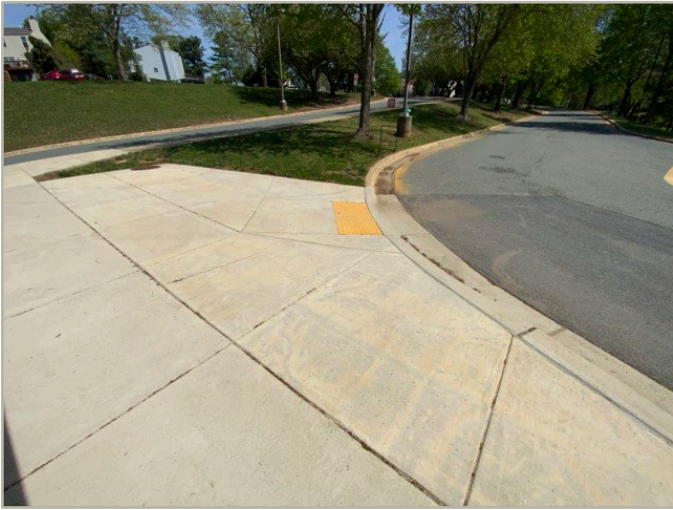
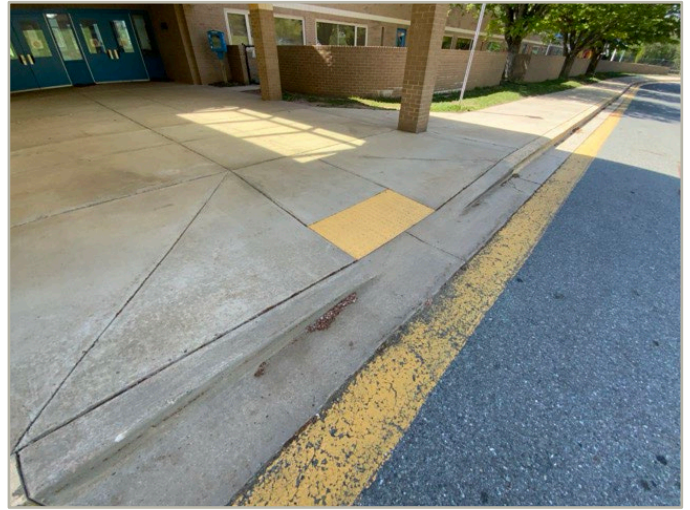
ACCESSIBLE RAMP OR PATH

CURB CUT

Question		Yes	No	NA	Comments
1	Is an accessible route present from public transportation stops and municipal sidewalks on or immediately adjacent to the property?	X			
2	Does a minimum of one accessible route appear to connect all public areas on the exterior, such as parking and other outdoor amenities, to accessible building entrances?	X			
3	Are curb ramps present at transitions through raised curbs on all accessible routes?	X			
4	Do curb ramps appear to have compliant slopes for all components?	X			
5	Do ramp runs on an accessible route appear to have compliant slopes?			X	
6	Do ramp runs on an accessible route appear to have a compliant rise and width?			X	
7	Do ramps on an accessible route appear to have compliant end and intermediate landings?			X	
8	Do ramps on an accessible route appear to have compliant handrails?			X

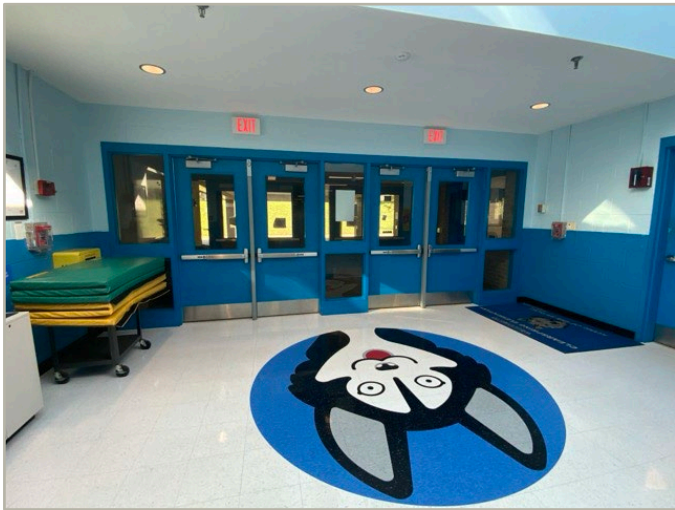
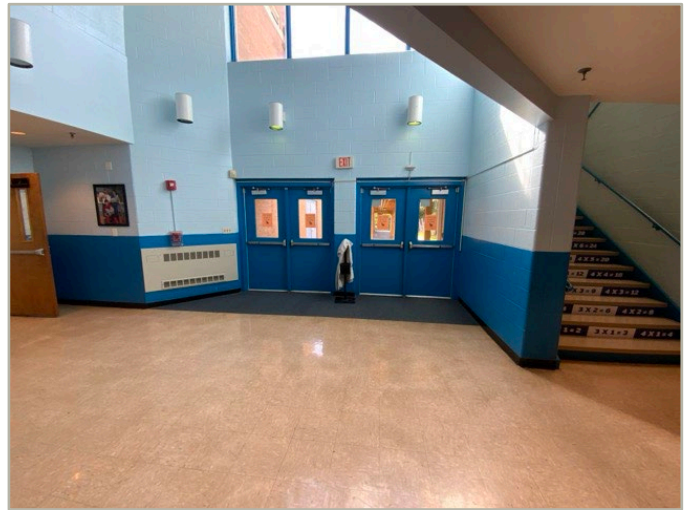
MAIN ACCESSIBLE ENTRANCE

ADDITIONAL ENTRANCE

Question		Yes	No	NA	Comments
1	Do a sufficient number of accessible entrances appear to be provided?	X			
2	If the main entrance is not accessible, is an alternate accessible entrance provided?	X			
3	Is signage provided indicating the location of alternate accessible entrances?	X			
4	Do doors at accessible entrances appear to have compliant maneuvering clearance area on each side?	X			
5	Do doors at accessible entrances appear to have compliant hardware?	X			
6	Do doors at accessible entrances appear to have a compliant clear opening width?	X			
7	Do pairs of accessible entrance doors in series appear to have the minimum clear space between them?	X			
8	Do thresholds at accessible entrances appear to have a compliant height?	X

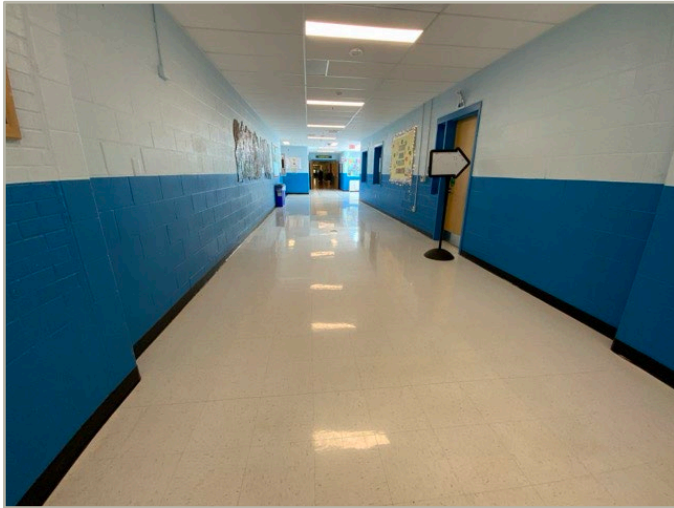
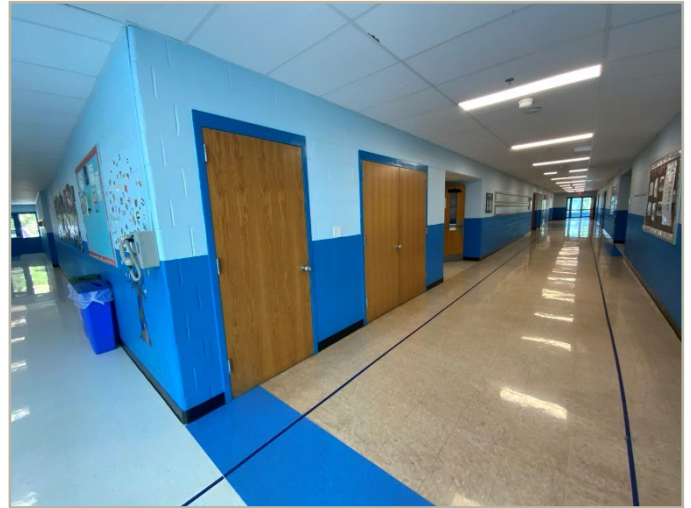
ACCESSIBLE INTERIOR PATH (RAMP/LIFT)

HARDWARE

Question		Yes	No	NA	Comments
1	Does an accessible route appear to connect all public areas inside the building?	X			
2	Do accessible routes appear free of obstructions and/or protruding objects?	X			
3	Do ramps on accessible routes appear to have compliant slopes?			X	
4	Do ramp runs on an accessible route appear to have a compliant rise and width?			X	
5	Do ramps on accessible routes appear to have compliant end and intermediate landings?			X	
6	Do ramps on accessible routes appear to have compliant handrails?			X	
7	Are accessible areas of refuge and the accessible means of egress to those areas identified with accessible signage?			X	
8	Do public transaction areas have an accessible, lowered service counter section?			X	
9	Do public telephones appear mounted with an accessible height and location?			X	
10	Do doors at interior accessible routes appear to have compliant maneuvering clearance area on each side?	X

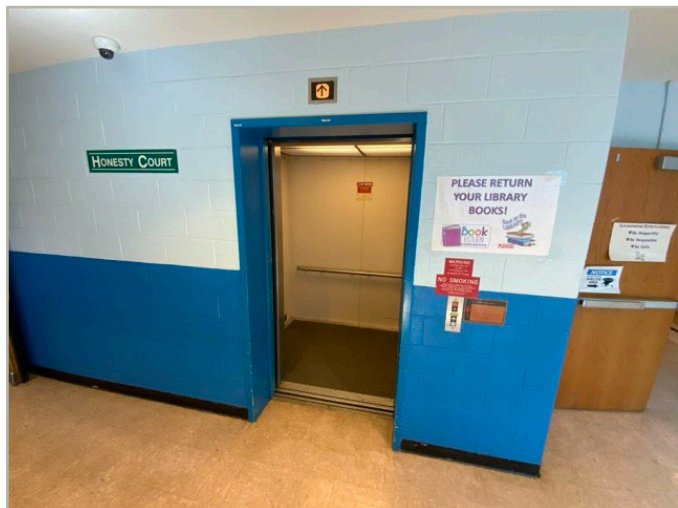
LOBBY VIEW OF CABS, WITH DOORS OPEN

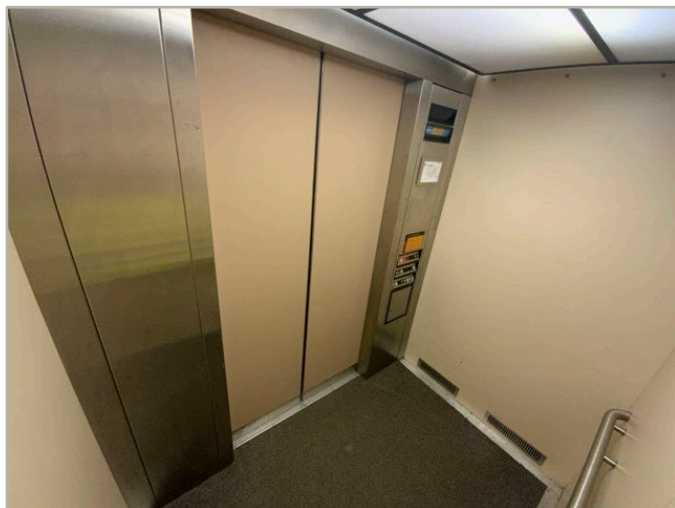
IN-CAB CONTROLS/EMERGENCY CALL PANEL

Question		Yes	No	NA	Comments
1	Are hallway call buttons configured with the "UP" button above the "DOWN" button?	X			
2	Is accessible floor identification signage present on the hoistway sidewalls on each level?	X			
3	Do the elevators have audible and visual arrival indicators at the lobby and hallway entrances?	X			
4	Do the elevator hoistway and car interior appear to have a minimum compliant clear floor area?	X			
5	Do the elevator car doors have automatic re-opening devices to prevent closure on obstructions?	X			
6	Do elevator car control buttons appear to be mounted at a compliant height?	X			
7	Are tactile and Braille characters mounted to the left of each elevator car control button?	X			
8	Are audible and visual floor position indicators provided in the elevator car?	X			
9	Is the emergency call system on or adjacent to the control panel and does it not require voice communication?	X

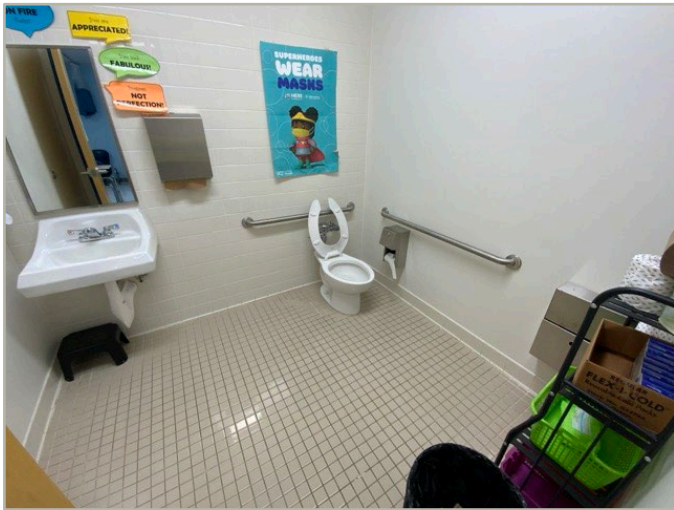
TOILET STALL OVERVIEW

Question		Yes	No	NA	Comments
1	Do publicly accessible toilet rooms appear to have a minimum compliant floor area?	X			
2	Does the lavatory appear to be mounted at a compliant height and with compliant knee area?	X			
3	Does the lavatory faucet have compliant handles?	X			
4	Is the plumbing piping under lavatories configured to protect against contact?	X			
5	Are grab bars provided at compliant locations around the toilet?	X			
6	Do toilet stall doors appear to provide the minimum compliant clear width?	X			
7	Do toilet stalls appear to provide the minimum compliant clear floor area?	X			
8	Where more than one urinal is present in a multi-user restroom, does minimum one urinal appear to be mounted at a compliant height and with compliant approach width?	X			
9	Do accessories and mirrors appear to be mounted at a compliant height?	X

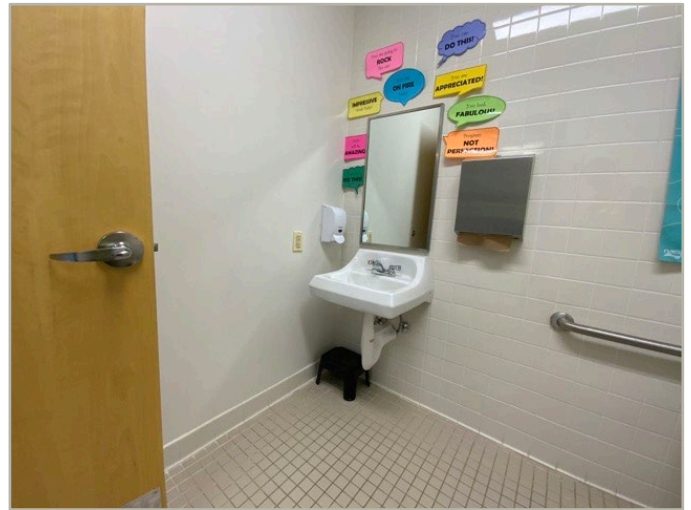
SINK, FAUCET HANDLES AND/OR ACCESSORIES

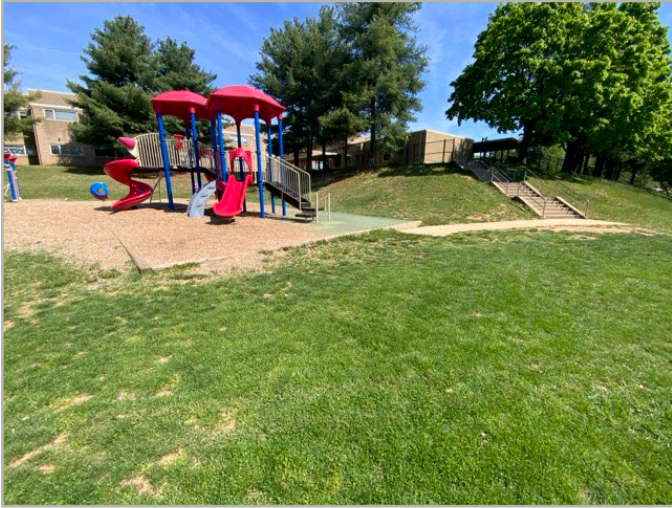
ACCESS ROUTE TO PLAYGROUND/BLEACHER/POOL

Question		Yes	No	NA	Comments
1	Is there an accessible route to the play areas, outdoor spectator sports seating areas, and swimming pools?	X			
2	Does the area adjacent to the play structure have solid surfacing or an accessible route to a stable and level transfer platform?	X			
3	At small bleachers adjacent to sports fields, is there an adjacent flat and level area of solid surfacing for wheelchairs?			X	
4	At grandstands or stadium seating for an outdoor theater or sporting event, is there an adequate number of accessible seats?			X	
5	Are there companion seats within or immediately adjacent to each wheelchair accessible seating area?			X	
6	At grandstands or stadiums with larger pressboxes, are the pressboxes accessible?			X	
7	Are publicly accessible swimming pools equipped with a pool access lift?			X

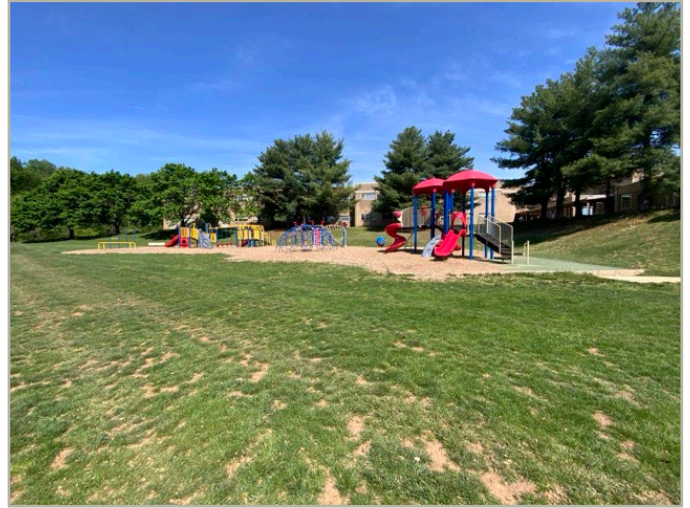
PLAYGROUND/BLEACHER AREA/PRESSBOX/POOL
