FACILITY CONDITION ASSESSMENT

Montgomery County Public Schools
45 West Gude Drive, Suite 4000
Rockville, MD 20850

Damascus Elementary School
10201 Bethesda Church Road
Damascus, MD 20872

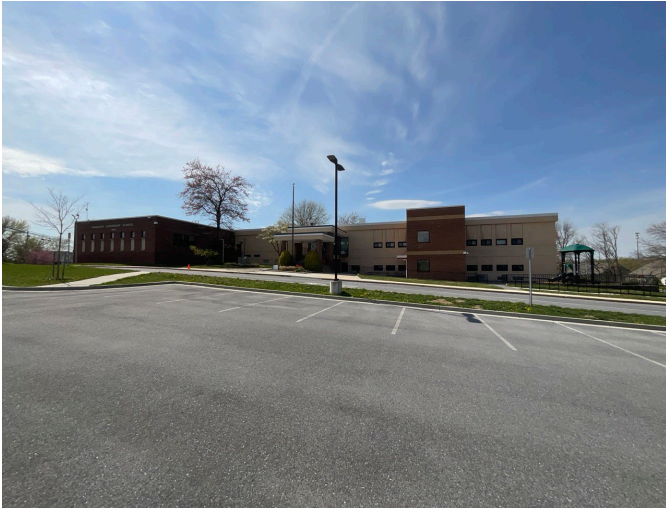
1 - FRONT ELEVATION

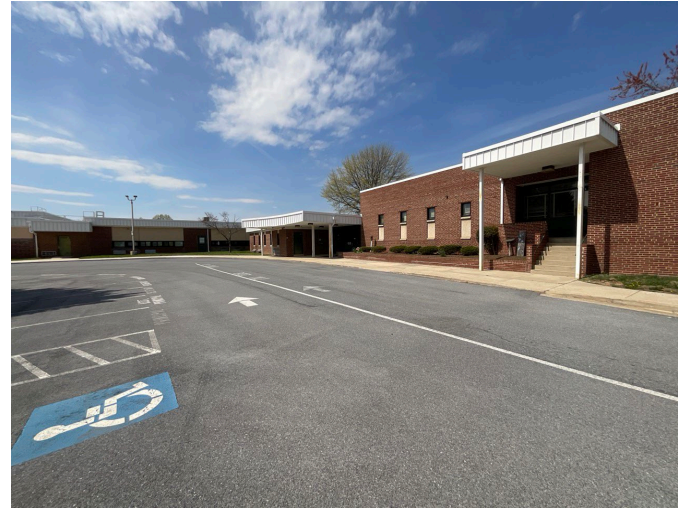
2 - LEFT ELEVATION

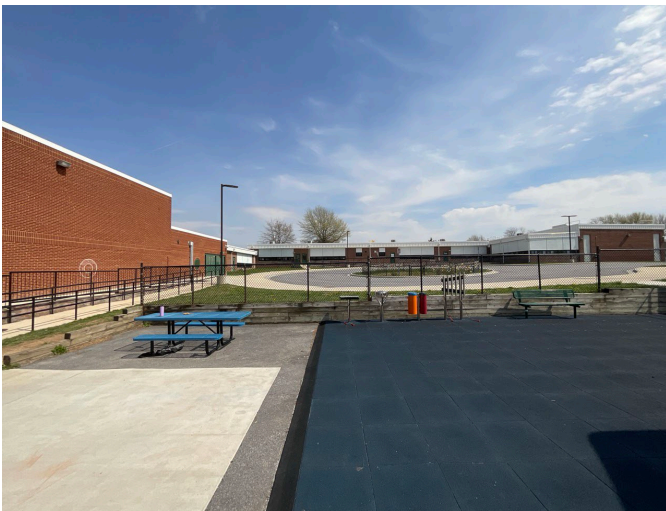
3 - REAR ELEVATION

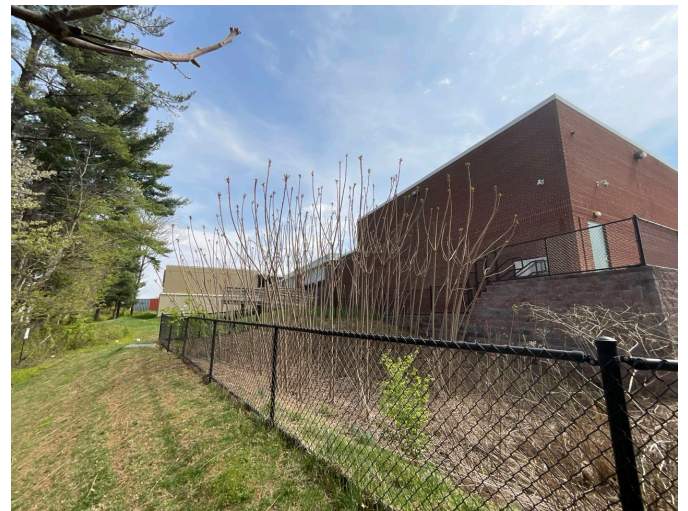
4 - RIGHT ELEVATION

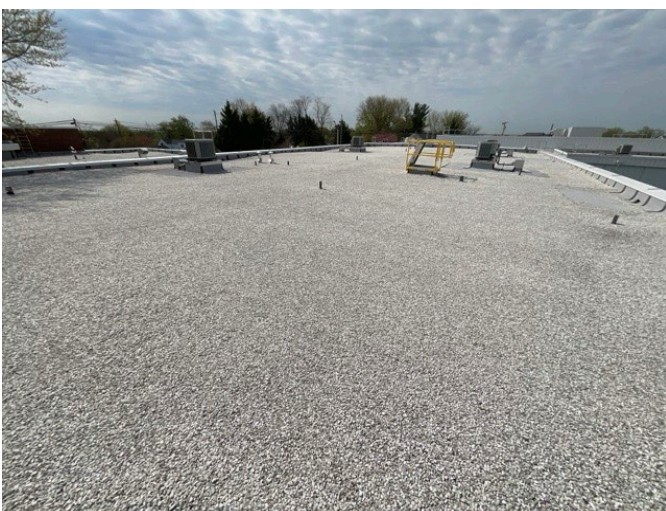
5 - ROOF

The building has masonry construction with bricks in some areas and CMU in others. The roof was reportedly replaced a few years ago, although it was reported to have had some issues. It is recommended to review if the roof is still under warranty for those repairs. Overall, the exterior envelope systems and components were observed to be performing adequately, although many windows are reaching the end of their expected life. Interior finishes have generally been replaced as needed and are anticipated for lifecycle replacement based on useful life and normal wear; however, some VCT is very dated and will need replacement in the near term. Also, cracking was reported and observed on the exterior stair/walkway structure. That should be evaluated and repaired.

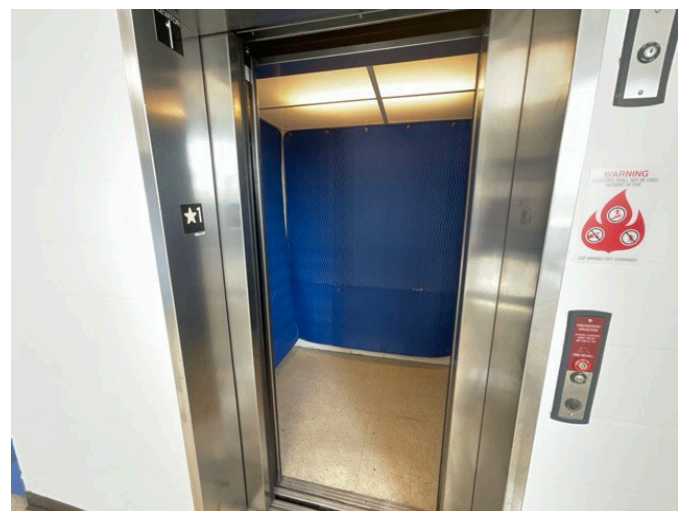
12 - ELEVATOR

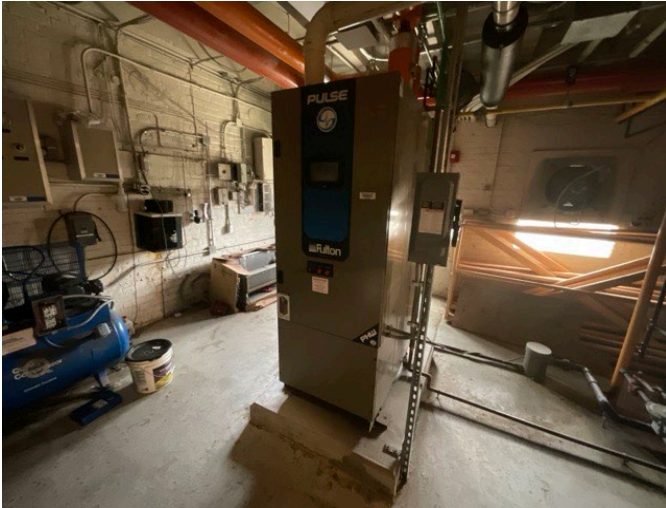
13 - NEWER BOILER

The building's HVAC is provided by a combination of boilers, RTU's, and scattered condensing units primarily on the roof. These condensing units are collectively from 2012. They are reaching the end of their expected lifecycle, and will begin to need replacement soon. The two standard boilers are from 1998 and the gas pulse combustion boiler is from 2013. These do not appear to have any issues. Some RTU's were becoming very aged and showed significant rust. These will need replacement soon.

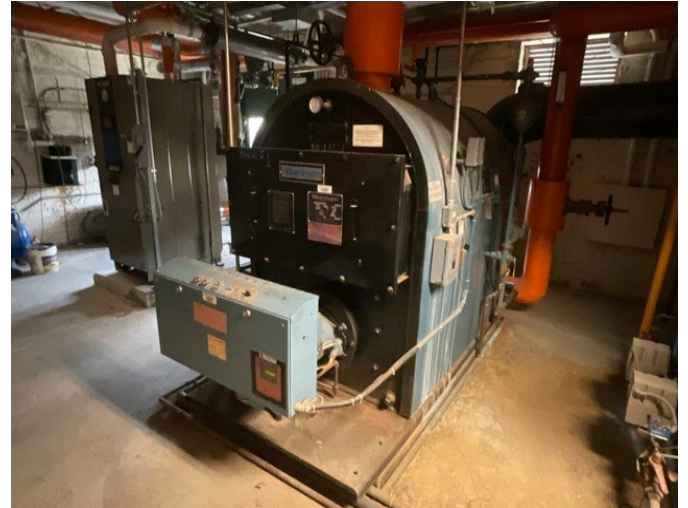
14 - OLDER BOILER

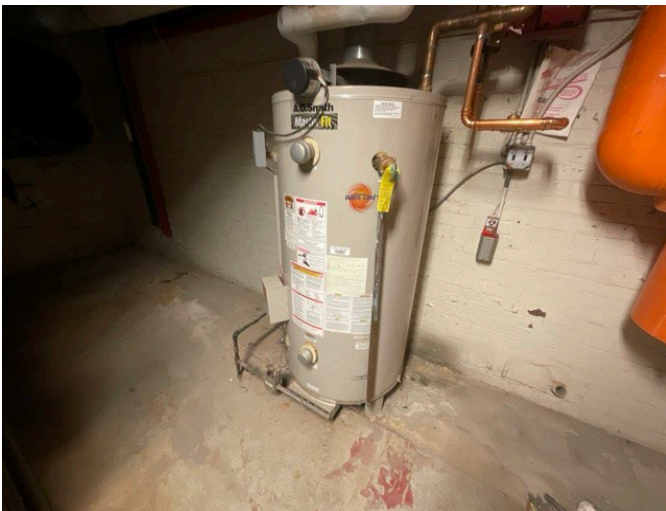
15 - WATER HEATER

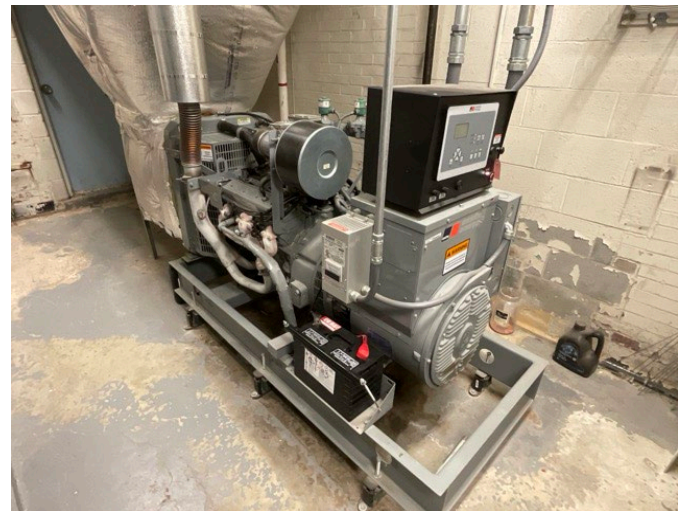
16 - GENERATOR

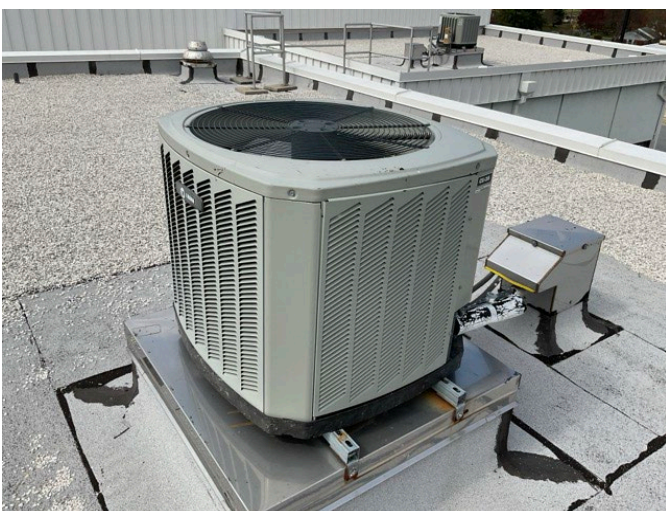
17 - TYPICAL CONDENSING UNIT

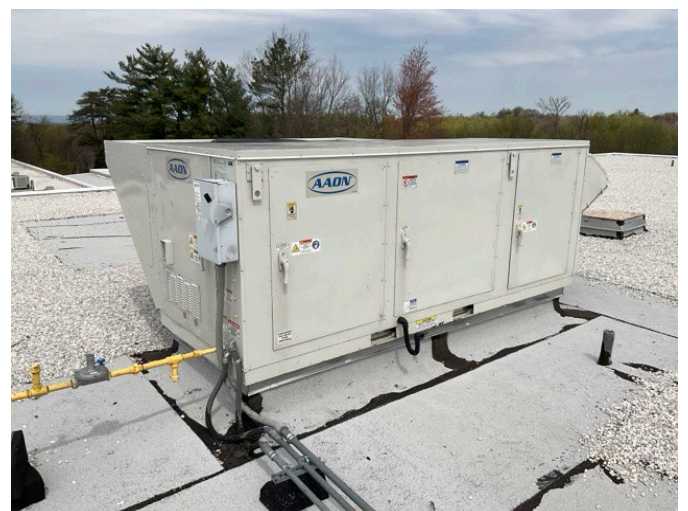
18 - PACKAGED ROOFTOP UNIT

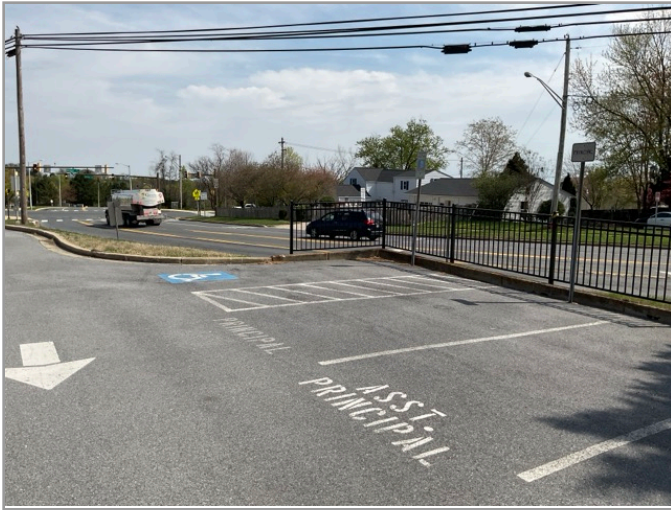
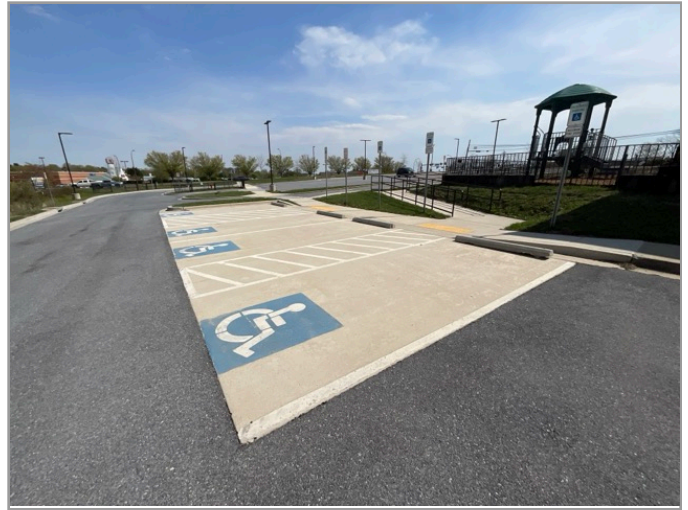
OVERVIEW OF ACCESSIBLE PARKING AREA

2ND AREA OF ACCESSIBLE PARKING

Question		Yes	No	NA	Comments
1	Does the required number of standard ADA designated spaces appear to be provided ?	✗			
2	Does the required number of van-accessible designated spaces appear to be provided ?	✗			
3	Are accessible spaces on the shortest accessible route to an accessible building entrance ?	✗			
4	Does parking signage include the International Symbol of Accessibility ?	✗			
5	Does each accessible space have an adjacent access aisle ?	✗			
6	Do parking spaces and access aisles appear to be relatively level and without obstruction ?	✗

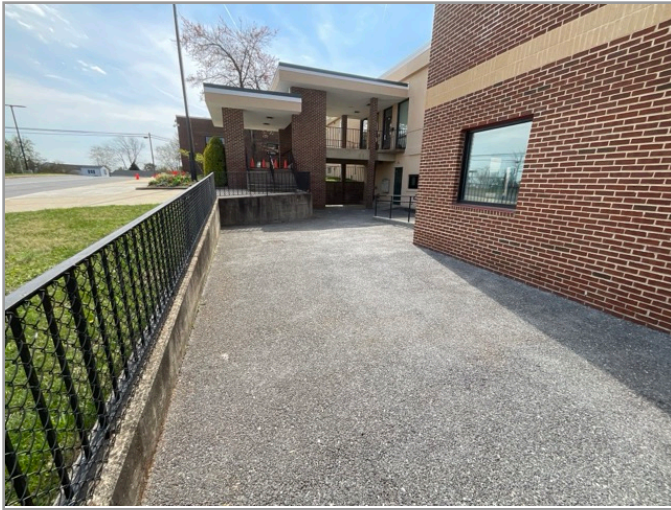
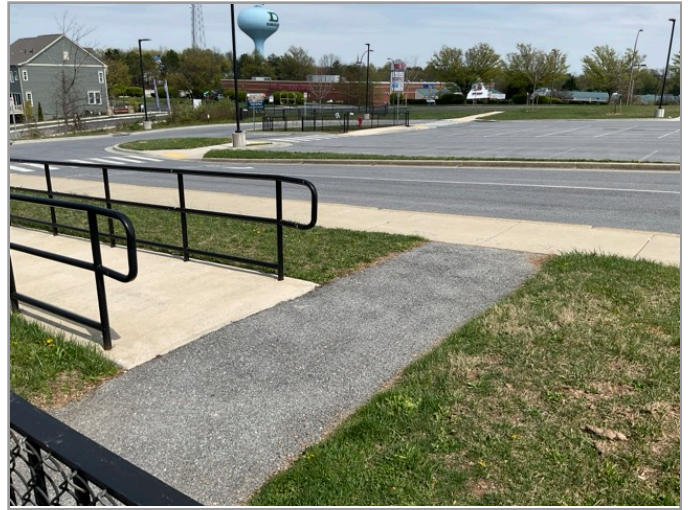
ACCESSIBLE PATH

Question		Yes	No	NA	Comments
1	Is an accessible route present from public transportation stops and municipal sidewalks on or immediately adjacent to the property ?	✗			
2	Does a minimum of one accessible route appear to connect all public areas on the exterior, such as parking and other outdoor amenities, to accessible building entrances ?	✗			
3	Are curb ramps present at transitions through raised curbs on all accessible routes?	✗			
4	Do curb ramps appear to have compliant slopes for all components ?	✗			
5	Do ramp runs on an accessible route appear to have compliant slopes ?	✗			
6	Do ramp runs on an accessible route appear to have a compliant rise and width ?	✗

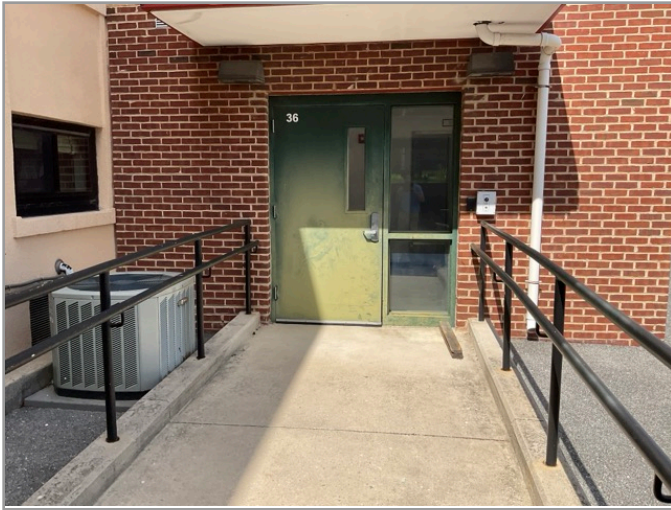
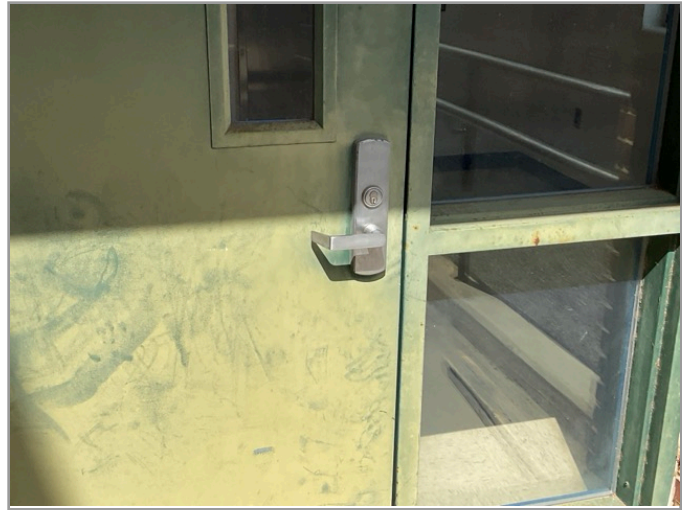
ACCESSIBLE ENTRANCE

DOOR HARDWARE

Question		Yes	No	NA	Comments
1	Do a sufficient number of accessible entrances appear to be provided ?	✗			
2	If the main entrance is not accessible, is an alternate accessible entrance provided?	✗			
3	Is signage provided indicating the location of alternate accessible entrances ?		✗		No signage to accessible entrances observed
4	Do doors at accessible entrances appear to have compliant maneuvering clearance area on each side ?	✗			
5	Do doors at accessible entrances appear to have compliant hardware ?	✗			
6	Do doors at accessible entrances appear to have a compliant clear opening width ?	✗

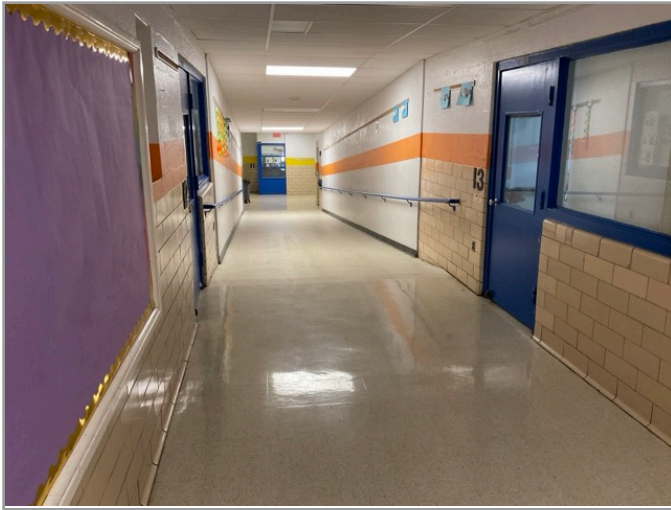
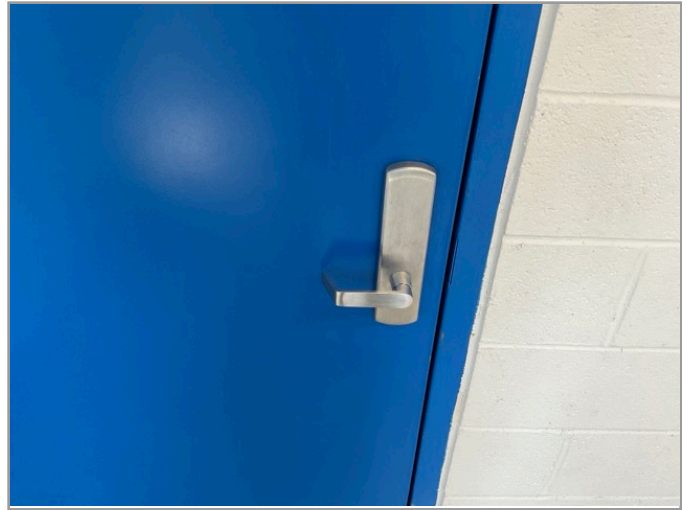
ACCESSIBLE INTERIOR PATH

DOOR HARDWARE

Question		Yes	No	NA	Comments
1	Does an accessible route appear to connect all public areas inside the building ?	✗			
2	Do accessible routes appear free of obstructions and/or protruding objects ?	✗			
3	Do ramps on accessible routes appear to have compliant slopes ?	✗			
4	Do ramp runs on an accessible route appear to have a compliant rise and width ?	✗			
5	Do ramps on accessible routes appear to have compliant end and intermediate landings ?	✗			
6	Do ramps on accessible routes appear to have compliant handrails ?	✗

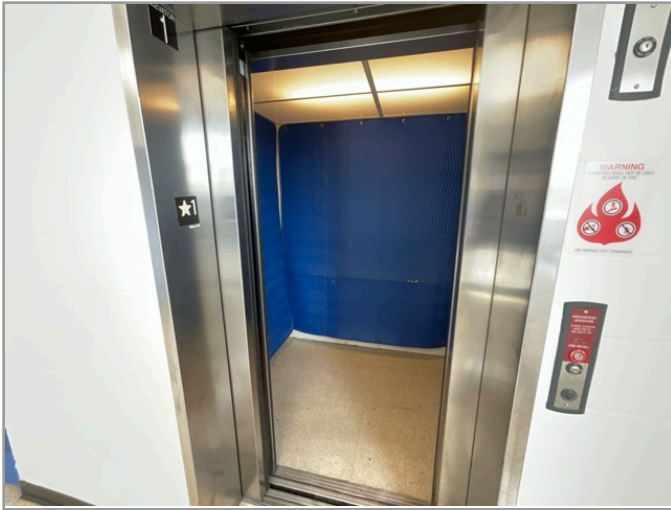
LOBBY LOOKING AT CAB

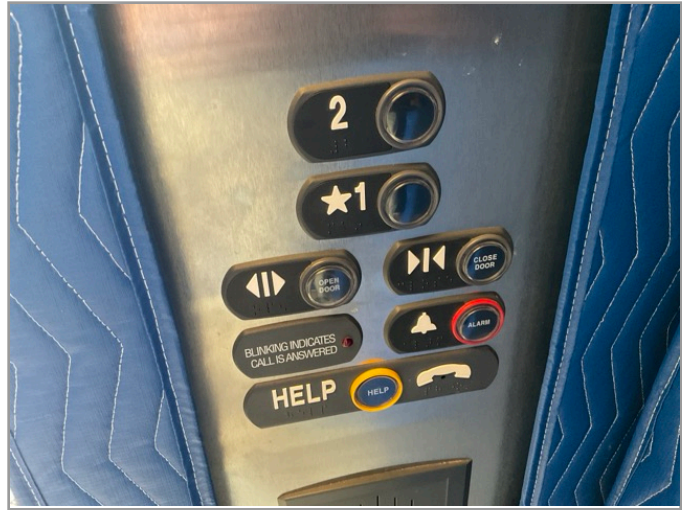
IN-CAB CONTROLS

Question		Yes	No	NA	Comments
1	Are hallway call buttons configured with the "UP" button above the "DOWN" button?	✗			
2	Is accessible floor identification signage present on the hoistway sidewalls on each level ?	✗			
3	Do the elevators have audible and visual arrival indicators at the lobby and hallway entrances?	✗			
4	Do the elevator hoistway and car interior appear to have a minimum compliant clear floor area ?	✗			
5	Do the elevator car doors have automatic re-opening devices to prevent closure on obstructions?	✗			
6	Do elevator car control buttons appear to be mounted at a compliant height ?	✗

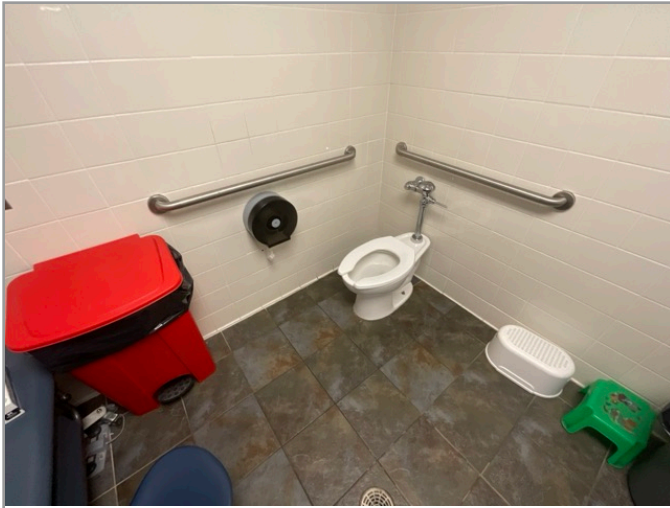
TOILET STALL OVERVIEW

Question		Yes	No	NA	Comments
1	Do publicly accessible toilet rooms appear to have a minimum compliant floor area ?	✗			
2	Does the lavatory appear to be mounted at a compliant height and with compliant knee area ?	✗			
3	Does the lavatory faucet have compliant handles ?	✗			
4	Is the plumbing piping under lavatories configured to protect against contact ?	✗			
5	Are grab bars provided at compliant locations around the toilet ?	✗			
6	Do toilet stall doors appear to provide the minimum compliant clear width ?	✗

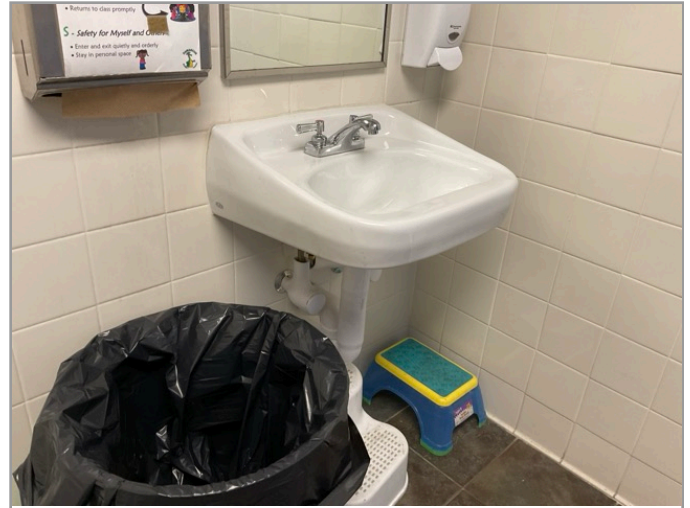
SINK, FAUCET HANDLES AND ACCESSORIES

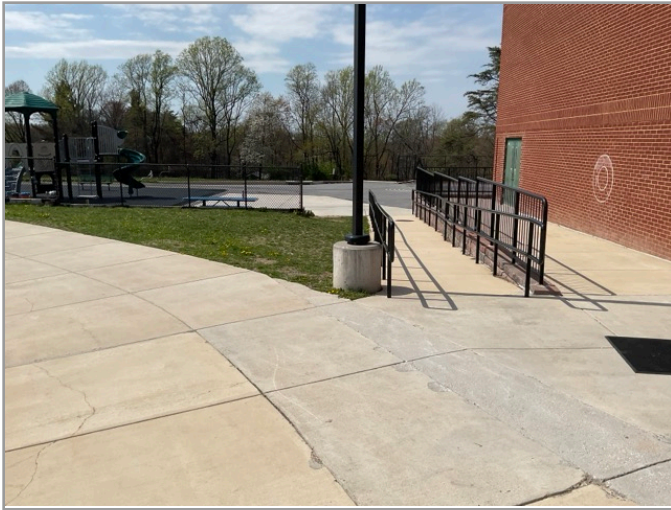
ACCESSIBLE ROUTE TO PLAYGROUND

Question		Yes	No	NA	Comments
1	Is there an accessible route to the play area / s?	✗			
2	Has the play area been reviewed for accessibility ?			✗	Unknown
3	Are publicly accessible swimming pools equipped with an entrance lift ?			✗

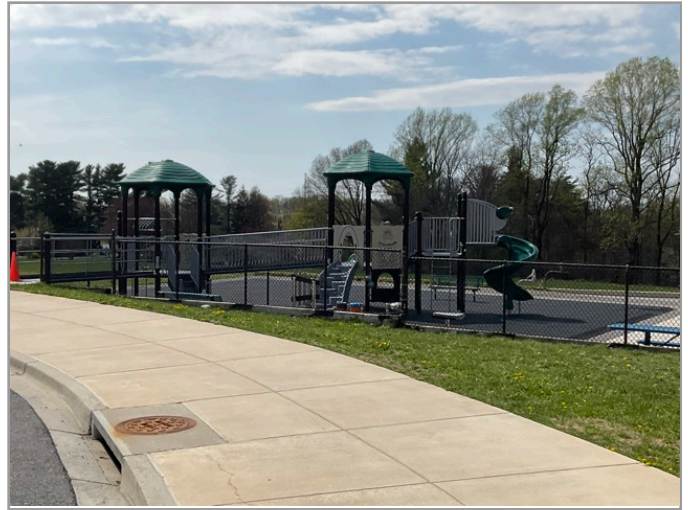
OVERVIEW OF PLAYGROUND
