FACILITY CONDITION ASSESSMENT

Montgomery County Public Schools
45 West Gude Drive, Suite 4000
Rockville, MD 20850

Beall Elementary School
451 Beall Avenue
Rockville, MD 20850

April 10, 2026

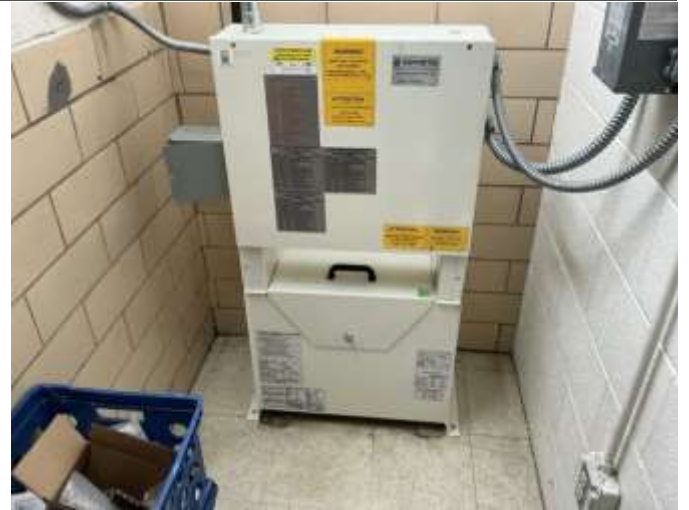
20 - ELEVATOR MACHINERY

The building has one hydraulic elevator serving two floors. POC reports that school personnel constantly get stuck in the elevator and it has been repaired constantly but the problems persist. The building is also served by a wheelchair lift, but the lifts constantly get stuck when in use. Repairs are recommended in the near term.

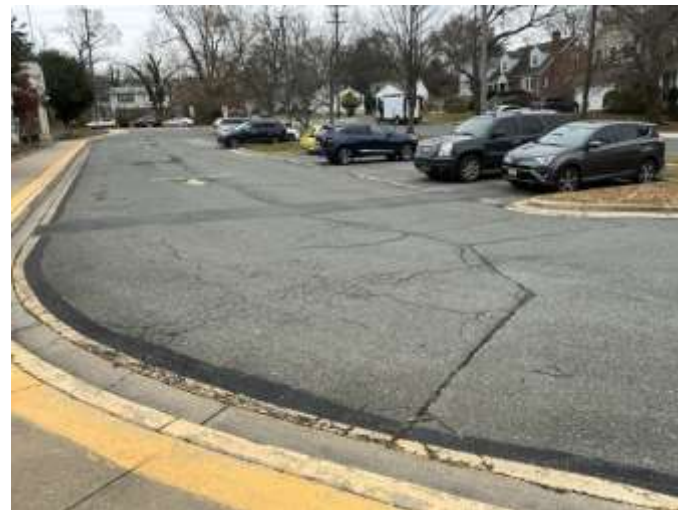
34 - MAIN PARKING AREA

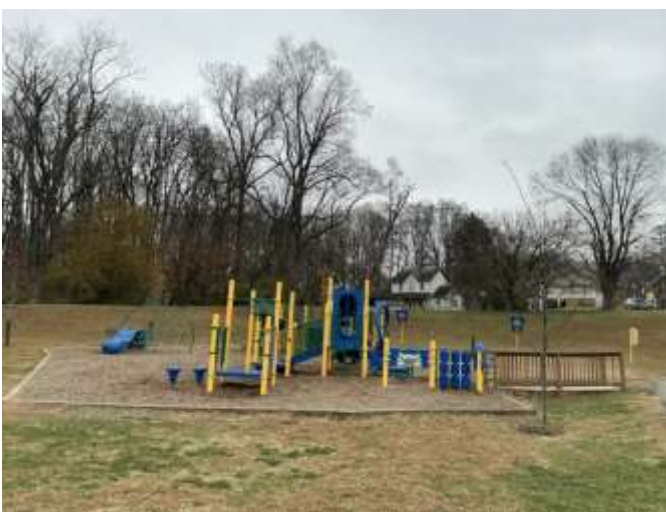
35 - PLAYGROUND

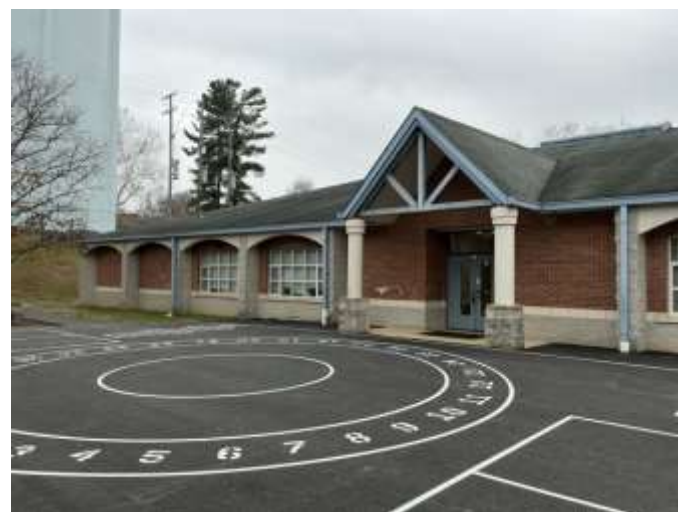
36 - KINDERGARTEN PLAYGROUND

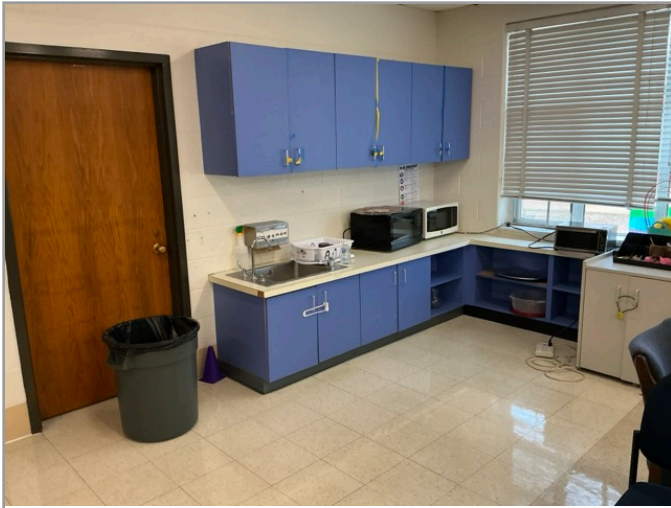
KITCHEN OVERVIEW

Question		Yes	No	NA	Comments
1	Do kitchens/kitchenettes appear to have a minimum compliant path of travel or area of maneuverability ?	✗			
2	Are the appliances centered for a parallel or forward approach with adequate clear floor space ?			✗	
3	Is there an accessible countertop/preparation space of proper width and height ?	✗			
4	Is there an accessible sink space of proper width and height ?	✗			
5	Does the sink faucet have compliant handles ?	✗			
6	Is the plumbing piping under the sink configured to protect against contact ?			✗	Plumbing in cabinet

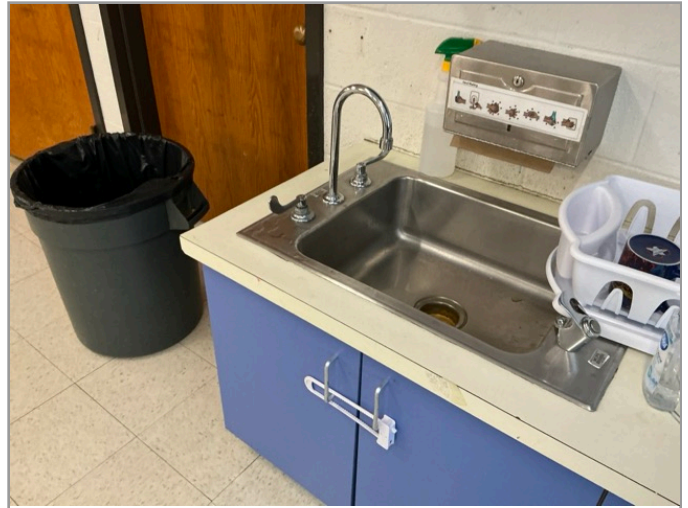
SINK CLEARANCE (SIDE APPROACH)
