FACILITY CONDITION ASSESSMENT

Montgomery County Public Schools

Rachel Carson Elementary School
100 Tschiffely Square Road
Gaithersburg, MD 20878

February 26, 2026

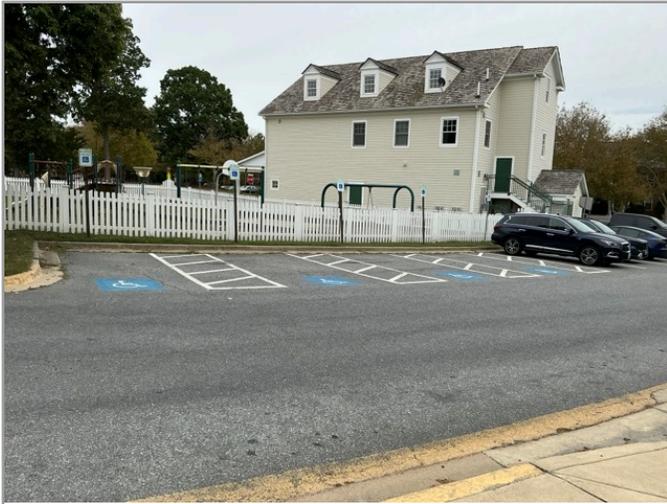
OVERVIEW OF ACCESSIBLE PARKING AREA

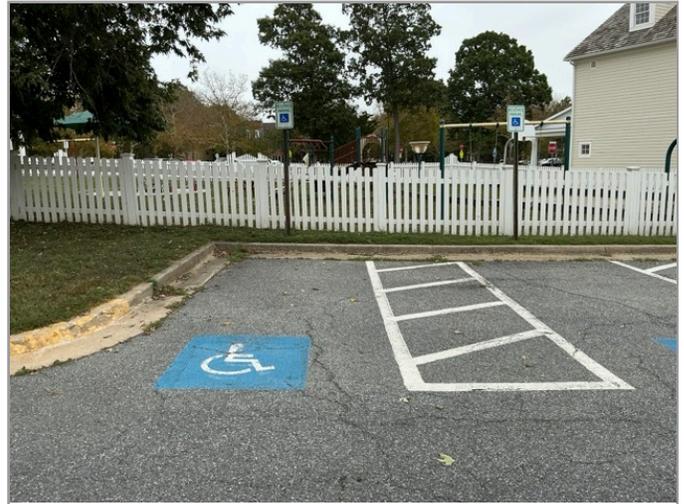
CLOSE-UP OF STALL

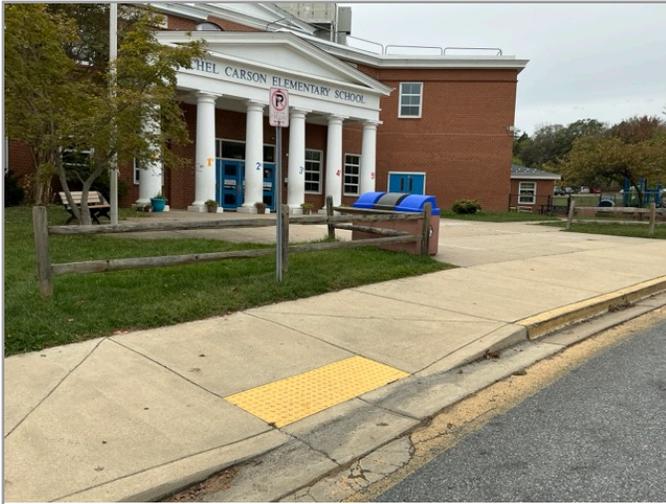
ACCESSIBLE PATH

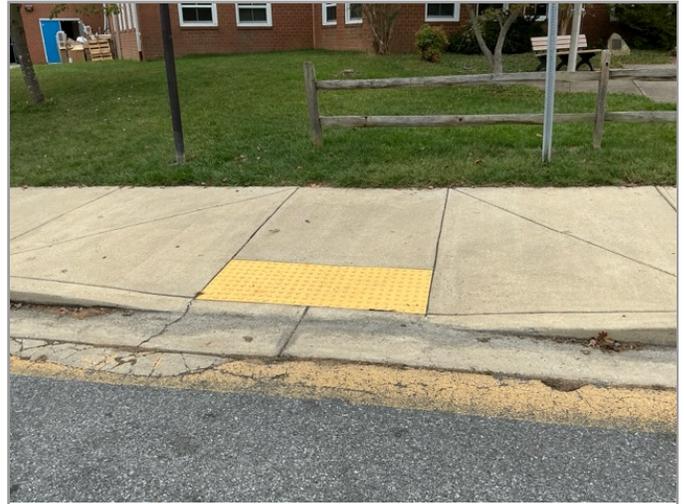
CURB CUT

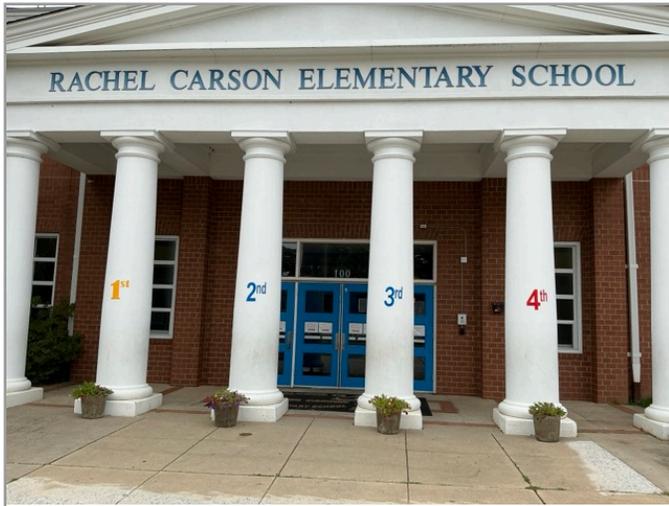
MAIN ENTRANCE

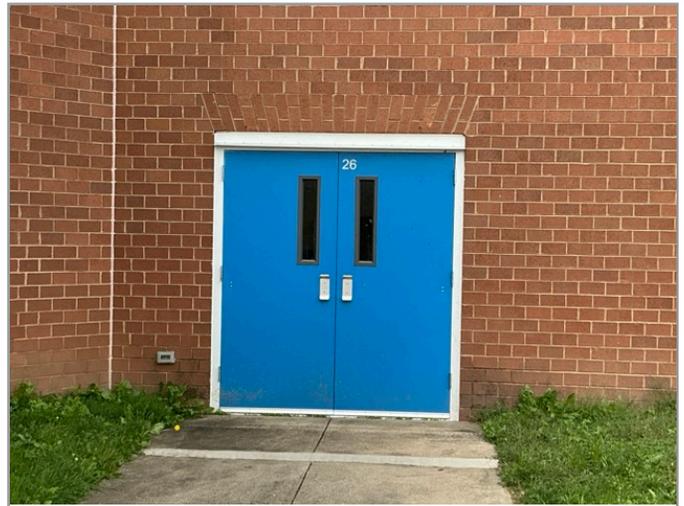
ADDITIONAL ENTRANCE

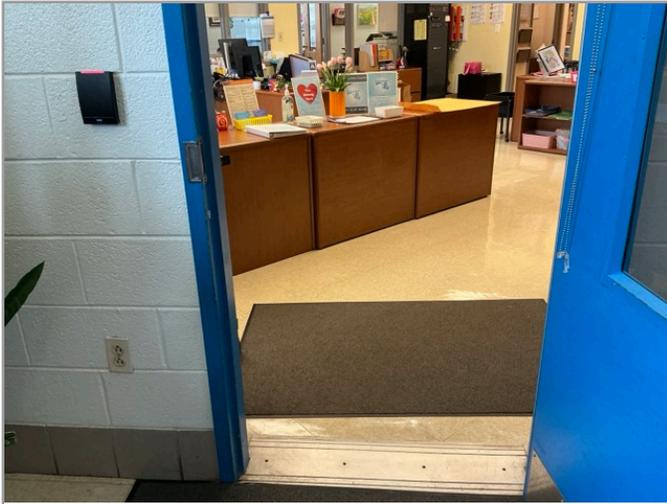
ACCESSIBLE INTERIOR PATH

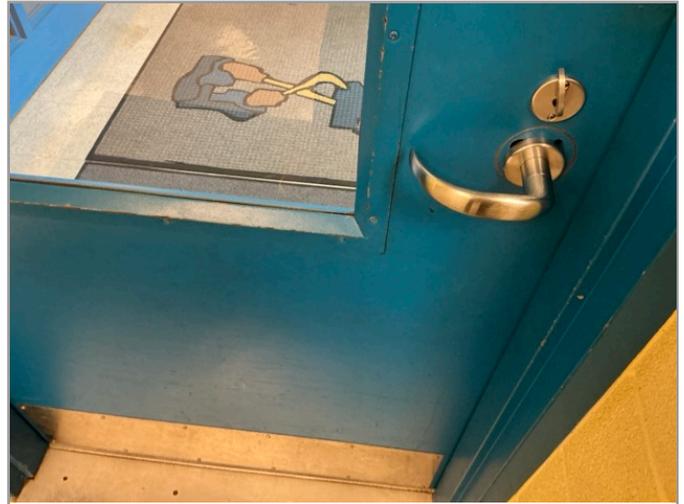
DOOR HARDWARE

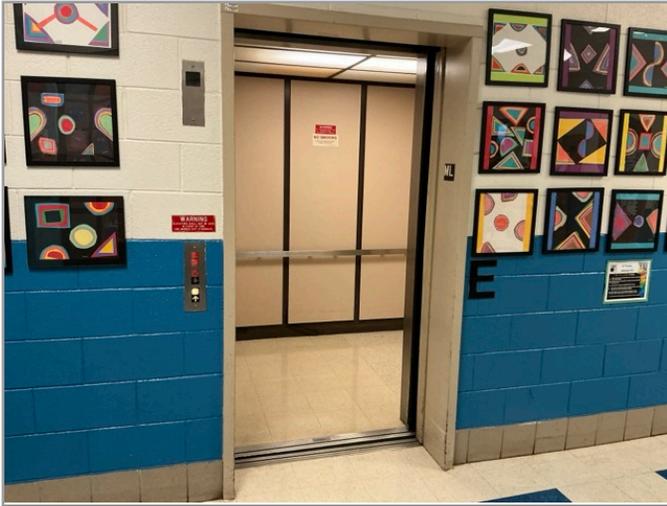
LOBBY LOOKING AT CABS

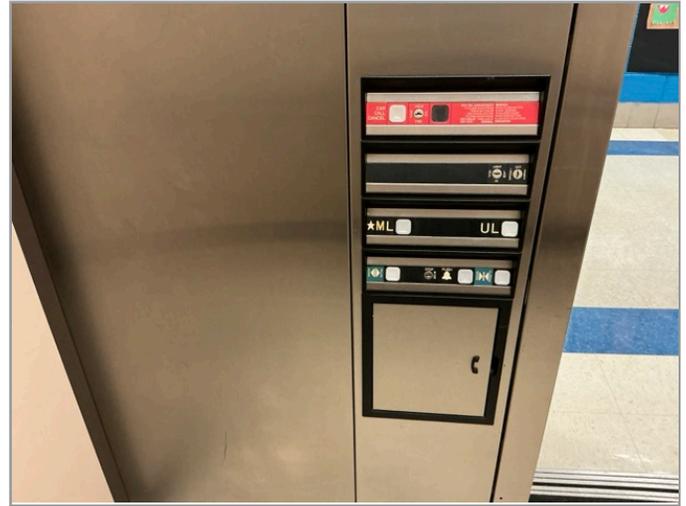
IN-CAB CONTROLS

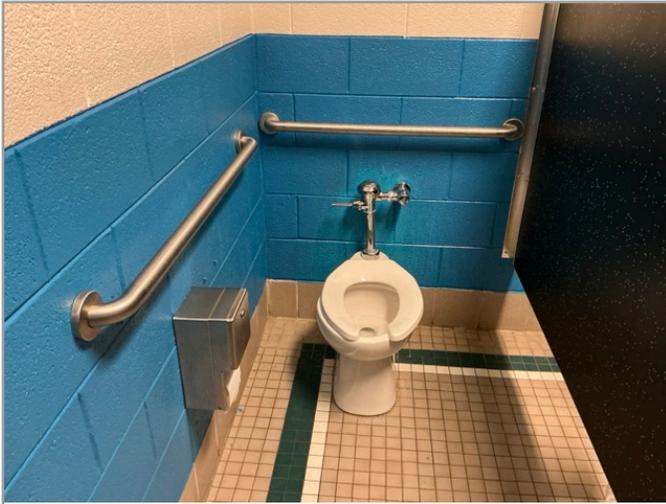
TOILET STALL OVERVIEW

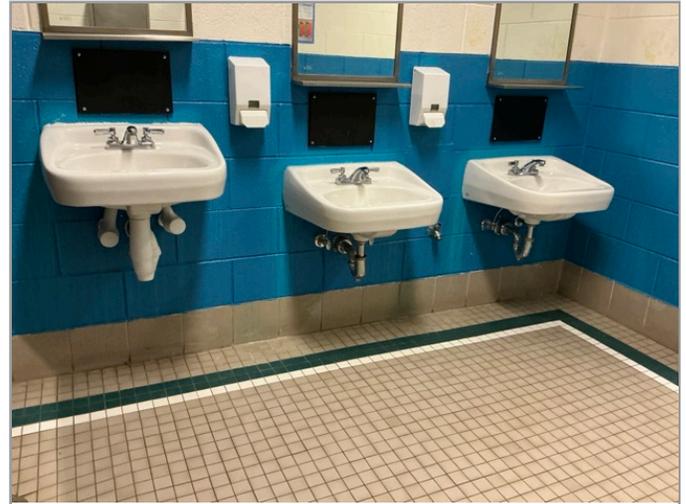
SINK, FAUCET HANDLES AND ACCESSORIES

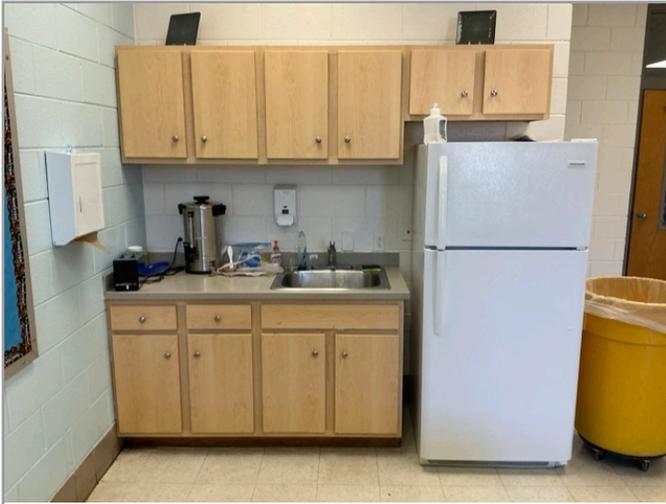
BREAKROOM PATH OF TRAVEL

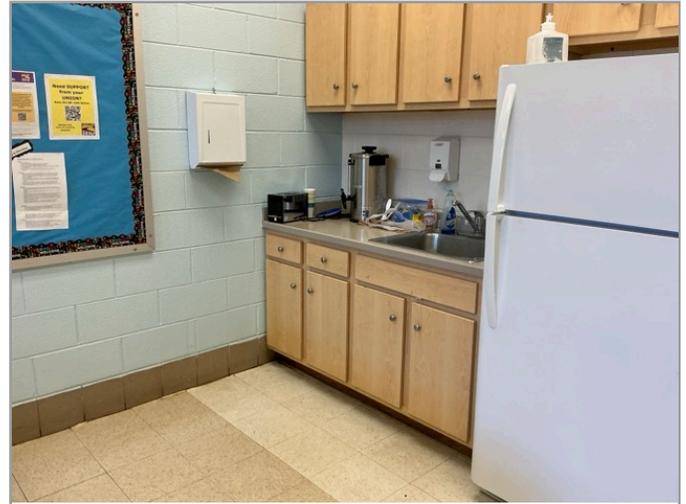
BREAKROOM OVERVIEW

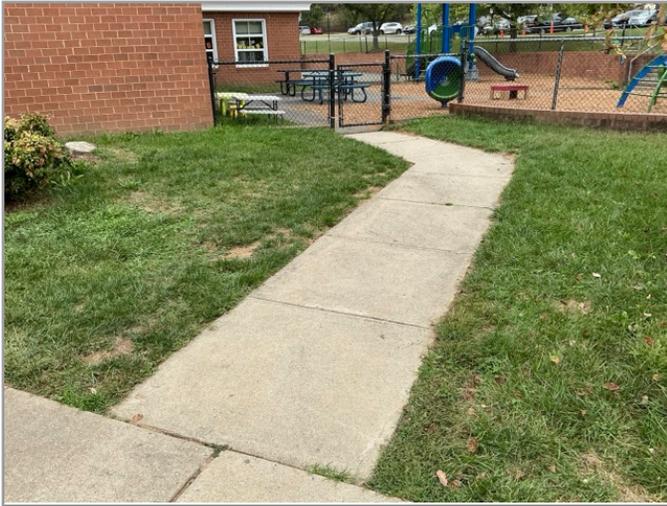
ACCESSIBLE ROUTE TO PLAYGROUND

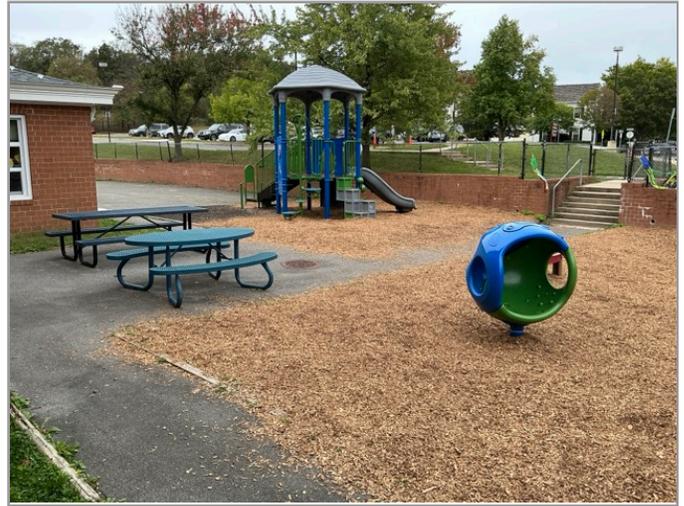
OVERVIEW OF PLAYGROUND
