# FACILITY CONDITION ASSESSMENT

**Montgomery County Public Schools**  
45 West Gude Drive, Suite 4000  
Rockville, MD 20850

Clopper Mill Elementary School  
18501 Cinnamon Drive  
Germantown, MD 20874

*August 13, 2025*

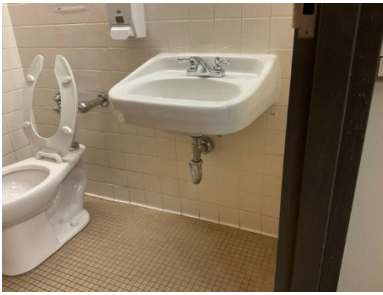
ADA Restroom - AssetCALC ID: 9273770

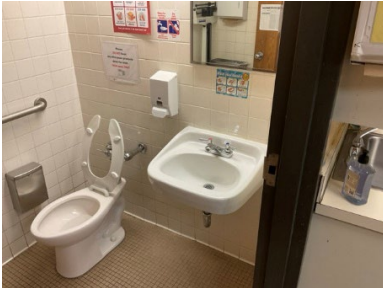
ADA Restroom - AssetCALC ID: 9273801

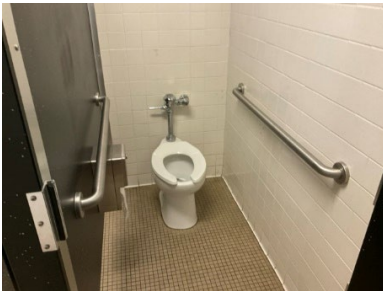
ADA Restroom - AssetCALC ID: 9273843

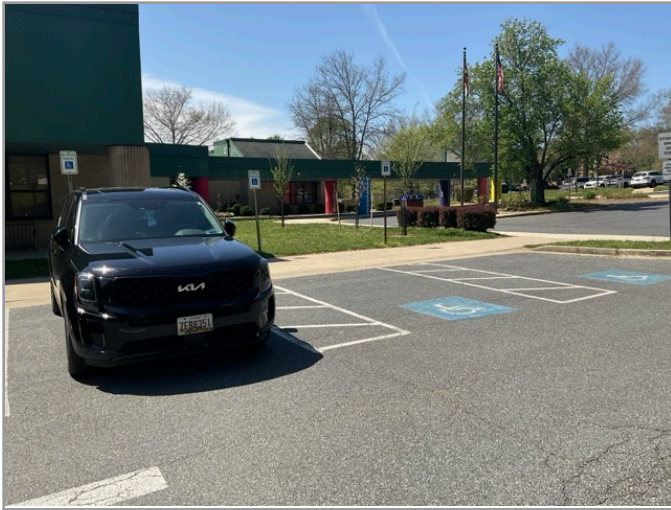
OVERVIEW OF ACCESSIBLE PARKING AREA

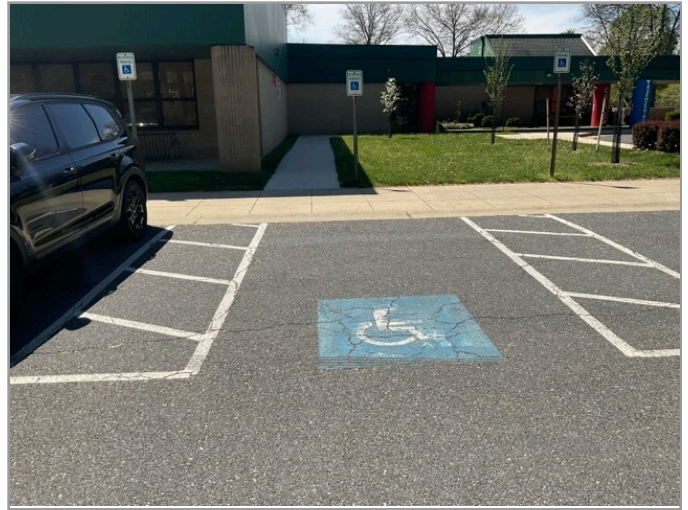
CLOSE-UP OF STALL

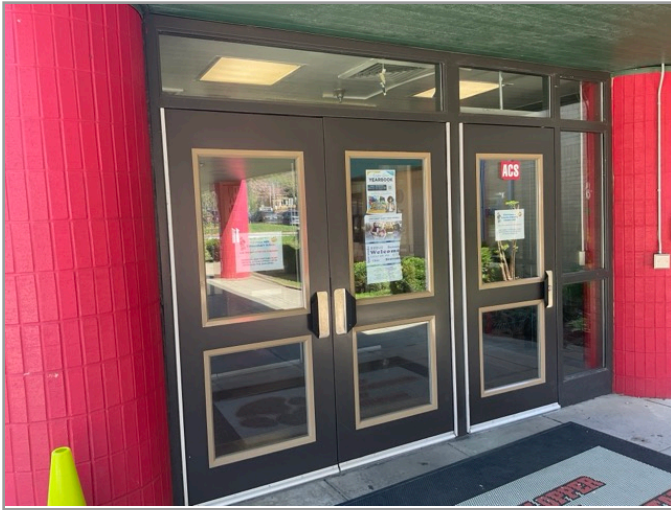
ACCESSIBLE ENTRANCE

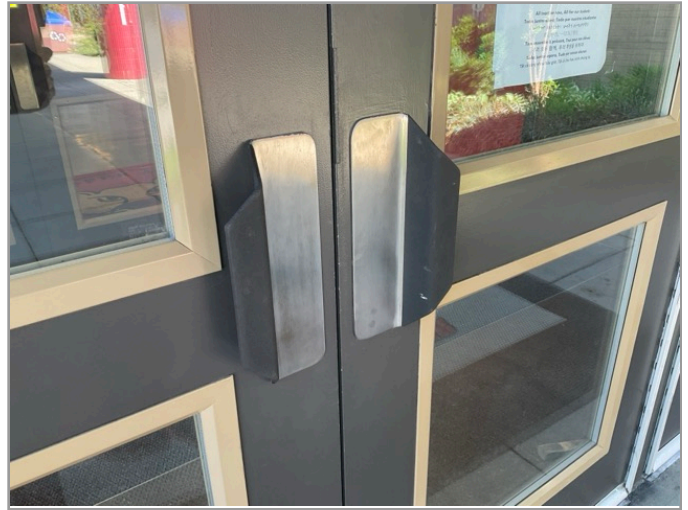
DOOR HARDWARE

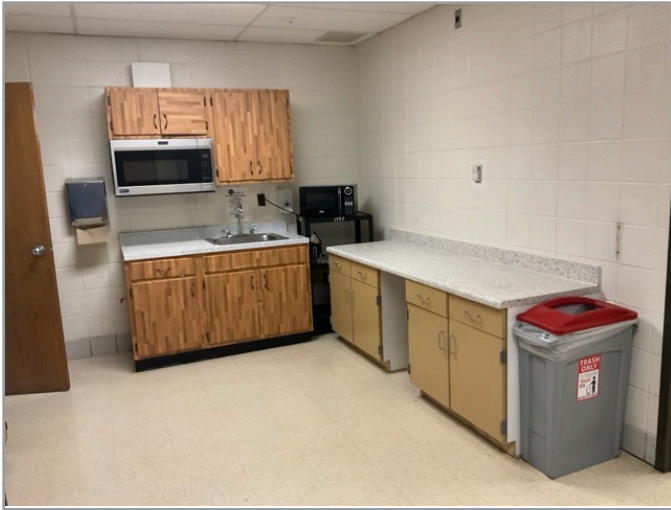
KITCHEN OVERVIEW

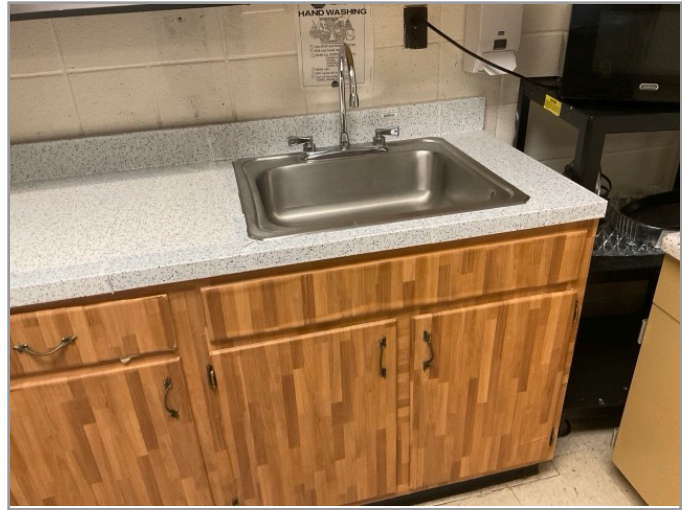
SINK CLEARANCE
