# FACILITY CONDITION ASSESSMENT

Summit Hall Elementary School  
101 West Deer Park Road,  
Gaithersburg, MD 20877

172559.25R000-118.354

May 4, 2026

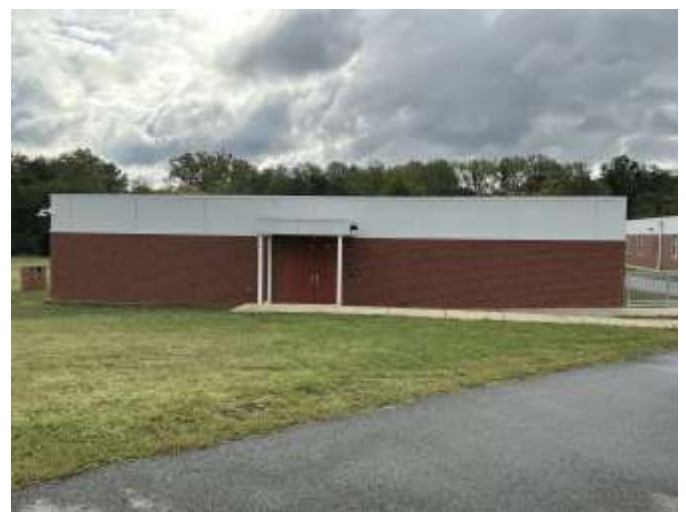
30 - MODULAR CLASSROOM BUILDING A

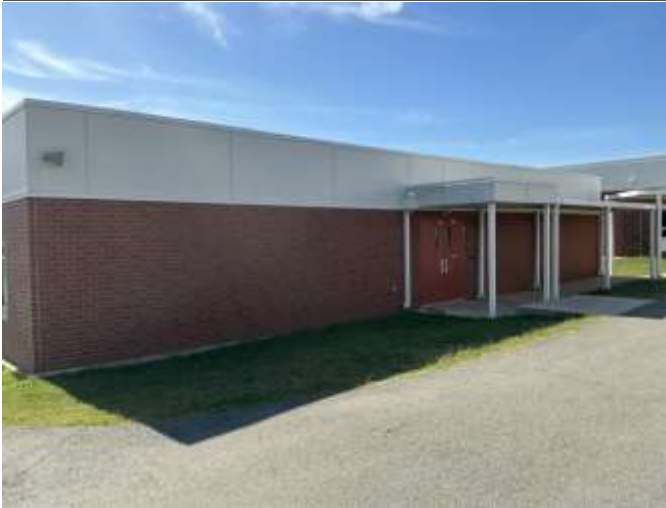
31 - MODULAR CLASSROOM BUILDING B

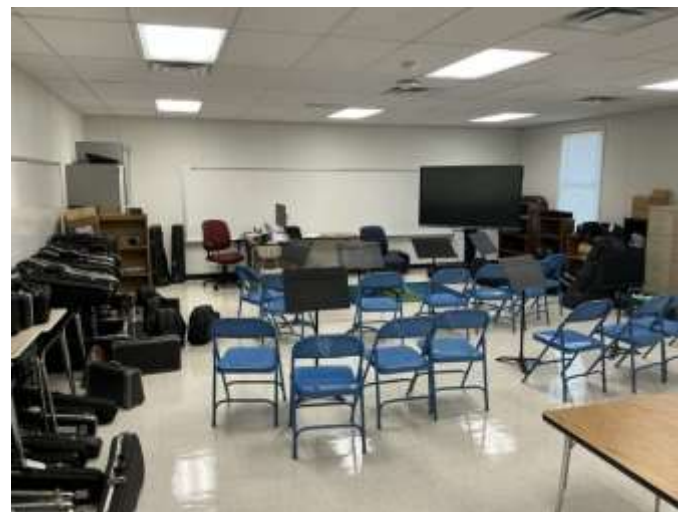
34 - MODULAR BUILDING A MUSIC CLASSROOM

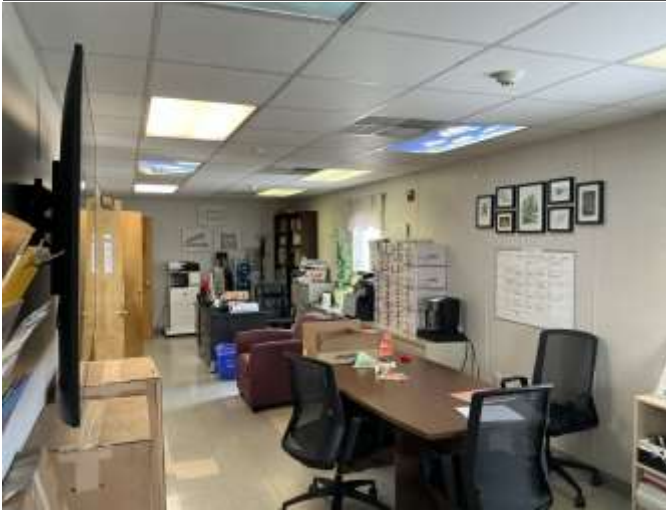
37 - JENNY CENTER OFFICES

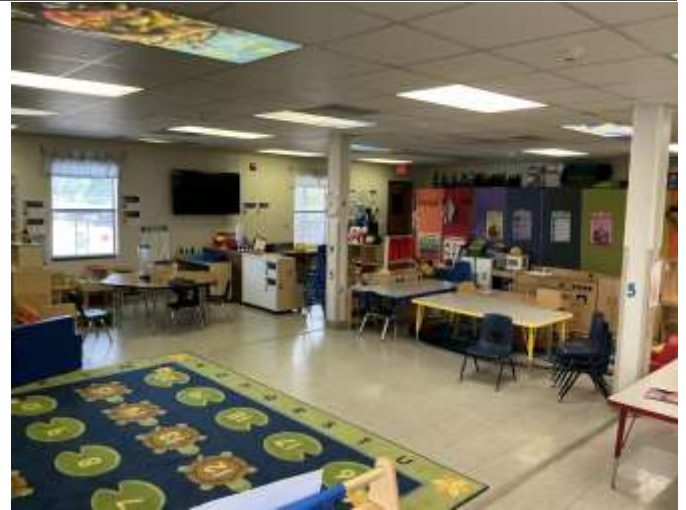
38 - JENNY CENTER CLASSROOM

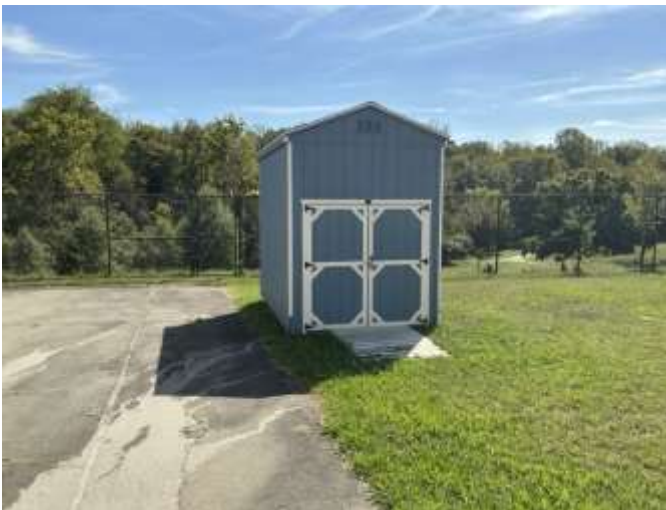
39 - PLAY AREA STORAGE BUILDING

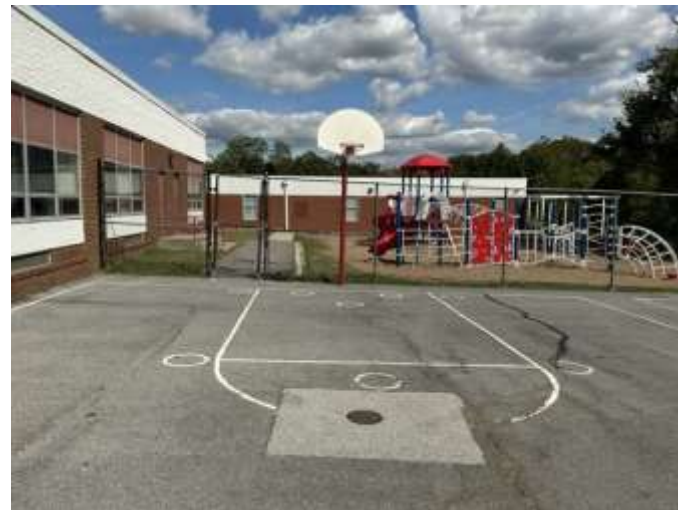
40 - REAR PLAY AREA

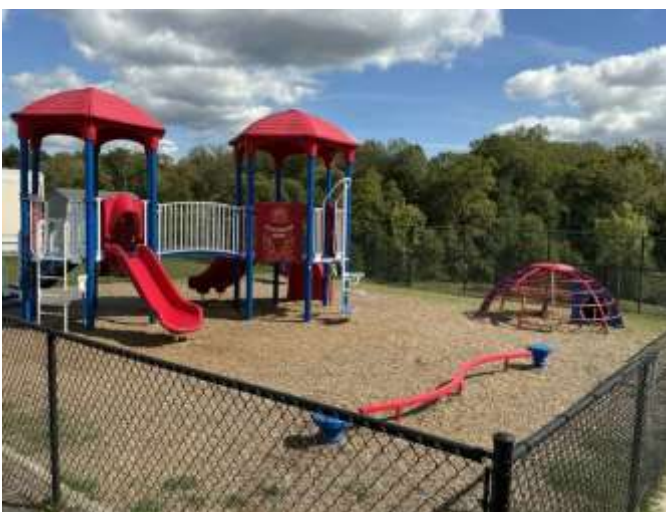
41 - OVERVIEW OF PLAYGROUND

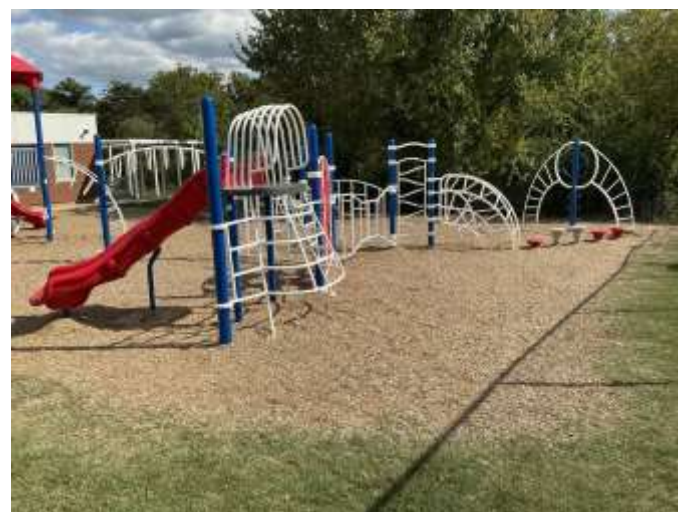
42 - PLAY STRUCTURE
