# FACILITY CONDITION ASSESSMENT

*prepared for*

172559.25R000-209.354

Up County Early Childhood Center at Emory Grove  
18100 Washington Grove Lane  
Gaithersburg, MD 20877

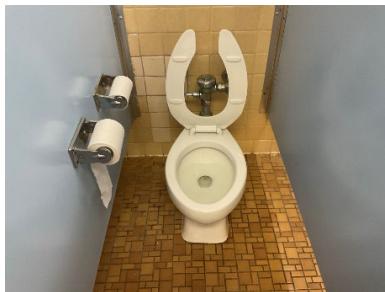
Toilet Partitions, Location/Clearance  
Main Building Up County Early Childhood Center at Emory Grove Restrooms

ADA Restroom toilet stall - AssetCALC ID: 9506348

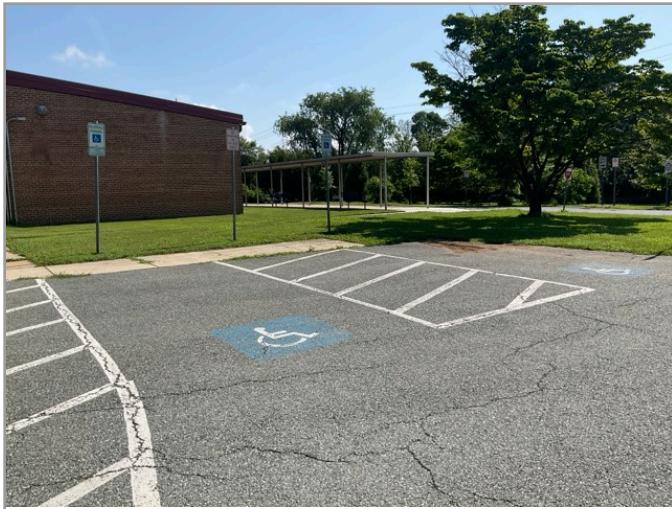
OVERVIEW OF ACCESSIBLE PARKING AREA

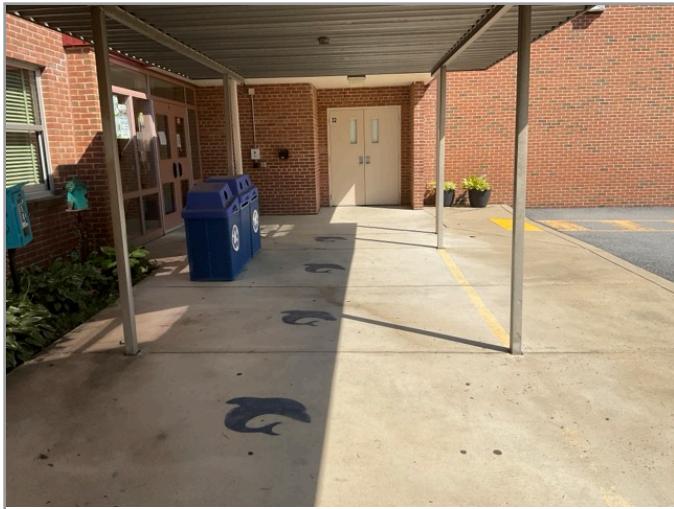
ACCESSIBLE PATH

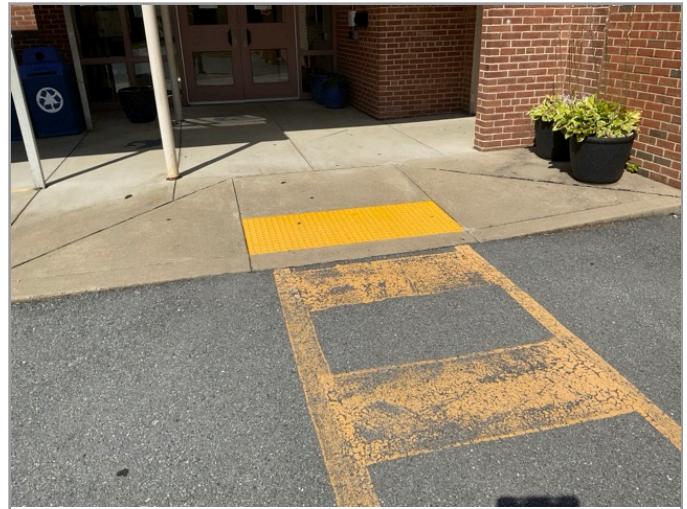
CURB CUT

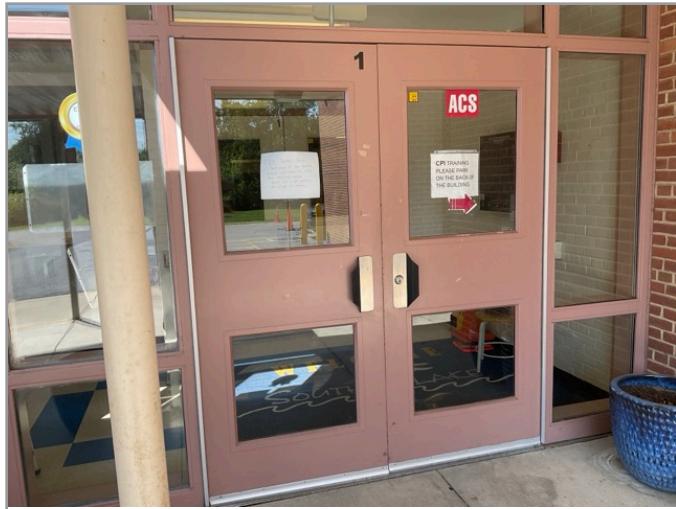
ACCESSIBLE ENTRANCE

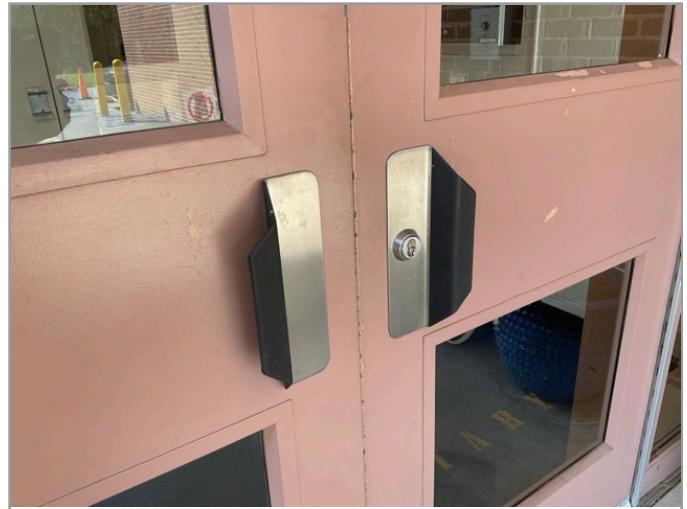
DOOR HARDWARE

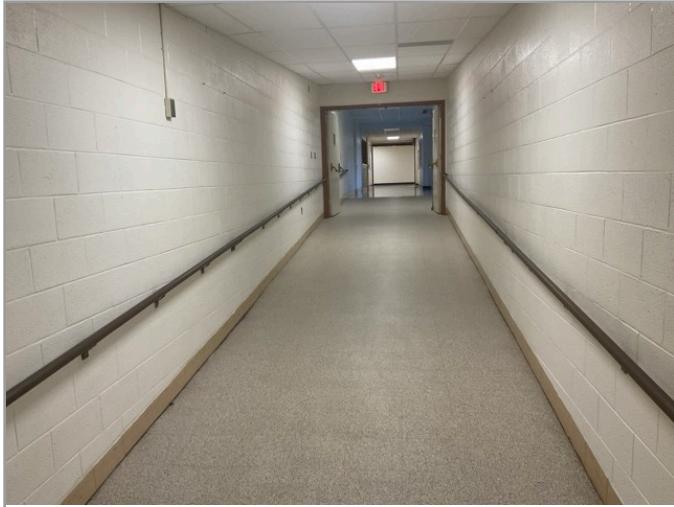
ACCESSIBLE INTERIOR RAMP

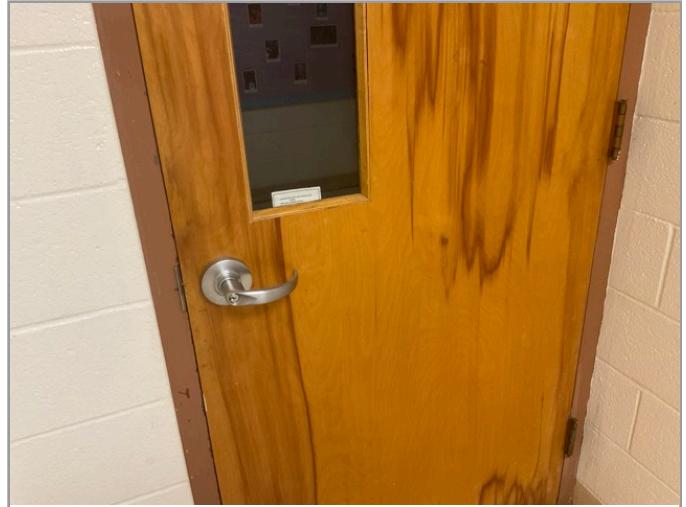
DOOR HARDWARE

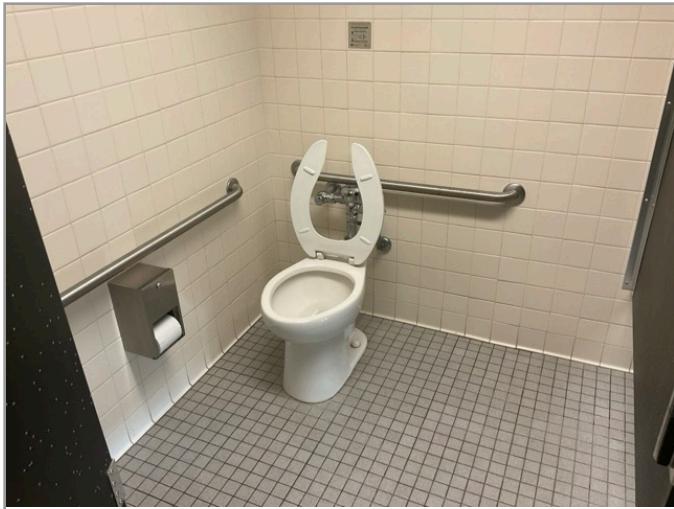
TOILET STALL OVERVIEW

Question		Yes	No	NA	Comments
1	Do publicly accessible toilet rooms appear to have a minimum compliant floor area ?	✗			
2	Does the lavatory appear to be mounted at a compliant height and with compliant knee area ?	✗			
3	Does the lavatory faucet have compliant handles ?	✗			
4	Is the plumbing piping under lavatories configured to protect against contact ?		✗		Some sinks missing wraps
5	Are grab bars provided at compliant locations around the toilet ?		✗		Some missing grab bars
6	Do toilet stall doors appear to provide the minimum compliant clear width ?		✗		Some incompliant toilet stalls

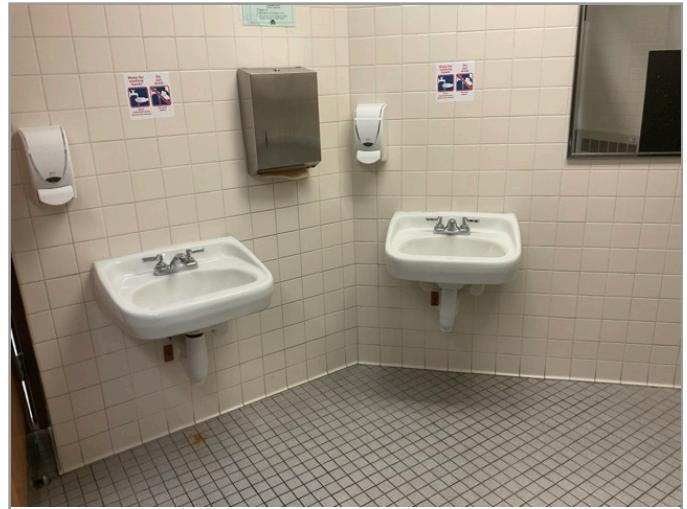
SINK, FAUCET HANDLES AND ACCESSORIES

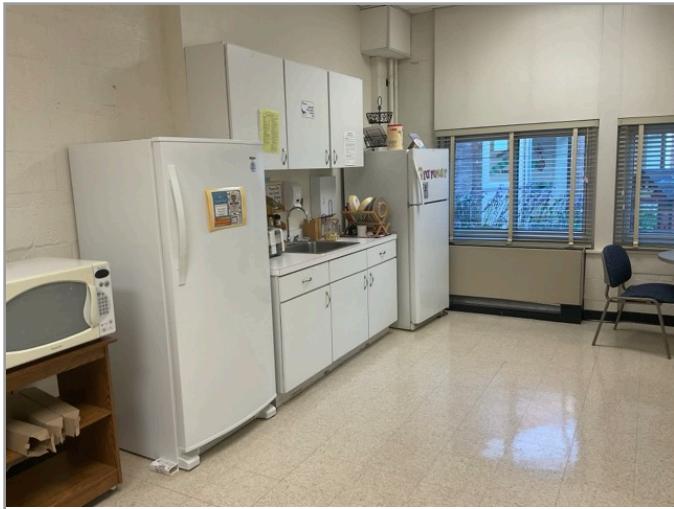
KITCHEN OVERVIEW

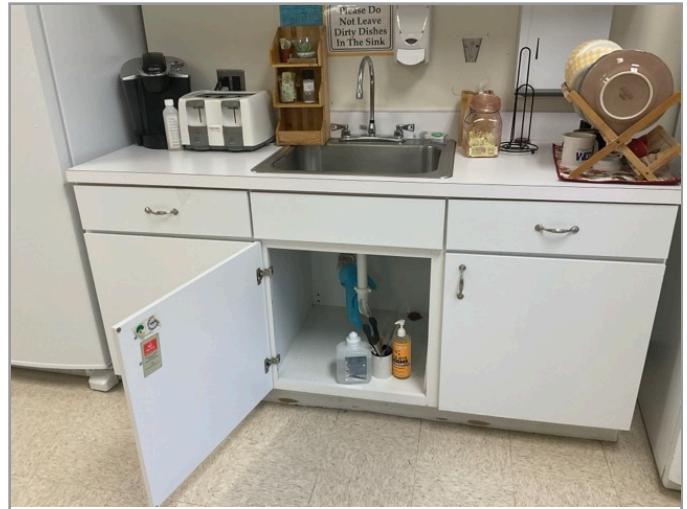
SINK CLEARANCE

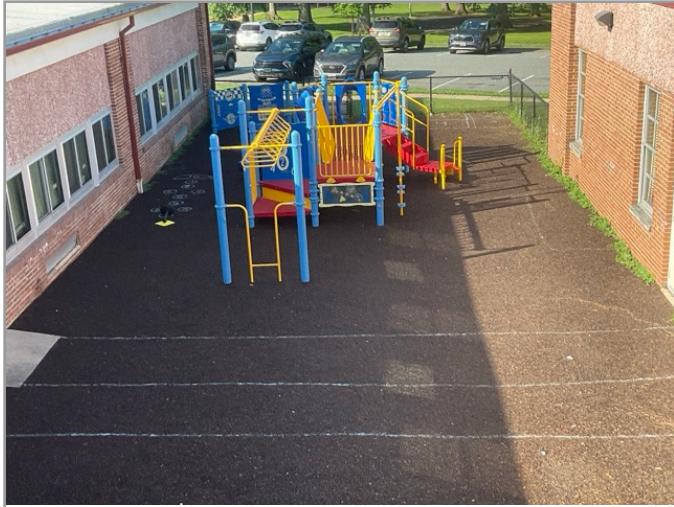
OVERVIEW OF PLAYGROUND

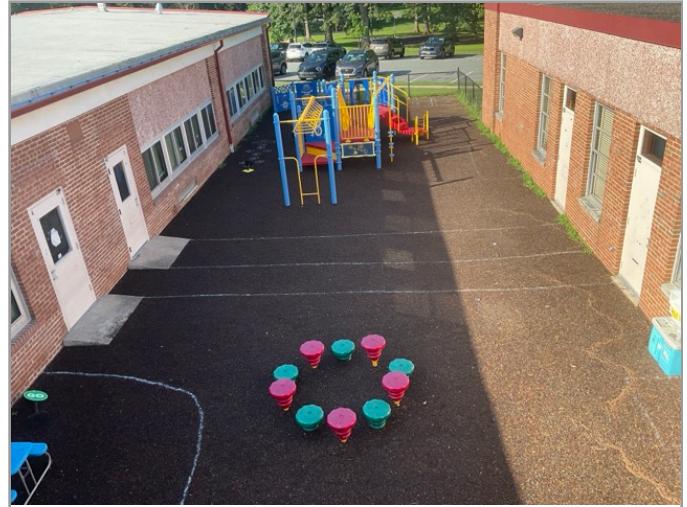
ACCESSIBLE ROUTE TO PLAYGROUND
